City of Irvine
Parks Master Plan
FINAL | JULY 2015

ADA Assessment of Play Areas in Irvine Parks

TECHNICAL SUPPLEMENT

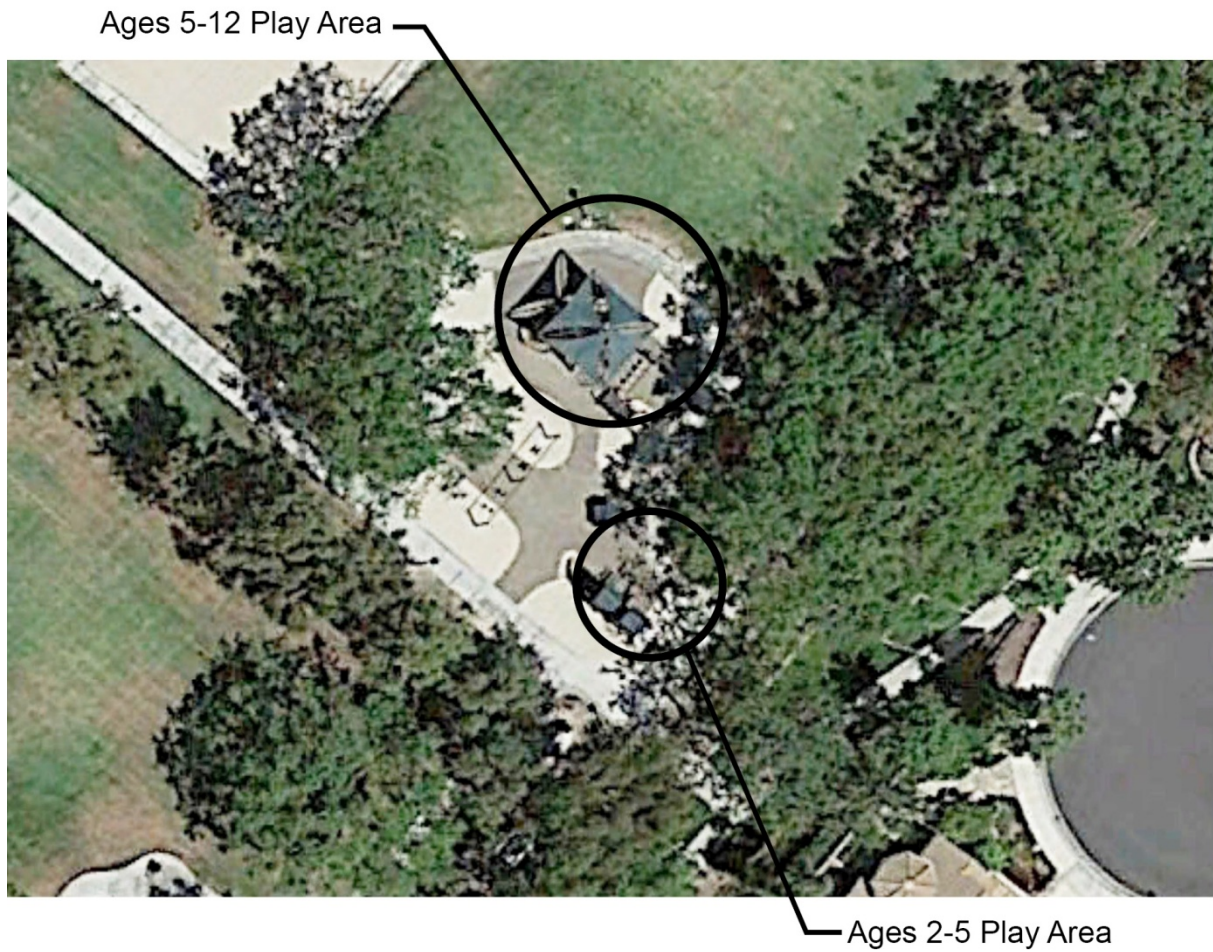
BLUE GUM PARK

Action	Action Note	Planning Cost Estimate	Relevant Code
Install or modify transfer system	The 30 by 48 inch ground space adjacent to transfer has a slope of up to 3.5 percent (2.0 percent maximum allowed).	\$400	CBC 11B-1008.3.1.3 ADA 1008.3.1.3
Install tread striping	Striping is not provided on stairs connecting play components.	\$200	CBC 11B-210.1 CBC 11B-504.4.1
Provide play components	Knee space at play table is 17 inches high and 23 inches wide between benches (knee clearance shall be 24 inches high minimum and 30 inches wide minimum for tables not set up for parallel approach). The table is not positioned to allow for a parallel approach. Table is 11 inches behind front of benches.	\$5,000	CBC 11B-1008.4.3 ADA 1008.4.3
Improve or evaluate play area surface	Further evaluation of fall attenuation surface is recommended.	\$0	CBC 11B-1008.2.6.1 ADA 1008.2.6.1 ADA 1008.2.6.2
Total		\$5,600

Action	Action Note	Planning Cost Estimate	Relevant Code
Provide an accessible path of travel	Vertical clearance at the accessible route under horizontal ladder is 78-3/4 inches (80 inches minimum required).	\$125	CBC 11B-1008.2 ADA 1008.2
Improve or evaluate play area surface	Further evaluation of fall attenuation surface is recommended. There is a 3/8 inch gap between the poured in place surface and adjacent concrete, will need maintenance in future.	\$0	CBC 11B-1008.2.6.1 ADA 1008.2.6.1 ADA 1008.2.6.2
Install or modify transfer system	The 30 by 48 inch ground space adjacent to transfer platform has a slope of up to 3.5 percent (2.0 percent maximum permitted).	\$400	CBC 11B-1008.3.1.3 ADA 1008.3.1.3
Install tread striping	Striping is not provided on stairs connecting play components.	\$200	CBC 11B-210.1 CBC 11B-504.4.1
Modify play component	A 30 by 48 inch minimum clear space with a slope of 2.0 percent maximum is not provided at the overhead spinner due to sand ground surface.	\$400	CBC 11B-1008.4.2 ADA 1008.4.2

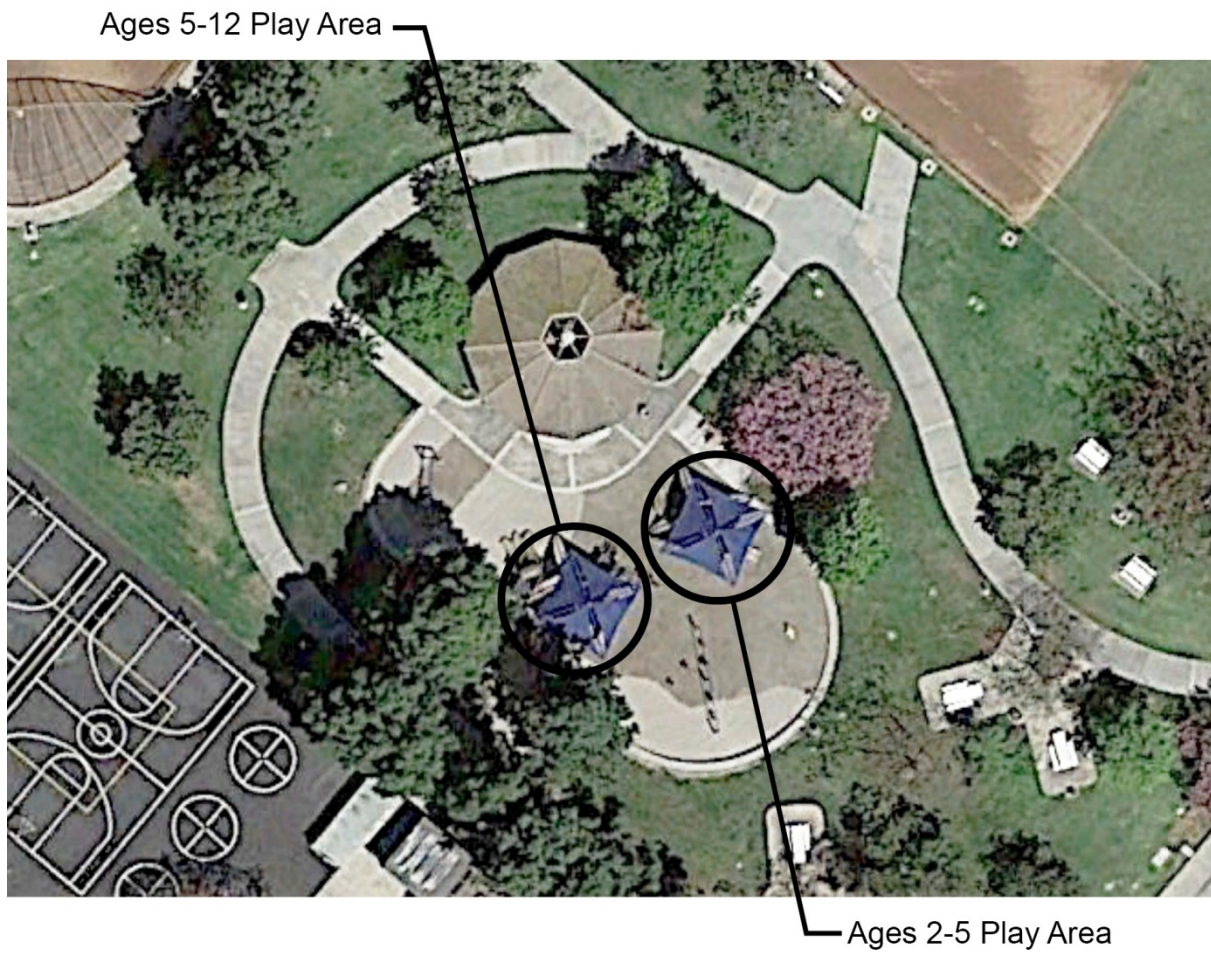
BRYWOOD PARK

Action	Action Note	Planning Cost Estimate	Relevant Code
Install or modify transfer system	The 30 by 48 inch ground space adjacent to transfer platform has a slope of up to 2.2 percent (2.0 percent maximum permitted).	\$400	CBC 11B-1008.3.1.3 ADA 1008.3.1.3
Install tread striping	Striping is not provided on stairs connecting play components.	\$200	CBC 11B-210.1 CBC 11B-504.4.1
Provide play components	Knee space at play table is 20-3/4 inches high and 23 inches wide between benches (24 inches minimum height and 30 inches minimum width). The table is not positioned to allow for a parallel approach. Table is 11 inches behind front of benches.	\$5,000	CBC 11B-1008.4.3 ADA 1008.4.3
Improve or evaluate play area surface	Further evaluation of fall attenuation surface is recommended.	\$0	CBC 11B-1008.2.6.1 ADA 1008.2.6.1 ADA 1008.2.6.2
Total		\$5,600

Action	Action Note	Planning Cost Estimate	Relevant Code
Improve or evaluate play area surface	Further evaluation of fall attenuation surface is recommended. Deteriorated top surface.	\$0	CBC 11B-1008.2.6.1 ADA 1008.2.6.1 ADA 1008.2.6.2
Install tread striping	Striping is not provided on stairs connecting play components.	\$200	CBC 11B-210.1 CBC 11B-504.4.1
Provide play components	Four ground level play components of two different types are provided for the 11 elevated play components on the structure (four ground level components of three different types minimum required).	\$5,000	CBC 11B-240.2.1.2 ADA 240.2.1.2
Total		\$5,200

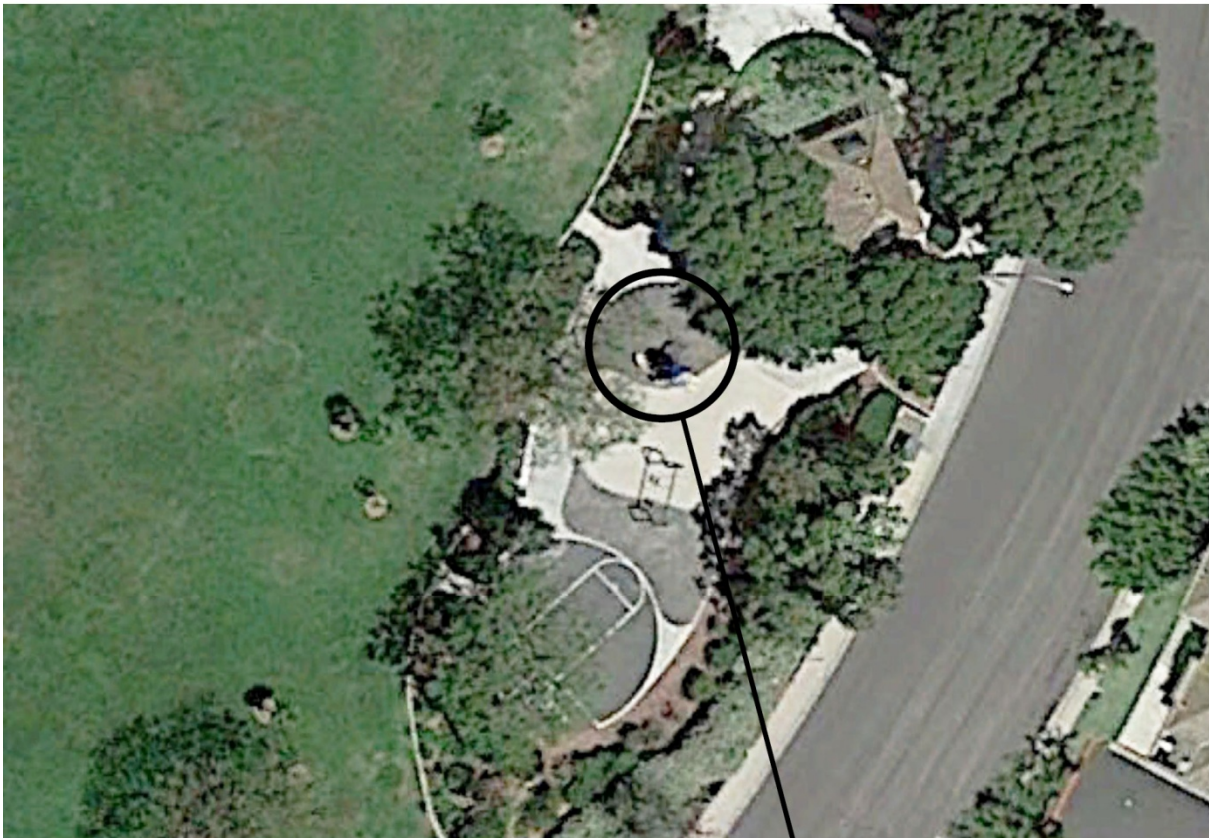
CANYON PARK

Action	Action Note	Planning Cost Estimate	Relevant Code
Provide an accessible path of travel	An accessible route is not provided to alphabet panel due to 12 inches wide poured in place surface and sand for six linear feet.	\$180	CBC 11B-206.2.17.1 CBC 11B-1008.2 ADA 206.2.17.1 ADA 1008.2
Improve or evaluate play area surface	Further evaluation of fall attenuation surface is recommended. Top layer of surface worn near swings.	\$0	CBC 11B-1008.2.6.1 ADA 1008.2.6.1 ADA 1008.2.6.2
Install tread striping	Striping is not provided on stairs connecting play components.	\$200	CBC 11B-210.1 CBC 11B-504.4.1
Modify play component	A 30 by 48 inch minimum clear space with a slope of 2.0 percent maximum is not provided at the alphabet panel due to sand surface.	\$400	CBC 11B-1008.4.2 ADA 1008.4.2
Total		\$780

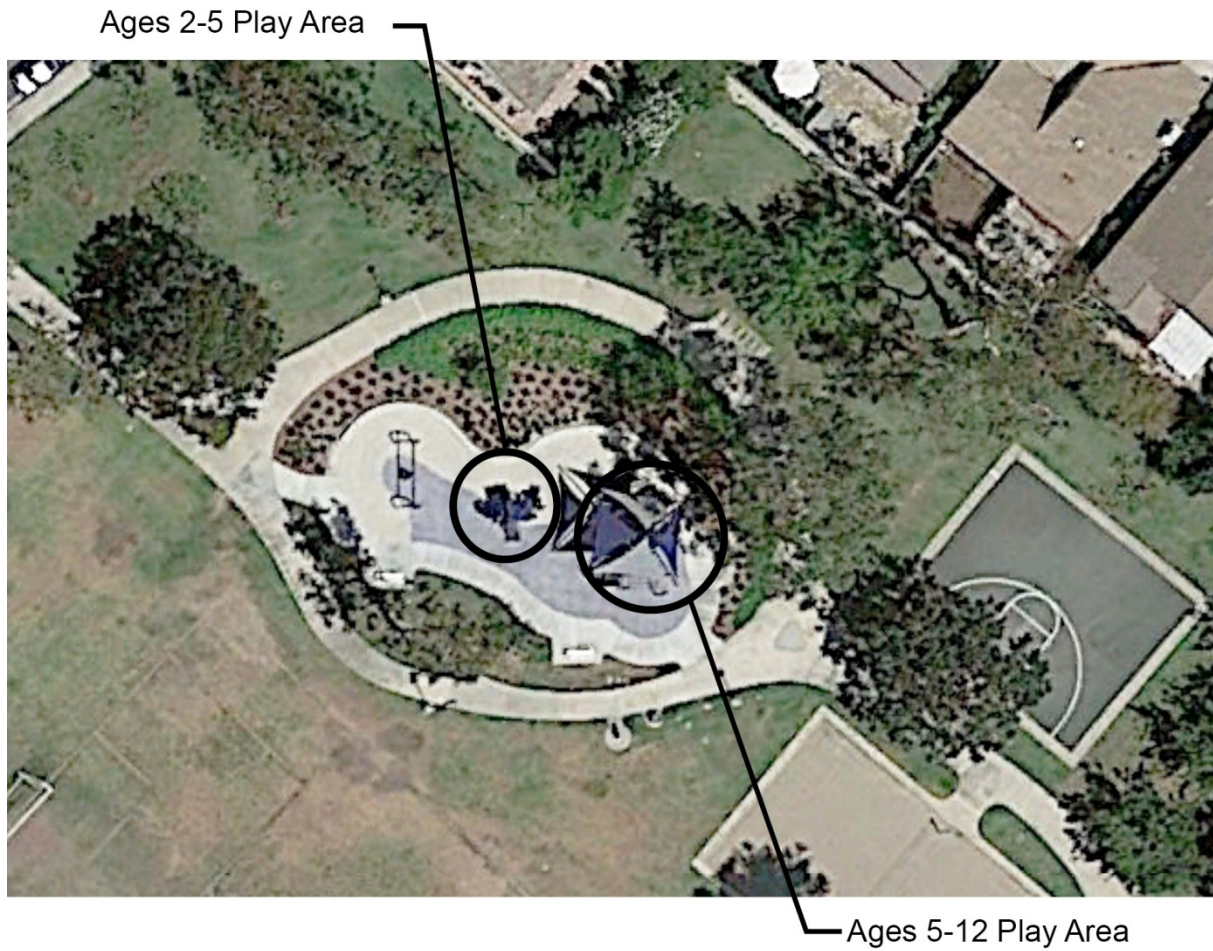
CARROTWOOD PARK

Action	Action Note	Planning Cost Estimate	Relevant Code
Improve or evaluate play area surface	Further evaluation of fall attenuation surface is recommended.	\$0	CBC 11B-1008.2.6.1 ADA 1008.2.6.1 ADA 1008.2.6.2
Install or modify transfer system	The 30 by 48 inch ground space adjacent to transfer platform has a slope of up to 2.3 percent (2.0 percent maximum allowed). Transfer platform surface height is 10-1/2 inches (11 inches minimum to 18 inches maximum allowed) above the accessible surfacing.	\$5,000	CBC 11B-1008.3.1.2 CBC 11B-1008.3.1.3 ADA 1008.3.1.2 ADA 1008.3.1.3
Install tread striping	Striping is not provided on stairs connecting play components.	\$200	CBC 11B-210.1 CBC 11B-504.4.1
Total		\$5,200

Action	Action Note	Planning Cost Estimate	Relevant Code
Provide an accessible path of travel	An accessible route is not provided to the play table at the ages 5 to12 play structure. Play table is located in sand.	\$400	CBC 11B-206.2.17.1 CBC 11B-1008.2 ADA 206.2.17.1 ADA 1008.2
Improve or evaluate play area surface	Further evaluation of fall attenuation surface is recommended.	\$0	CBC 11B-1008.2.6.1 ADA 1008.2.6.1 ADA 1008.2.6.2
Install or modify transfer system	The 30 by 48 inch ground space adjacent to transfer platform has a slope of up to 2.6 percent (2.0 percent maximum permitted).	\$400	CBC 11B-1008.3.1.3 ADA 1008.3.1.3
Install tread striping	Striping is not provided on stairs connecting play components.	\$200	CBC 11B-210.1 CBC 11B-504.4.1
Modify play component	The ground level play panel is centered at 48 inches above accessible surface with the highest operable point at 61 inches (adult maximum reach is 48 inches; advisory: 44 inches maximum for ages 5 to12).	\$125	CBC 11B-308.1 ADA 308.1

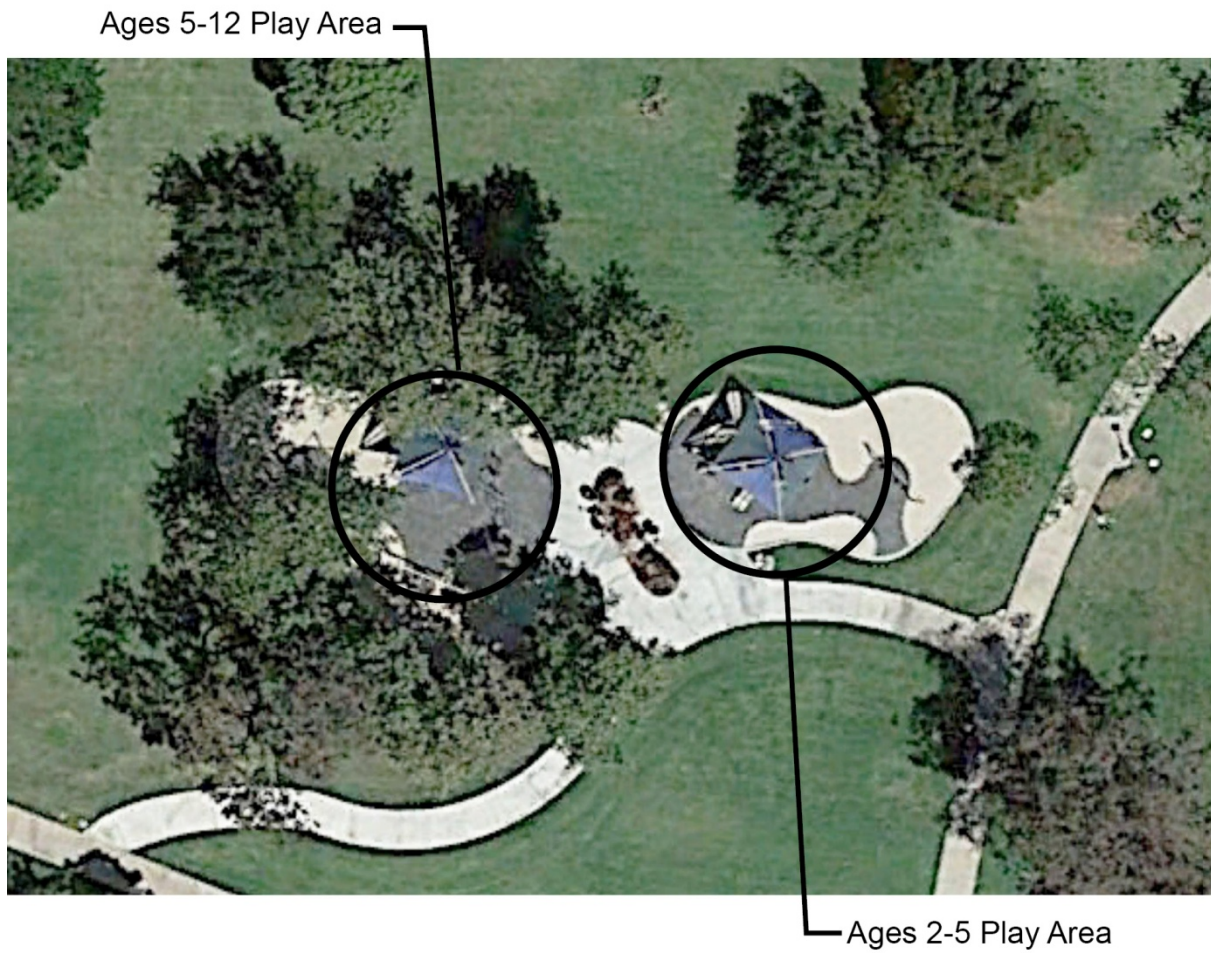
CHAPARRAL PARK

Action	Action Note	Planning Cost Estimate	Relevant Code
Install or modify transfer system	The 30 by 48 inch ground space adjacent to transfer platform has a slope of up to 3.0 percent (2.0 percent maximum permitted).	\$400	CBC 11B-1008.3.1.3 ADA 1008.3.1.3
Install tread striping	Striping is not provided on stairs connecting play components.	\$200	CBC 11B-210.1 CBC 11B-504.4.1
Modify play component	The 30 by 48 inch ground space at the swings has a slope of up to 2.5 percent (2.0 percent maximum allowed). The 30 by 48 inch ground space at table has a slope of up to 3.7 percent (2.0 percent maximum allowed).	\$800	CBC 11B-1008.4.1 CBC 11B-1008.4.2 ADA 1008.4.1 ADA 1008.4.2
Improve or evaluate play area surface	Further evaluation of fall attenuation surface is recommended.	\$0	CBC 11B-1008.2.6.1 ADA 1008.2.6.1 ADA 1008.2.6.2
Total		\$1,400

Action	Action Note	Planning Cost Estimate	Relevant Code
Improve or evaluate play area surface	Further evaluation of fall attenuation surface is recommended. Deteriorated top surface.	\$0	CBC 11B-1008.2.6.1 ADA 1008.2.6.1 ADA 1008.2.6.2
Modify play component	The 30 by 48 inch ground space adjacent to the uphill swing has a slope of up to 2.3 percent (2.0 percent maximum allowed). The 30 by 48 inch ground space adjacent to the maze panel has a slope of up to 2.4 percent (2.0 percent maximum allowed).	\$0	CBC 11B-1008.4.2 ADA 1008.4.2
Install tread striping	Striping is not provided on stairs connecting play components.	\$200	CBC 11B-210.1 CBC 11B-504.4.1
Total		\$200

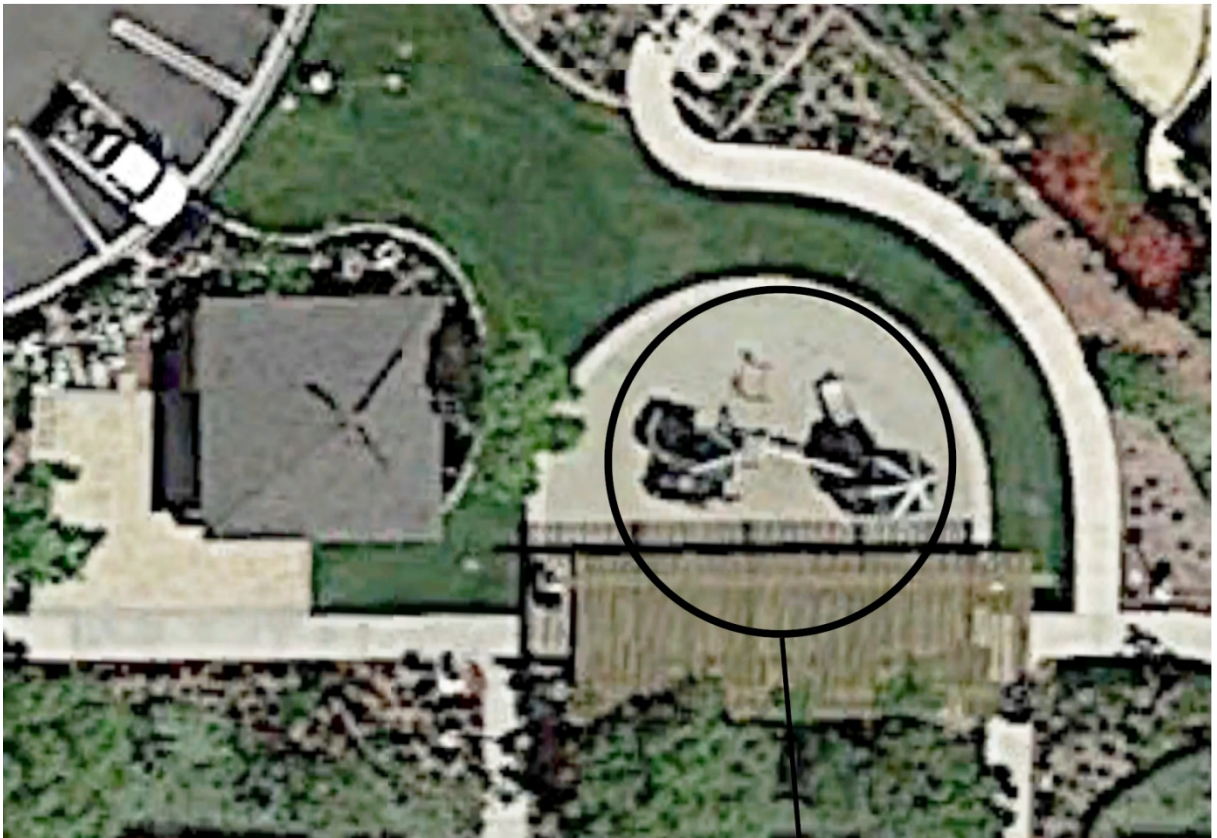
CITRUSGLEN PARK

Action	Action Note	Planning Cost Estimate	Relevant Code
Improve or evaluate play area surface	Further evaluation of fall attenuation surface is recommended. Deteriorated top surface and cracks observed in poured in place surface.	\$0	CBC 11B-1008.2.6.1 ADA 1008.2.6.1 ADA 1008.2.6.2
Install or modify transfer system	Transfer platform surface heights are 18-1/2 and 20-7/8 inches (11 inches minimum to 18 inches maximum required) above the accessible surfacing. Adjacent decks are 14 or 15-1/2 inches above ground surface but lack the required vertical supports.	\$5,000	CBC 11B-1008.3.1.2 ADA 1008.3.1.2
Install tread striping	Striping is not provided on stairs connecting play components.	\$200	CBC 11B-210.1 CBC 11B-504.4.1
Modify play component	The ground level spin panel is centered at 45 inches above play surface (advisory: 44 inches maximum for ages 5 to 12).	\$125	CBC 11B-308.1 ADA 308.1
Provide an accessible path of travel	Vertical clearance of accessible route is 67 inches at ring trek (80 inches minimum required).	\$125	CBC 11B-1008.2

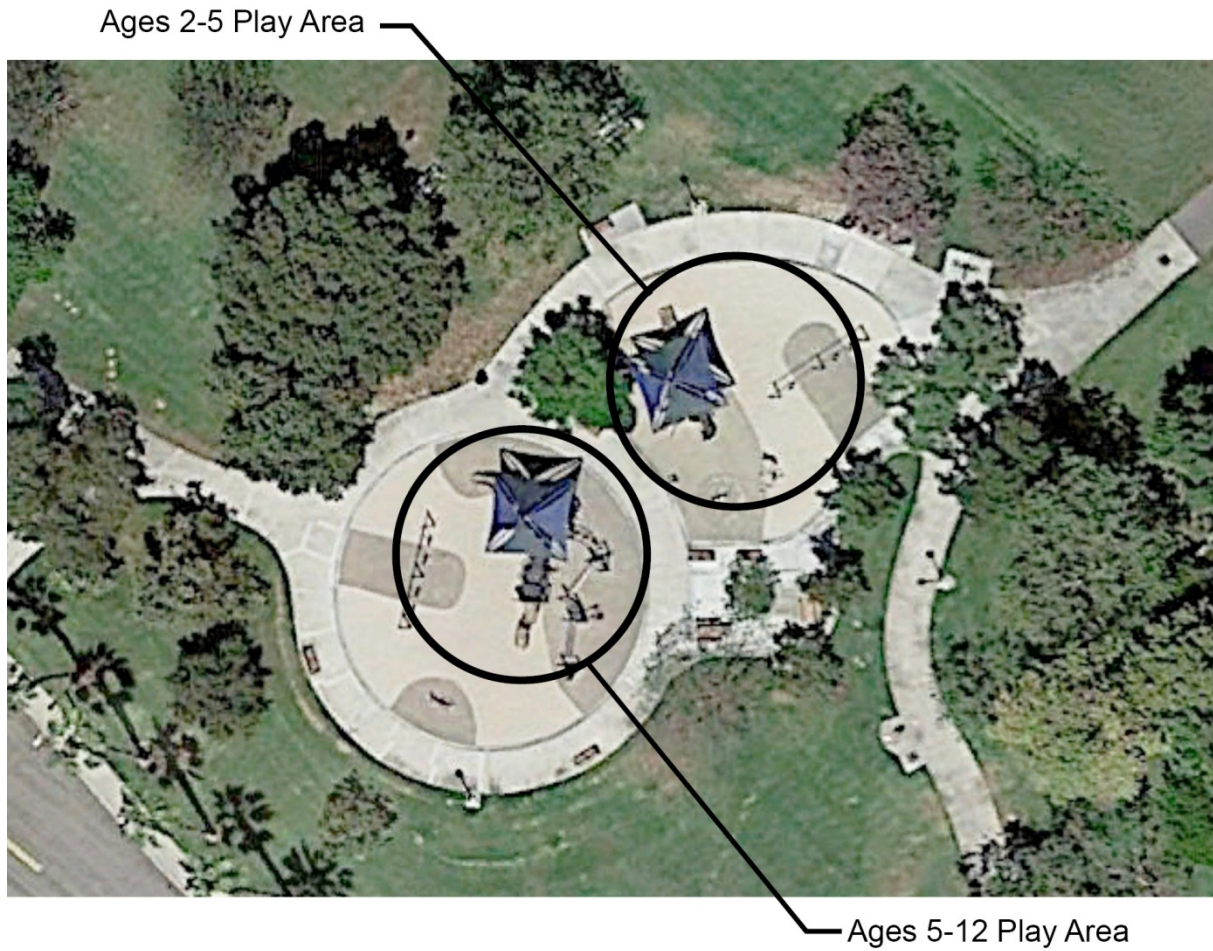
Action	Action Note	Planning Cost Estimate	Relevant Code
Improve or evaluate play area surface	Further evaluation of fall attenuation surface is recommended. There is up to 1/2 inch changes in level between poured in place surface and adjacent concrete. Cracks observed in top layer of accessible surface.	\$0	CBC 11B-1008.2.6.1 ADA 1008.2.6.1 ADA 1008.2.6.2
Modify play component	The 30 by 48 inch ground space adjacent to the fire truck spring toy has a slope of up to 2.7 percent (2.0 percent maximum allowed). The 30 by 48 inch ground space adjacent to the toddler swing with belt has a slope of up to 2.3 percent (2.0 percent maximum allowed). The 30 by 48 inch ground space at sand-play tables does not provide an accessible surface.	\$1,200	CBC 11B-1008.4.2 ADA 1008.4.2
Provide play components	Knee space at play table is 20-5/8 inches high (24 inches minimum height for tables not set up for parallel approach). The table is not positioned to allow for a parallel approach. Table is 7-5/8 inches behind front of benches.	\$5,000	CBC 11B-1008.4.3 ADA 1008.4.3

Action	Action Note	Planning Cost Estimate	Relevant Code
Improve or evaluate play area surface	Further evaluation of fall attenuation surface is recommended. There are up to 1/2 inch changes in level between poured in place surface and adjacent concrete. Cracks observed in top layer of accessible surface.	\$0	CBC 11B-1008.2.6.1 ADA 1008.2.6.1 ADA 1008.2.6.2
Install or modify transfer system	The 30 by 48 inch ground space adjacent to transfer platform has a slope of up to 2.4 percent (2.0 percent maximum permitted).	\$400	CBC 11B-1008.3.1.3 ADA 1008.3.1.3
Install tread striping	Striping is not provided on stairs connecting play components.	\$200	CBC 11B-210.1 CBC 11B-504.4.1
Total		\$600

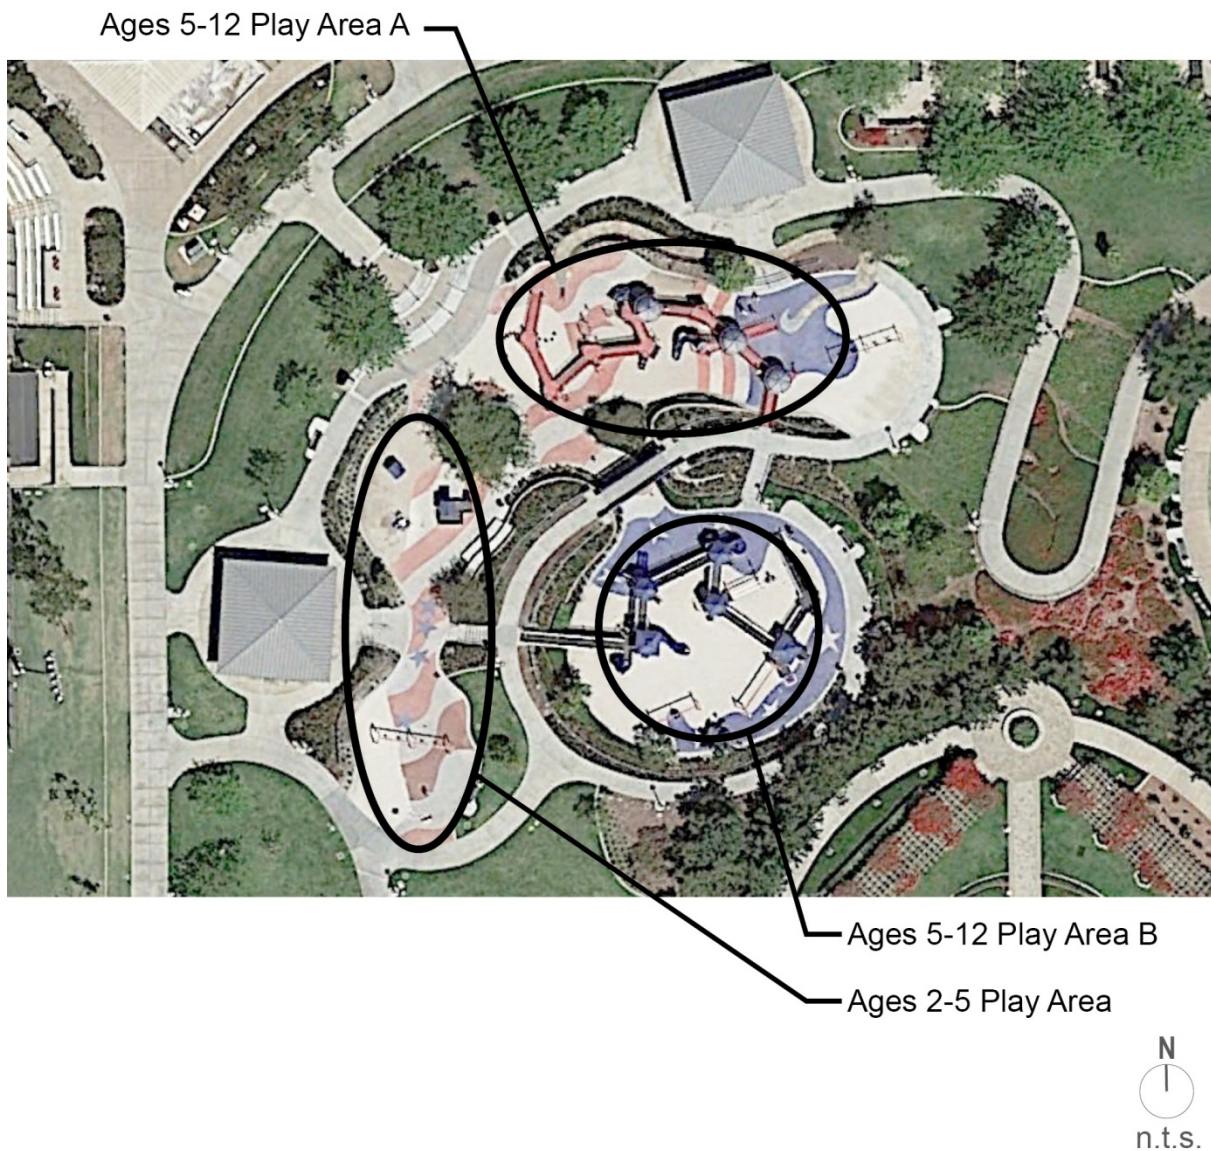
Action	Action Note	Planning Cost Estimate	Relevant Code
Provide an accessible path of travel	An accessible route is not provided from an accessible play area entry to the club house in the sand play area route is seven linear feet from poured in place surface.	\$210	CBC 11B-206.2.17.1 CBC 11B-1008.2 ADA 206.2.17.1 ADA 1008.2
Improve or evaluate play area surface	Further evaluation of fall attenuation surface is recommended.	\$0	CBC 11B-1008.2.6.1 ADA 1008.2.6.1 ADA 1008.2.6.2
Install tread striping	Striping is not provided on stairs connecting play components.	\$200	CBC 11B-210.1 CBC 11B-504.4.1
Install or modify transfer system	A transfer system is not provided onto the composite structure.	\$5,000	CBC 11B-1008.3 ADA 1008.3
Total		\$5,410

Action	Action Note	Planning Cost Estimate	Relevant Code
Improve or evaluate play area surface	Further evaluation of fall attenuation surface is recommended.	\$0	CBC 11B-1008.2.6.1 ADA 1008.2.6.1 ADA 1008.2.6.2
Install tread striping	Striping is not provided on stairs connecting play components.	\$200	CBC 11B-210.1 CBC 11B-504.4.1
Modify play component	A 30 by 48 inch clear space with a slope of 2.0 percent maximum is not provided at the fossil or spin panels below deck due to sand.	\$400	CBC 11B-1008.4.1 CBC 11B-1008.4.2 ADA 1008.4.1 ADA 1008.4.2
Provide an accessible path of travel	An accessible route is not provided from an accessible play area entry to the fossil and spin panels below the deck in the sand play area, route is seven linear feet from poured in place surface.	\$210	CBC 11B-206.2.17.1 CBC 11B-1008.2 ADA 206.2.17.1 ADA 1008.2
Total		\$810

Action	Action Note	Planning Cost Estimate	Relevant Code
Improve or evaluate play area surface	Further evaluation of fall attenuation surface is recommended.	\$0	CBC 11B-1008.2.6.1 ADA 1008.2.6.1 ADA 1008.2.6.2
Install tread striping	Striping is not provided on stairs connecting play components.	\$200	CBC 11B-210.1 CBC 11B-504.4.1
Regrade or replace ramp	Ramp connecting elevated play components has one section with a 15-1/2 inches rise and another with an 18-1/2 inches rise (12 inches maximum allowed). Three changes in level up to 1/2 inch (ramps are to be free of changes of level) were observed from ramp surfaces to adjacent deck surfaces.	\$0	CBC 11B-405.4 CBC 11B-1008.2.5.2 ADA 405.4 ADA 1008.2.5.2
Install or modify transfer system	The 30 by 48 inch ground space adjacent to transfer platform has a slope of up to 16 percent at the edge of the poured in place and sand surfaces (2.0 percent maximum allowed).	\$400	CBC 11B-1008.3.1.3 ADA 1008.3.1.3

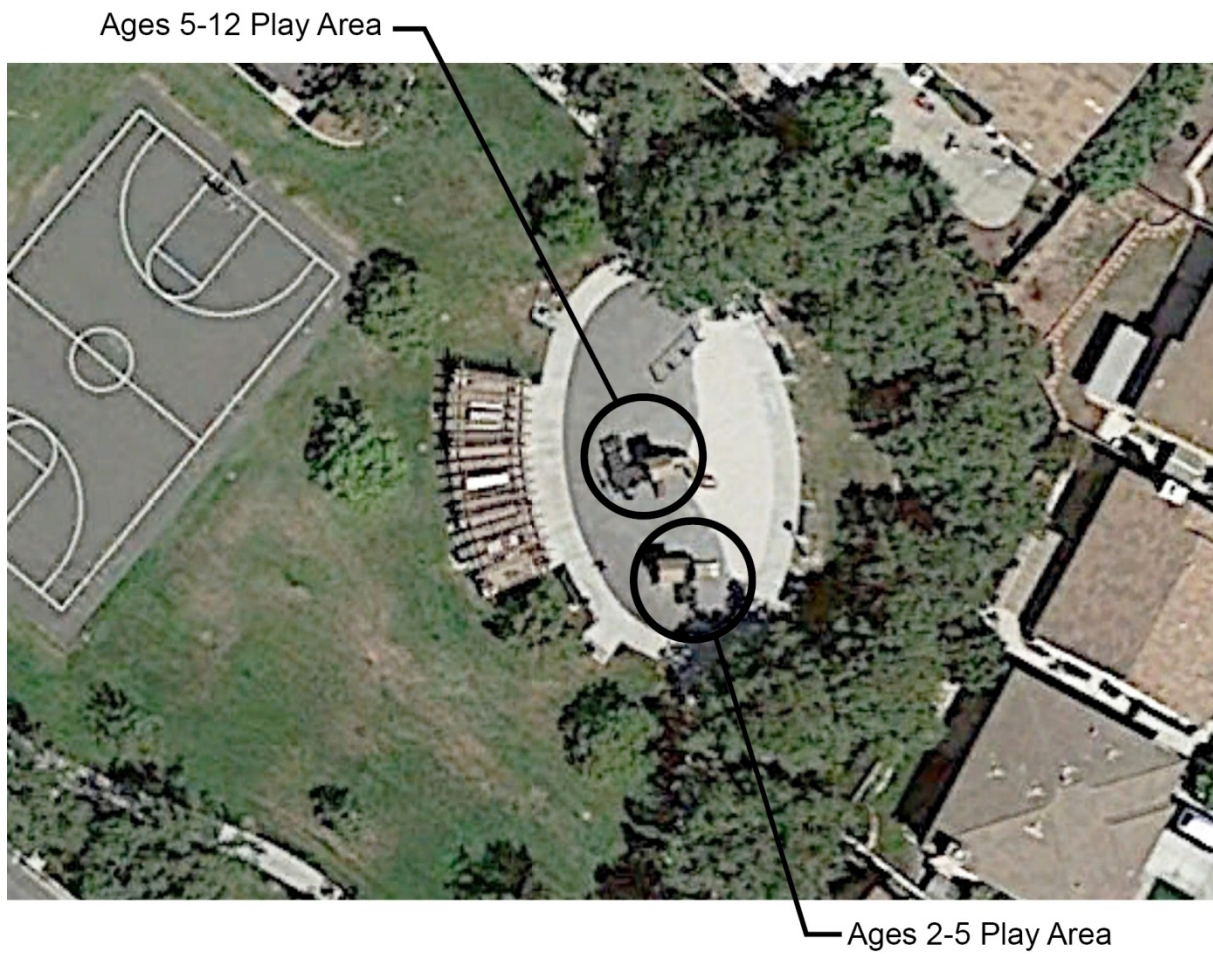
Action	Action Note	Planning Cost Estimate	Relevant Code
Improve or evaluate play area surface	Further evaluation of fall attenuation surface is recommended. Sand surface had migrated onto poured in place to a depth that would not be considered firm and stable. Ongoing maintenance required.	\$0	CBC 11B-1008.2.6.1 ADA 1008.2.6.1 ADA 1008.2.6.2
Install tread striping	Striping is not provided on stairs connecting play components.	\$200	CBC 11B-210.1 CBC 11B-504.4.1
Total		\$200

Action	Action Note	Planning Cost Estimate	Relevant Code
Improve or evaluate play area surface	Further evaluation of fall attenuation surface is recommended. Sand surface had migrated onto poured in place to a depth that would not be considered firm and stable. Ongoing maintenance required.	\$0	CBC 11B-1008.2.6.1 ADA 1008.2.6.1 ADA 1008.2.6.2
Install tread striping	Striping is not provided on stairs connecting play components.	\$200	CBC 11B-210.1 CBC 11B-504.4.1
Provide play components	No ground level play components are provided for ages 5 to 12 where five elevated play components are provided (two ground level components are required including two different types of components)).	\$5,000	CBC 11B-240.2.1.2 ADA 240.2.1.2
Total		\$5,200

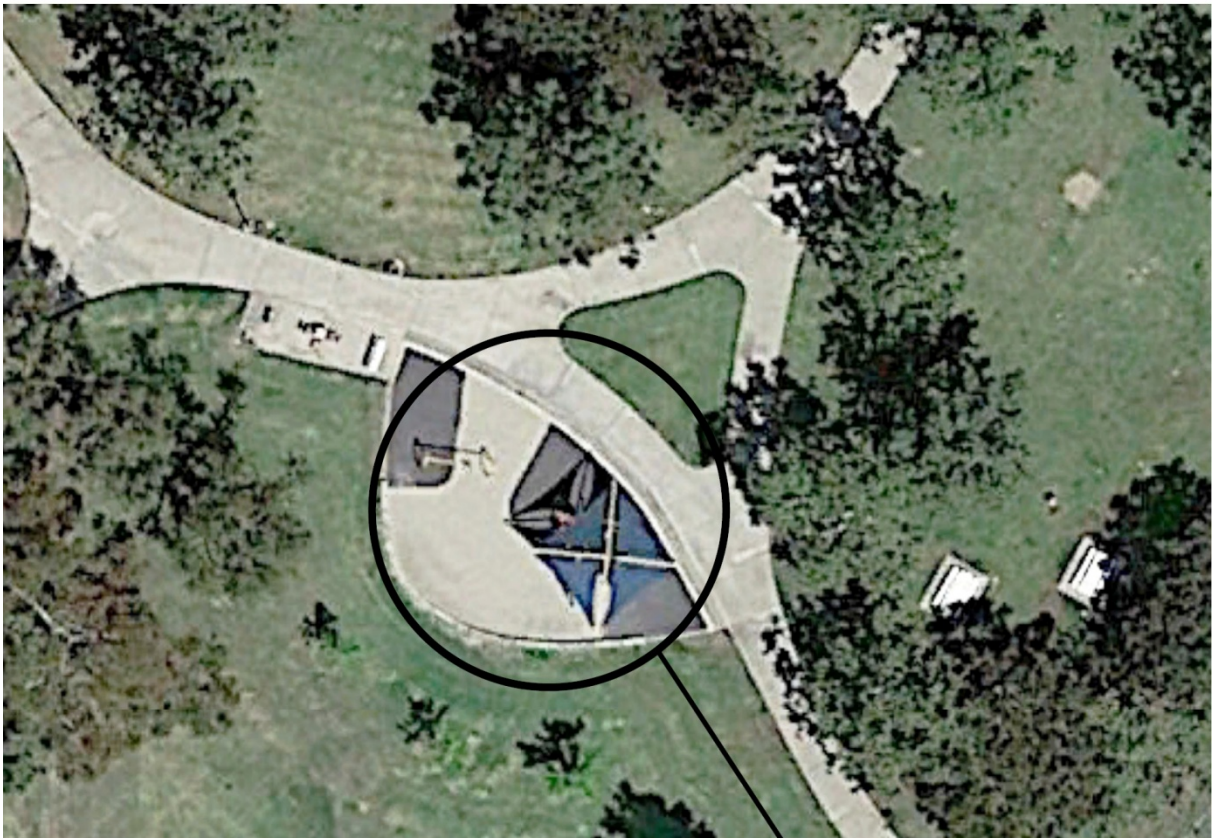
Action	Action Note	Planning Cost Estimate	Relevant Code
Improve or evaluate play area surface	Further evaluation of fall attenuation surface is recommended.	\$0	CBC 11B-1008.2.6.1 ADA 1008.2.6.1 ADA 1008.2.6.2
Provide an accessible path of travel	An accessible route is not provided to the fossil panel or the spin wheel.	\$400	CBC 11B-206.2.17.1 CBC 11B-1008.2 ADA 206.2.17.1 ADA 1008.2
Install or modify transfer system	The 30 by 48 inch ground space adjacent to transfer platform has a slope of up to 3.0 percent (2.0 percent maximum allowed).	\$400	CBC 11B-1008.3.1.3 ADA 1008.3.1.3
Install tread striping	Striping is not provided on stairs connecting play components.	\$200	CBC 11B-210.1 CBC 11B-504.4.1
Modify play component	A 30 by 48 inch minimum clear space with a slope of 2.0 percent maximum is not provided at the fossil panel or the spin wheel due to sand surface.	\$400	CBC 11B-1008.4.1 CBC 11B-1008.4.2 ADA 1008.4.1 ADA 1008.4.2

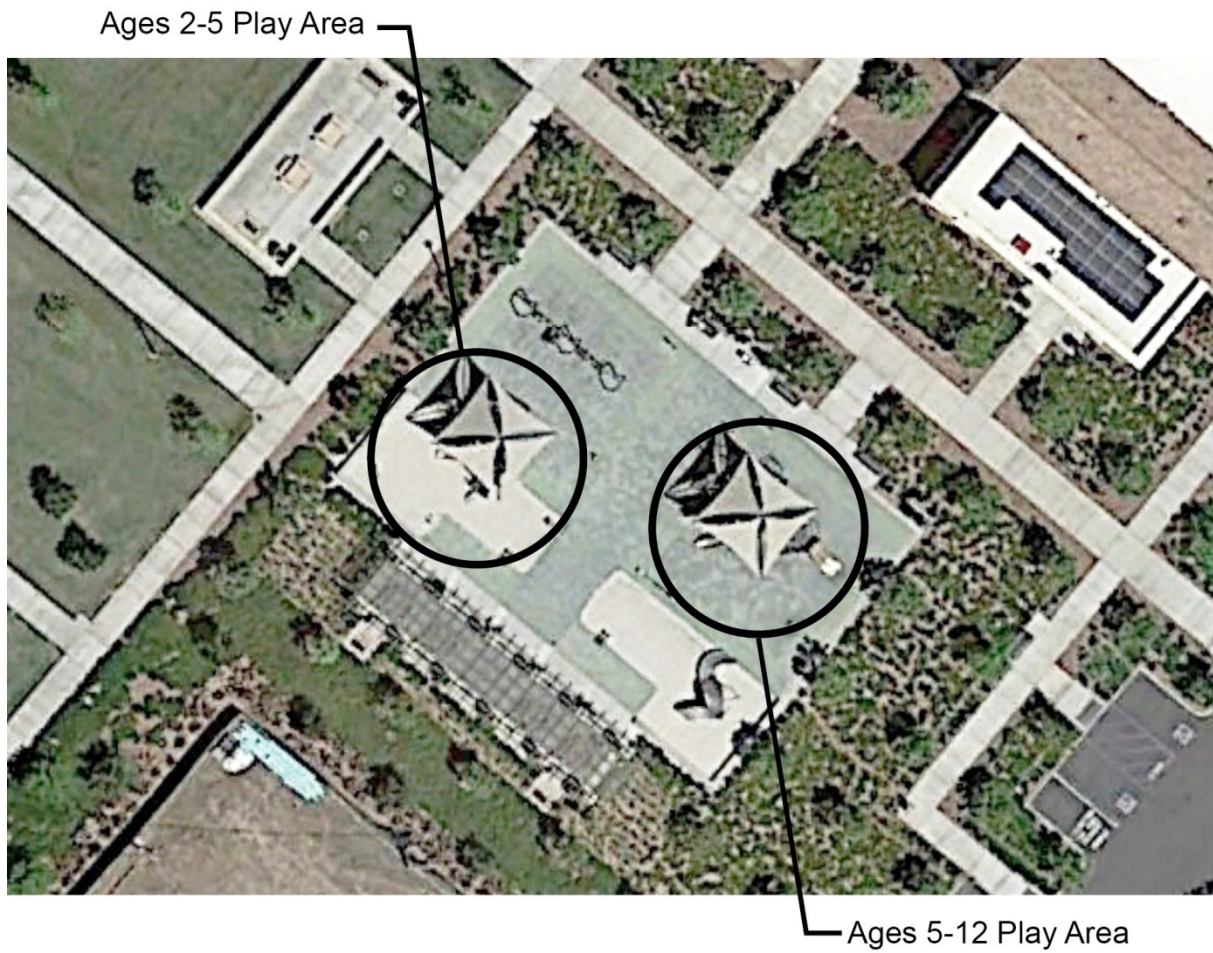
Action	Action Note	Planning Cost Estimate	Relevant Code
Install tread striping	Striping is not provided on stairs connecting play components.	\$200	CBC 11B-210.1 CBC 11B-504.4.1
Improve or evaluate play area surface	Further evaluation of fall attenuation surface is recommended.	\$0	CBC 11B-1008.2.6.1 ADA 1008.2.6.1 ADA 1008.2.6.2
Provide play components	Knee space at play table is 19 inches high (24 inches minimum height required). The table is not positioned to allow for a parallel approach. Table is 11 inches behind front of benches.	\$5,000	CBC 11B-1008.4.3 ADA 1008.4.3
Total		\$5,200

Action	Action Note	Planning Cost Estimate	Relevant Code
Install tread striping	Striping is not provided on stairs connecting play components.	\$200	CBC 11B-210.1 CBC 11B-504.4.1
Improve or evaluate play area surface	Further evaluation of fall attenuation surface is recommended.	\$0	CBC 11B-1008.2.6.1 ADA 1008.2.6.1 ADA 1008.2.6.2
Total		\$200

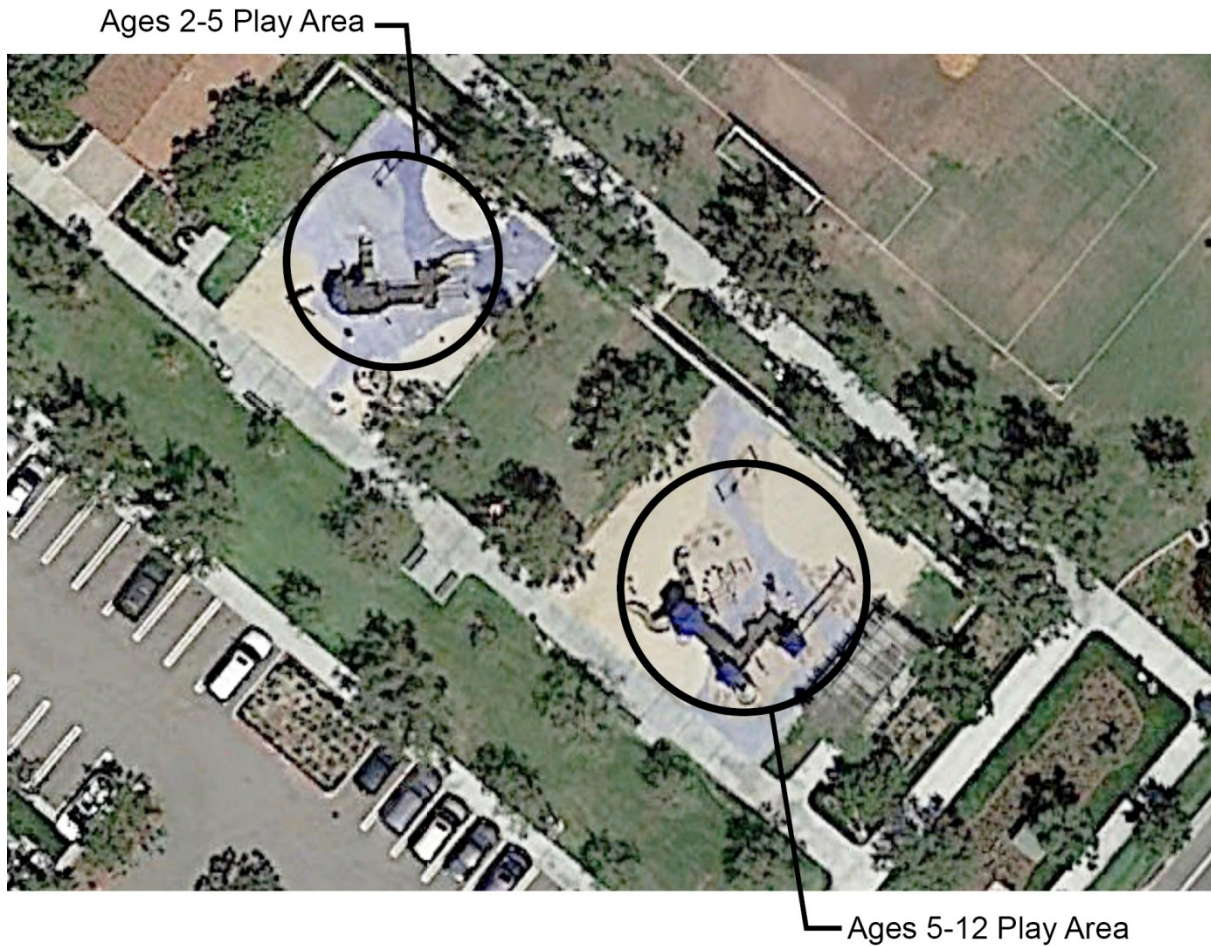
Action	Action Note	Planning Cost Estimate	Relevant Code
Improve or evaluate play area surface	Further evaluation of fall attenuation surface is recommended. Deteriorated top layer of poured in place surface has holes up to five by eight inches.	\$0	CBC 11B-1008.2.6.1 ADA 1008.2.6.1 ADA 1008.2.6.2
Install tread striping	Striping is not provided on stairs connecting play components.	\$200	CBC 11B-210.1 CBC 11B-504.4.1
Install or modify transfer system	The 30 by 48 inch ground space adjacent to transfer platform has a slope of up to 2.7 percent (2.0 percent maximum permitted).	\$400	CBC 11B-1008.3.1.3 ADA 1008.3.1.3
Provide an accessible path of travel	An accessible route is not provided to the turtle platform, route is four linear feet over sand surface.	\$120	CBC 11B-206.2.17.1 CBC 11B-1008.2 ADA 206.2.17.1 ADA 1008.2
Total		\$720

Action	Action Note	Planning Cost Estimate	Relevant Code
Provide an accessible path of travel	An accessible route is not provided to the swings. Route to swings overlaps with path of zipline component that is 71 inches above the ground (80 inches minimum overhead clearance required).	\$0	CBC 11B-206.2.17.1 CBC 11B-1008.2 ADA 206.2.17.1 ADA 1008.2
Improve or evaluate play area surface	Further evaluation of fall attenuation surface is recommended. Deteriorated top layer of poured in place surface.	\$0	CBC 11B-1008.2.6.1 ADA 1008.2.6.1 ADA 1008.2.6.2
Install tread striping	Striping is not provided on stairs connecting play components.	\$200	CBC 11B-210.1 CBC 11B-504.4.1
Modify play component	Slope of the 30 by 48 inch clear floor space at swings is up to 2.3 percent (2.0 percent maximum allowed).	\$400	CBC 11B-1008.4.2 ADA 1008.4.2
Total		\$600

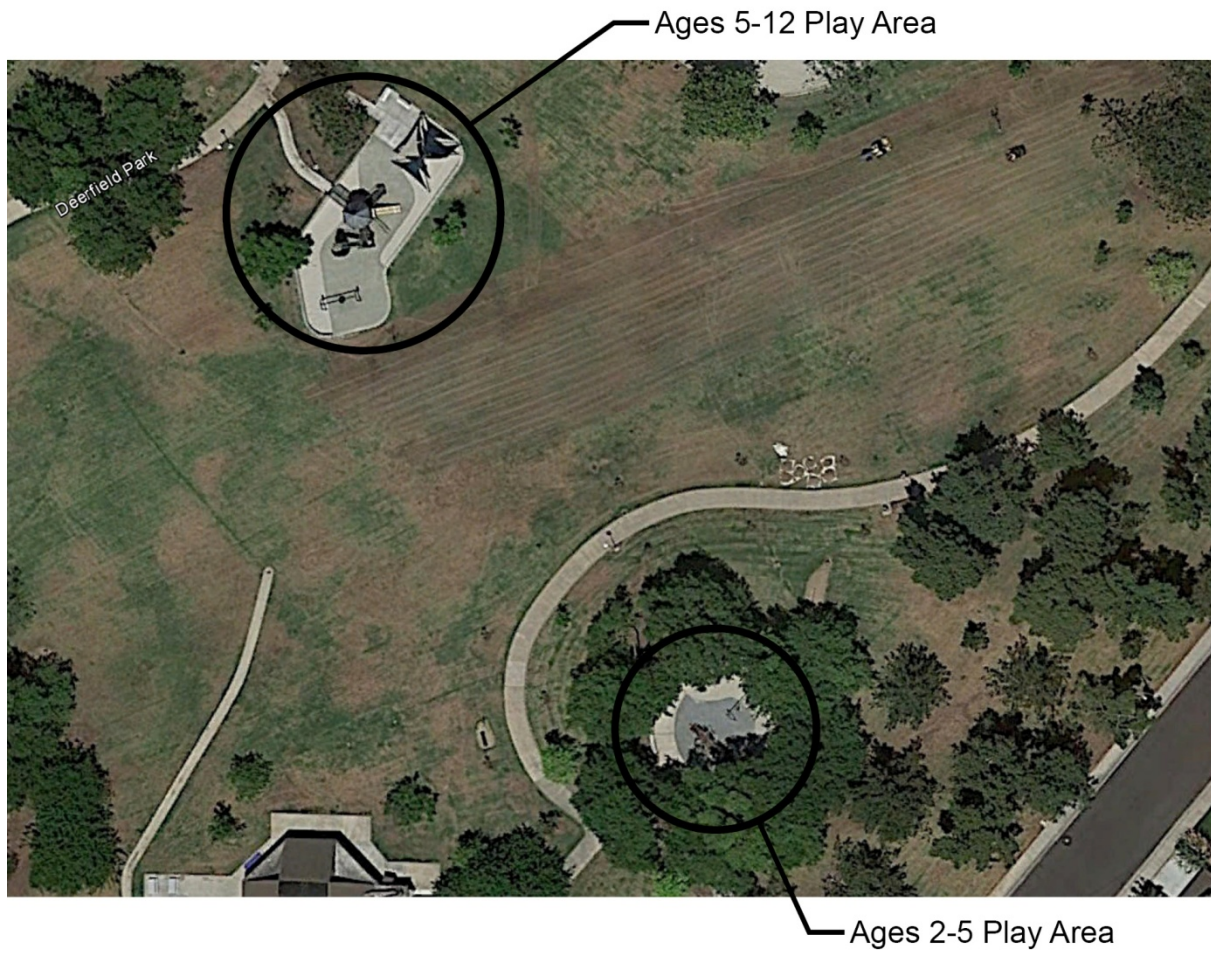
Action	Action Note	Planning Cost Estimate	Relevant Code
Improve or evaluate play area surface	Further evaluation of fall attenuation surface is recommended.	\$0	CBC 11B-1008.2.6.1 ADA 1008.2.6.1 ADA 1008.2.6.2
Provide play components	Three of the five elevated play components are beyond a route that is 17-1/4 inches wide for 49 inches (at least 50 percent of elevated play components must be located on an accessible route).	\$5,000	CBC 11B-240.2.2 ADA 240.2.2
Provide an accessible path of travel	Elevated route on composite structure is 17-1/4 inches wide (36 inches minimum width; may be reduced to 32 inches minimum for a distance of 24 inches max).	\$5,000	CBC 11B-1008.2.4.2 ADA 1008.2.4.2
Install tread striping	Striping is not provided on stairs connecting play components.	\$200	CBC 11B-210.1 CBC 11B-504.4.1
Total		\$10,200

Action	Action Note	Planning Cost Estimate	Relevant Code
Install tread striping	Striping is not provided on stairs connecting play components.	\$200	CBC 11B-210.1 CBC 11B-504.4.1
Improve or evaluate play area surface	Further evaluation of fall attenuation surface is recommended. A 3/4 inch gap was observed between the poured in place surface and the concrete curb.	\$0	CBC 11B-1008.2.6.1 ADA 1008.2.6.1 ADA 1008.2.6.2
Provide an accessible path of travel	Accessible routes are not provided to the tire swing or the platform in the sand play area. Bridge route to elevated deck has a 1-5/8 inch change in level at joint in park walk (1/4 inch maximum permitted, up to 1/2 inch with a bevel).	\$0	CBC 11B-303.1 CBC 11B-206.2.17.1 CBC 11B-1008.2 ADA 206.2.17.1 ADA 303.1 ADA 1008.2
Provide an accessible path of travel	Path of travel to tire swing is 18 inches wide on outside of climber (ground level routes have 60 inches minimum width for play areas greater than 1,000 square feet. Route may be reduced to 36 inches for a maximum distance of 60 inches). Route to platform is 11 linear feet of sand surface.	\$1,440	CBC 11B-1008.2.4.1 ADA 1008.2.4.1

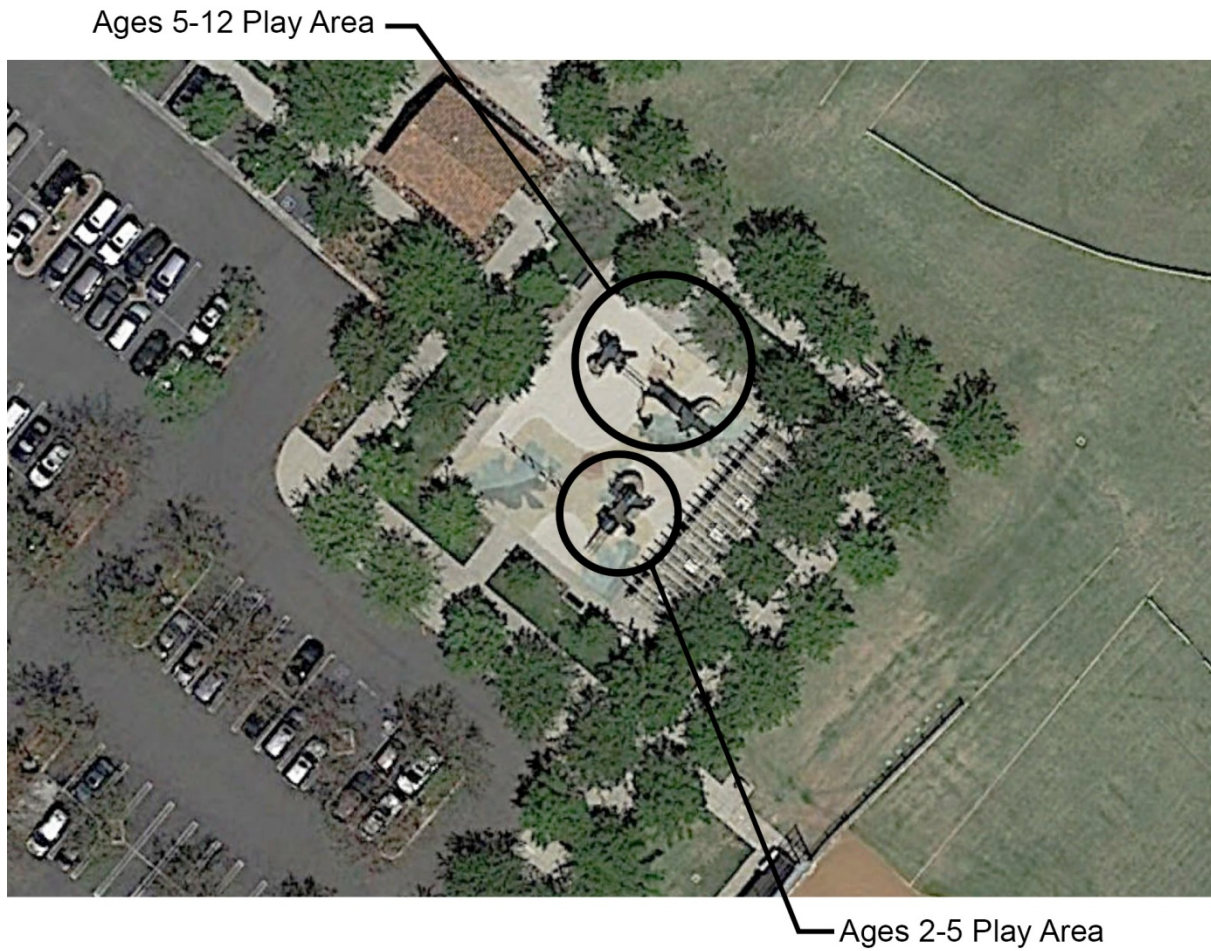
Action	Action Note	Planning Cost Estimate	Relevant Code
Install tread striping	Striping is not provided on stairs connecting play components.	\$200	CBC 11B-210.1 CBC 11B-504.4.1
Improve or evaluate play area surface	Further evaluation of fall attenuation surface is recommended. Top layer of poured in place surface worn and separating up to 1/2 inch at color seams.	\$0	CBC 11B-1008.2.6.1 ADA 1008.2.6.1 ADA 1008.2.6.2
Total		\$200

Action	Action Note	Planning Cost Estimate	Relevant Code
Install tread striping	Striping is not provided on stairs connecting play components.	\$200	CBC 11B-210.1 CBC 11B-504.4.1
Improve or evaluate play area surface	Further evaluation of fall attenuation surface is recommended. Top layer of poured in place surface worn and separating up to 1/2 inch at color seams.	\$0	CBC 11B-1008.2.6.1 ADA 1008.2.6.1 ADA 1008.2.6.2
Provide play components	Four ground level play components of two different types are provided for the eight elevated components on the structure (three ground level components are required including three different types of components).	\$5,000	CBC 11B-240.2.1.2 ADA 240.2.1.2
Total		\$5,200
