City of Irvine
Parks Master Plan
FINAL | JULY 2015

ADA Assessment of Play Areas in Irvine Parks

TECHNICAL SUPPLEMENT

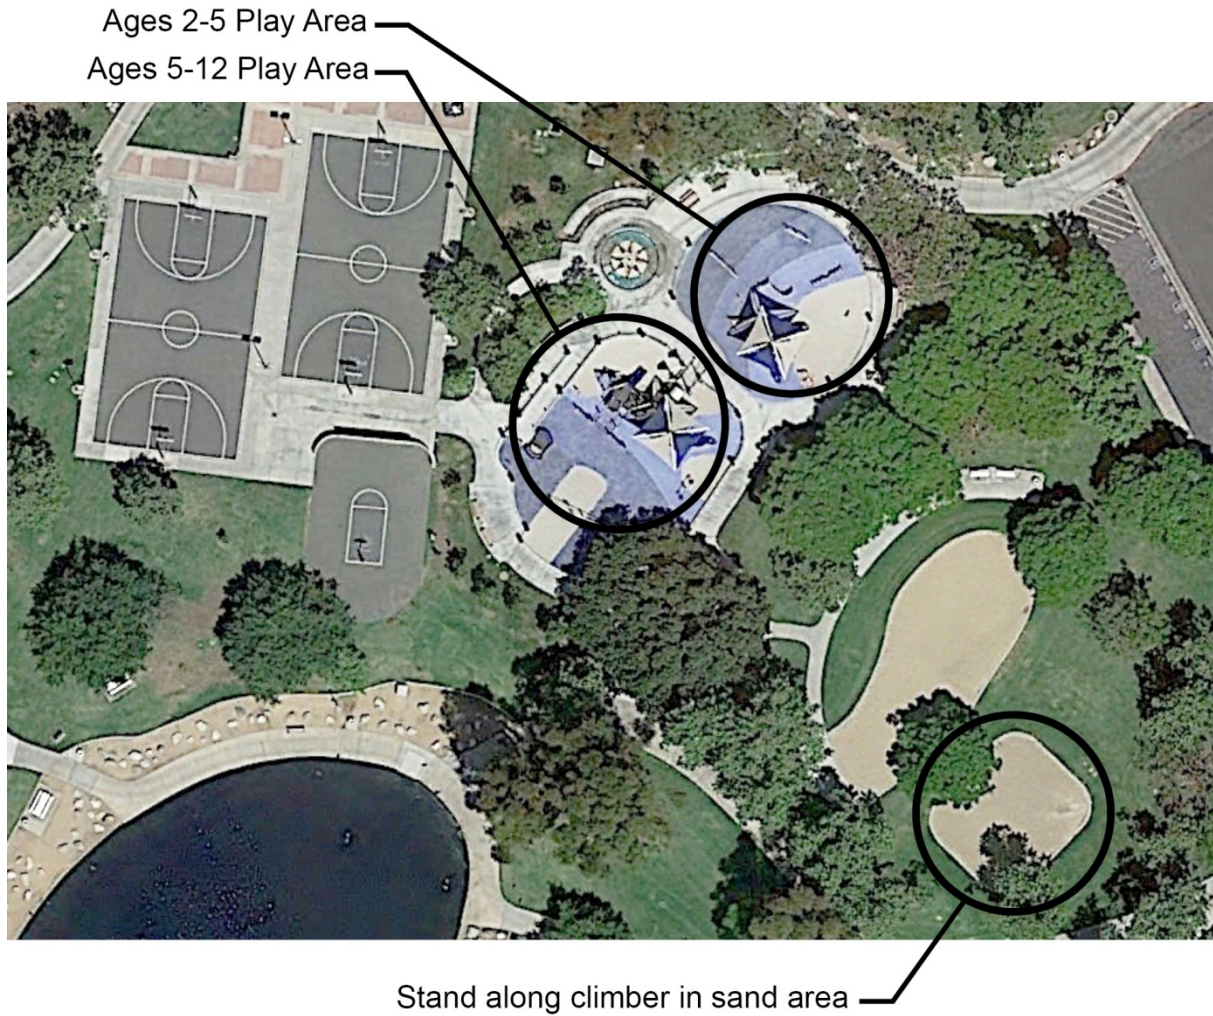
Action	Action Note	Planning Cost Estimate	Relevant Code
Provide an accessible path of travel	An accessible route is not provided to the only single user spring toy. Route is seven linear feet over sand surface.	\$210	CBC 11B-206.2.17.1 CBC 11B-1008.2 ADA 206.2.17.1 ADA 1008.2
Provide an accessible path of travel	Route into ground level boat structure is 32 inches wide (60 inches minimum is required. Route may be reduced to 36 inches wide for a maximum distance of 60 inches).	\$0	CBC 11B-1008.2.4.1 ADA 1008.2.4.1
Improve or evaluate play area surface	Further evaluation of fall attenuation surface is recommended. Deteriorated top layer of poured in place surface.	\$0	CBC 11B-1008.2.6.1 ADA 1008.2.6.1 ADA 1008.2.6.2
Install or modify transfer system	The 30 by 48 inch ground space is not centered at transfer platform due to curve in play surface.	\$400	CBC 11B-1008.3.1.3 ADA 1008.3.1.3
Provide an accessible path of travel	Elevated route on composite structure is 30 inches wide between central column and slide platform (36 inches minimum width is required; may be reduced to 32 inches minimum for a distance of 24 inches maximum).	\$5,000	CBC 11B-1008.2.4.2 ADA 1008.2.4.2

Action	Action Note	Planning Cost Estimate	Relevant Code
Improve or evaluate play area surface	Further evaluation of fall attenuation surface is recommended.	\$0	CBC 11B-1008.2.6.1 ADA 1008.2.6.1 ADA 1008.2.6.2
Install tread striping	Striping is not provided on stairs connecting play components.	\$200	CBC 11B-210.1 CBC 11B-504.4.1
Modify play component	Talk tube adjacent to transfer platform is not oriented to allow for the 30 by 48 inch clear floor space to be centered on component.	\$125	CBC 11B-1008.4.2 ADA 1008.4.2
Provide play components	Knee space at play table is 19-1/4 inches high (24 inches minimum height required).	\$5,000	CBC 11B-1008.4.3 ADA 1008.4.3
Regrade or replace ramp	Ramp to elevated play area has a nine inches rise on the concrete and a 10 inches rise on the structure for a combined rise of 19 inches (12 inches maximum is allowed). Ramp has a 3/8 inch change in level at top of incline and a 5/8 inch change in level at concrete/structure transition (ramps are to be free of changes in level).	\$8,500	CBC 11B-405.4 CBC 11B-1008.2.5.2 ADA 405.4 ADA 1008.2.5.2

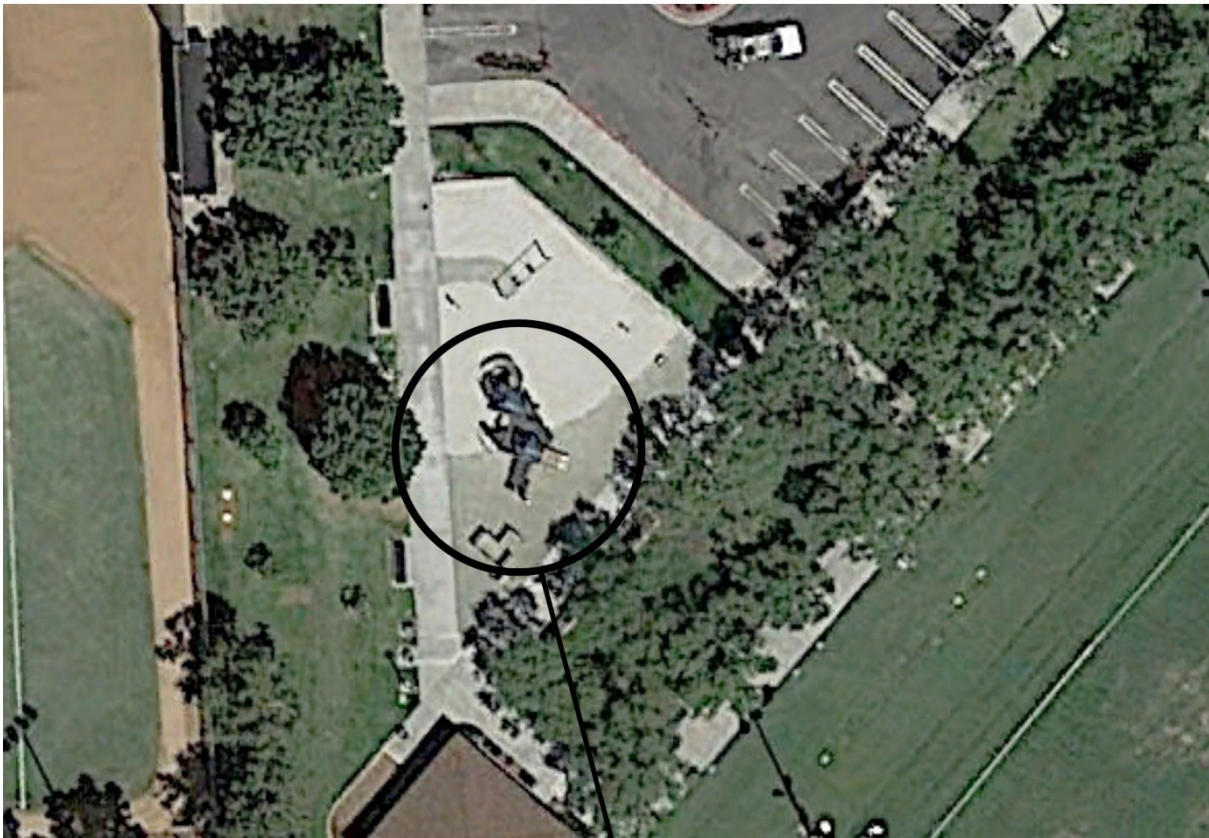
Action	Action Note	Planning Cost Estimate	Relevant Code
Provide an accessible path of travel	An accessible route is not provided to talk tube or dinosaur spring toy. Talk tube is located in sand 60 inches off accessible path of travel. Dinosaur spring toy is located on sand 96 inches off poured in place surface.	\$390	CBC 11B-206.2.17.1 CBC 11B-1008.2 ADA 206.2.17.1 ADA 1008.2
Improve or evaluate play area surface	Further evaluation of fall attenuation surface is recommended.	\$0	CBC 11B-1008.2.6.1 ADA 1008.2.6.1 ADA 1008.2.6.2
Install tread striping	Striping is not provided on stairs connecting play components.	\$200	CBC 11B-210.1 CBC 11B-504.4.1
Modify play component	A 60 inch diameter turning space is not provided at mirror in maze component. Path of travel inside maze is 40 inches wide and doglegs (44 inches wide minimum is required in play areas less than 1,000 square feet).	\$125	CBC 11B-1008.2.4.1 CBC 11B-1008.4.1 ADA 1008.2.4.1 ADA 1008.4.1

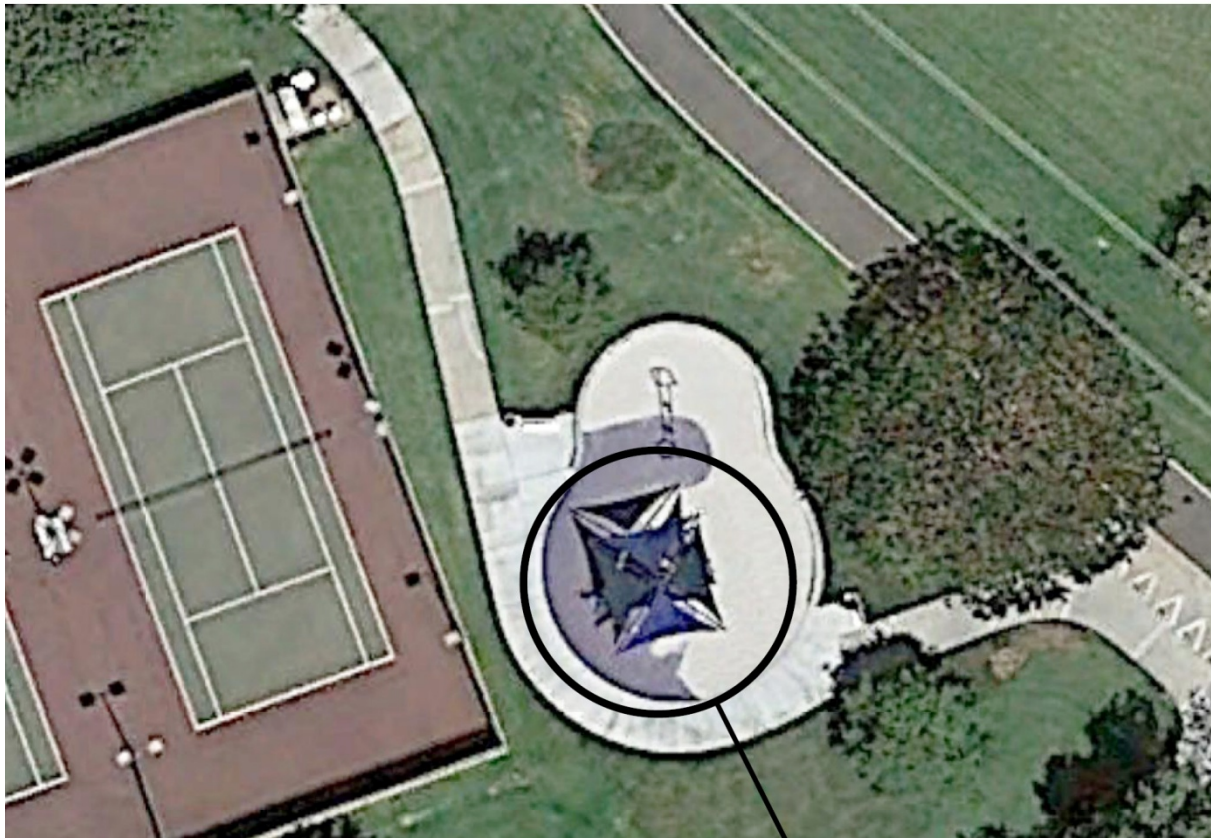
Action	Action Note	Planning Cost Estimate	Relevant Code
Provide an accessible path of travel	Route to play table is 29 inches wide (44 inches minimum required).	\$125	CBC 11B-1008.2 CBC 11B-1008.2.4.1 ADA 1008.2 ADA 1008.2.4.1
Improve or evaluate play area surface	Further evaluation of fall attenuation surface is recommended. Sand surface has migrated onto poured in place surface to a depth that would not be considered firm and stable. Ongoing maintenance required.	\$0	CBC 11B-1008.2.6.1 ADA 1008.2.6.1 ADA 1008.2.6.2
Install tread striping	Striping is not provided on stairs connecting play components.	\$200	CBC 11B-210.1 CBC 11B-504.4.1
Modify play component	A 30 by 48 inch minimum clear space is not provided at the play table due to slide.	\$400	CBC 11B-1008.4.1 CBC 11B-1008.4.2 ADA 1008.4.1 ADA 1008.4.2
Provide an accessible path of travel	Elevated route on composite structure is 17-1/4 inches wide for 50 inches (36 inches minimum width required; width may be reduced to 32 inches minimum for a distance of 24 inches maximum).	\$5,000	CBC 11B-1008.2.4.2 ADA 1008.2.4.2

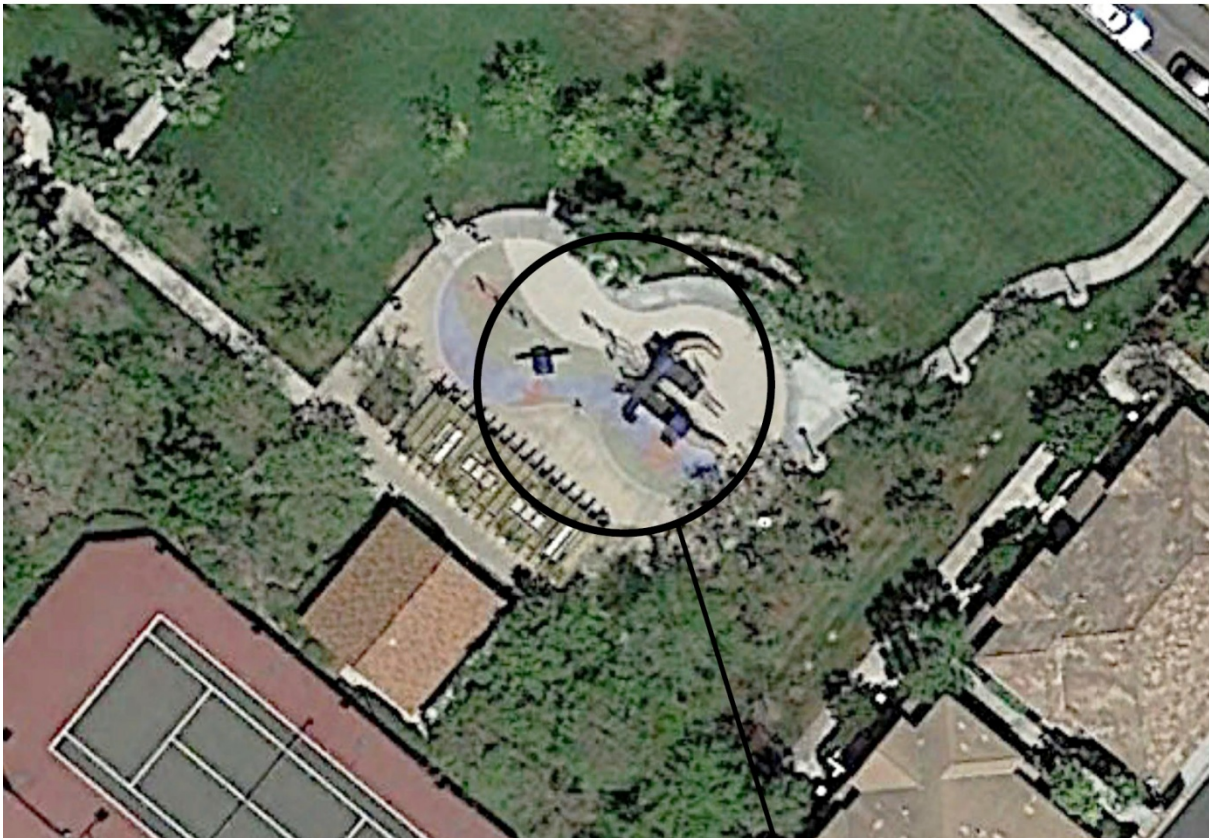
Action	Action Note	Planning Cost Estimate	Relevant Code
Provide an accessible path of travel	An accessible route is not provided to the stand alone climber. Climber is in sand. Route is 12 to 36 inches off poured in place surface.	\$120	CBC 11B-206.2.17.1 CBC 11B-1008.2 ADA 206.2.17.1 ADA 1008.2
Improve or evaluate play area surface	Further evaluation of fall attenuation surface is recommended.	\$0	CBC 11B-1008.2.6.1 ADA 1008.2.6.1 ADA 1008.2.6.2
Install tread striping	Striping is not provided on stairs connecting play components.	\$200	CBC 11B-210.1 CBC 11B-504.4.1
Modify play component	A 30 by 48 inch minimum clear space is not provided at stand alone climber due to sand surface.	\$400	CBC 11B-1008.4.2 ADA 1008.4.2
Total		\$720

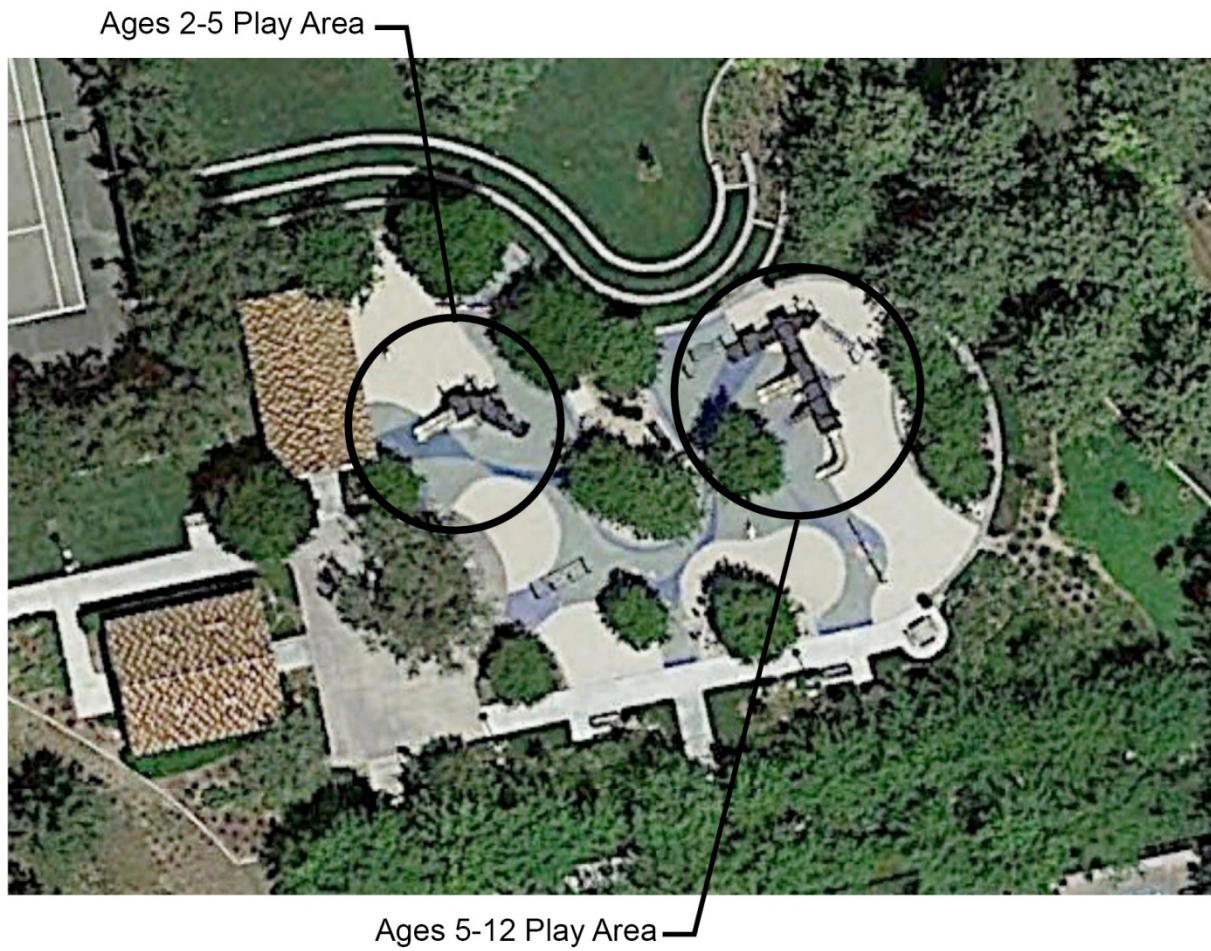
Action	Action Note	Planning Cost Estimate	Relevant Code
Provide an accessible path of travel	An accessible route to the play equipment area is not provided. Route is 10 linear feet over sand from poured in place surface to spring toy.	\$300	CBC 11B-206.2.17.1 CBC 11B-1008.2 ADA 206.2.17.1 ADA 1008.2
Improve or evaluate play area surface	Further evaluation of fall attenuation surface is recommended. Cracking and deterioration observed in top layer.	\$0	CBC 11B-1008.2.6.1 ADA 1008.2.6.1 ADA 1008.2.6.2
Install tread striping	Striping is not provided on stairs connecting play components.	\$200	CBC 11B-210.1 CBC 11B-504.4.1
Total		\$500

Action	Action Note	Planning Cost Estimate	Relevant Code
Provide an accessible path of travel	An accessible route to the play equipment area is not provided. Route is 30 linear feet over sand from poured in place surface to overhead spinner.	\$900	CBC 11B-206.2.17.1 CBC 11B-1008.2 ADA 206.2.17.1 ADA 1008.2
Improve or evaluate play area surface	Further evaluation of fall attenuation surface is recommended. Deterioration noted in top layer of poured in place surface.	\$0	CBC 11B-1008.2.6.1 ADA 1008.2.6.1 ADA 1008.2.6.2
Install or modify transfer system	Transfer platform has a surface height of 8-1/2 inches (11 inches minimum to 18 inches maximum allowed) above the accessible surfacing. Adjacent deck with a compliant height of 16-3/4 inches does not provide adequate clear floor space. Clear width between vertical supports is 20 inches (24 inches minimum required).	\$125	CBC 11B-1008.3.1.1 CBC 11B-1008.3.1.2 ADA 1008.3.1.1 ADA 1008.3.1.2

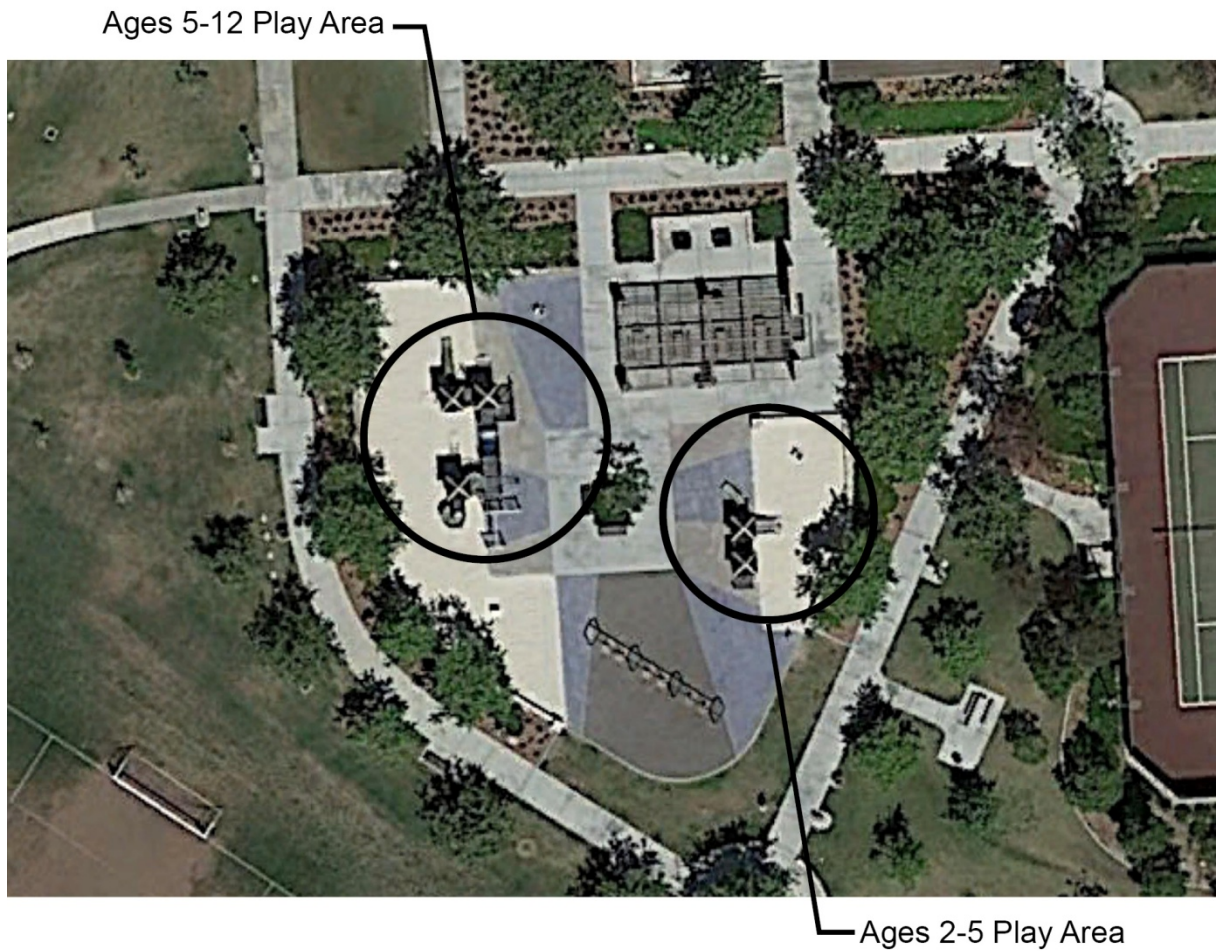
Action	Action Note	Planning Cost Estimate	Relevant Code
Provide an accessible path of travel	An accessible route to the spring toy is not provided. Route is 10 linear feet over sand.	\$300	CBC 11B-206.2.17.1 CBC 11B-1008.2 ADA 206.2.17.1 ADA 1008.2
Improve or evaluate play area surface	Further evaluation of fall attenuation surface is recommended. There is a 1/2 inch gap between poured in place surface and adjacent concrete for seven linear feet.	\$0	CBC 11B-1008.2.6.1 ADA 1008.2.6.1 ADA 1008.2.6.2
Provide an accessible path of travel	Route to play counter is 13 inches wide (44 inches minimum width required; route may be reduced to 36 inches for a maximum 60 inches).	\$500	CBC 11B-1008.2.4.1 ADA 1008.2.4.1
Install tread striping	Striping is not provided on stairs connecting play components.	\$200	CBC 11B-210.1 CBC 11B-504.4.1
Provide play components	Both parallel and front approach access to play table is blocked by fixed seating.	\$5,000	CBC 11B-1008.4.3 ADA 1008.4.3

Action	Action Note	Planning Cost Estimate	Relevant Code
Provide an accessible path of travel	Accessible routes to the chess table and sundial are not provided. Routes are eight linear feet of sand to the chess table and 10 linear feet of sand to sundial.	\$540	CBC 11B-206.2.17.1 CBC 11B-1008.2 ADA 206.2.17.1 ADA 1008.2
Improve or evaluate play area surface	Further evaluation of fall attenuation surface is recommended. Poured in place surface is separating at color seams.	\$0	CBC 11B-1008.2.6.1 ADA 1008.2.6.1 ADA 1008.2.6.2
Install tread striping	Striping is not provided on stairs connecting play components.	\$200	CBC 11B-210.1 CBC 11B-504.4.1
Install or modify transfer system	The 30 by 48 inch ground space adjacent to transfer platform has a slope of up to 3.2 percent (2.0 percent maximum permitted). There is up to a 2-3/4 inch gap between the structure deck and the clatter bridge boards (1/2 inch maximum opening is required).	\$400	CBC 11B-302.3 CBC 11B-1008.2.1 CBC 11B-1008.3.1.3 ADA 302.3 ADA 1008.2.1 ADA 1008.3.1.3

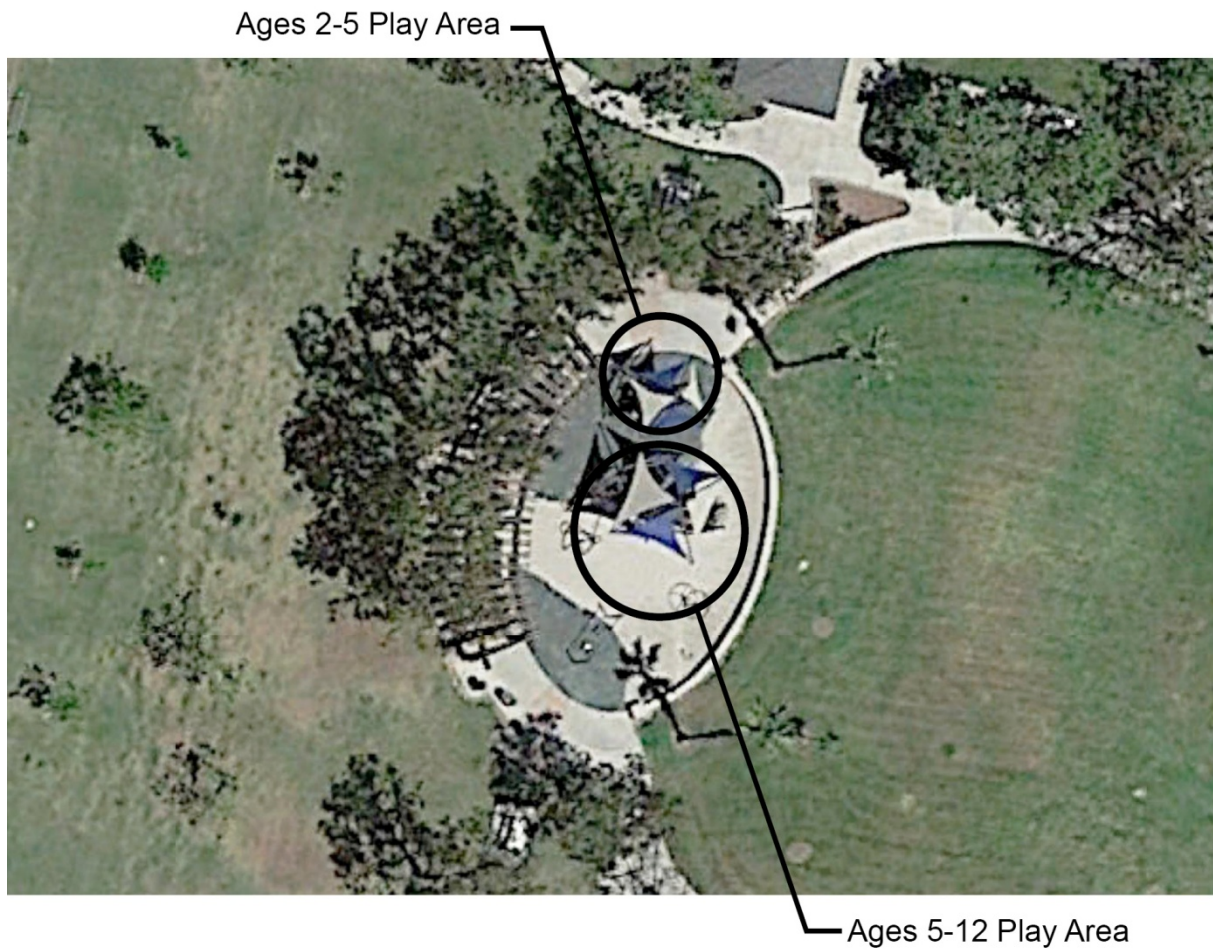
Action	Action Note	Planning Cost Estimate	Relevant Code
Improve or evaluate play area surface	Further evaluation of fall attenuation surface is recommended.	\$0	CBC 11B-1008.2.6.1 ADA 1008.2.6.1 ADA 1008.2.6.2
Install tread striping	Striping is not provided on stairs connecting play components.	\$200	CBC 11B-210.1 CBC 11B-504.4.1
Install or modify transfer system	The 30 by 48 inch ground space adjacent to transfer platform has a slope of up to 2.5 percent (2.0 percent maximum allowed).	\$400	CBC 11B-1008.3.1.3 ADA 1008.3.1.3
		\$600

Action	Action Note	Planning Cost Estimate	Relevant Code
Improve or evaluate play area surface	Further evaluation of fall attenuation surface is recommended.	\$0	CBC 11B-1008.2.6.1 ADA 1008.2.6.1 ADA 1008.2.6.2
Install tread striping	Striping is not provided on stairs connecting play components.	\$200	CBC 11B-210.1 CBC 11B-504.4.1
Provide an accessible path of travel	An accessible route is not provided to the overhead spin wheel. Route is 15 linear feet over sand from poured in place surface. An accessible route is not provided to two talk tubes, the sign language panel, and play window due to sand surface.	\$2,400	CBC 11B-206.2.17.1 CBC 11B-1008.2 ADA 206.2.17.1 ADA 1008.2
Modify play component	A 30 by 48 inch minimum clear space is not provided at two talk tubes, sign language panel, play window, and overhead spin component due to sand surface.	\$2,000	CBC 11B-1008.4.2 ADA 1008.4.2
Total		\$4,600

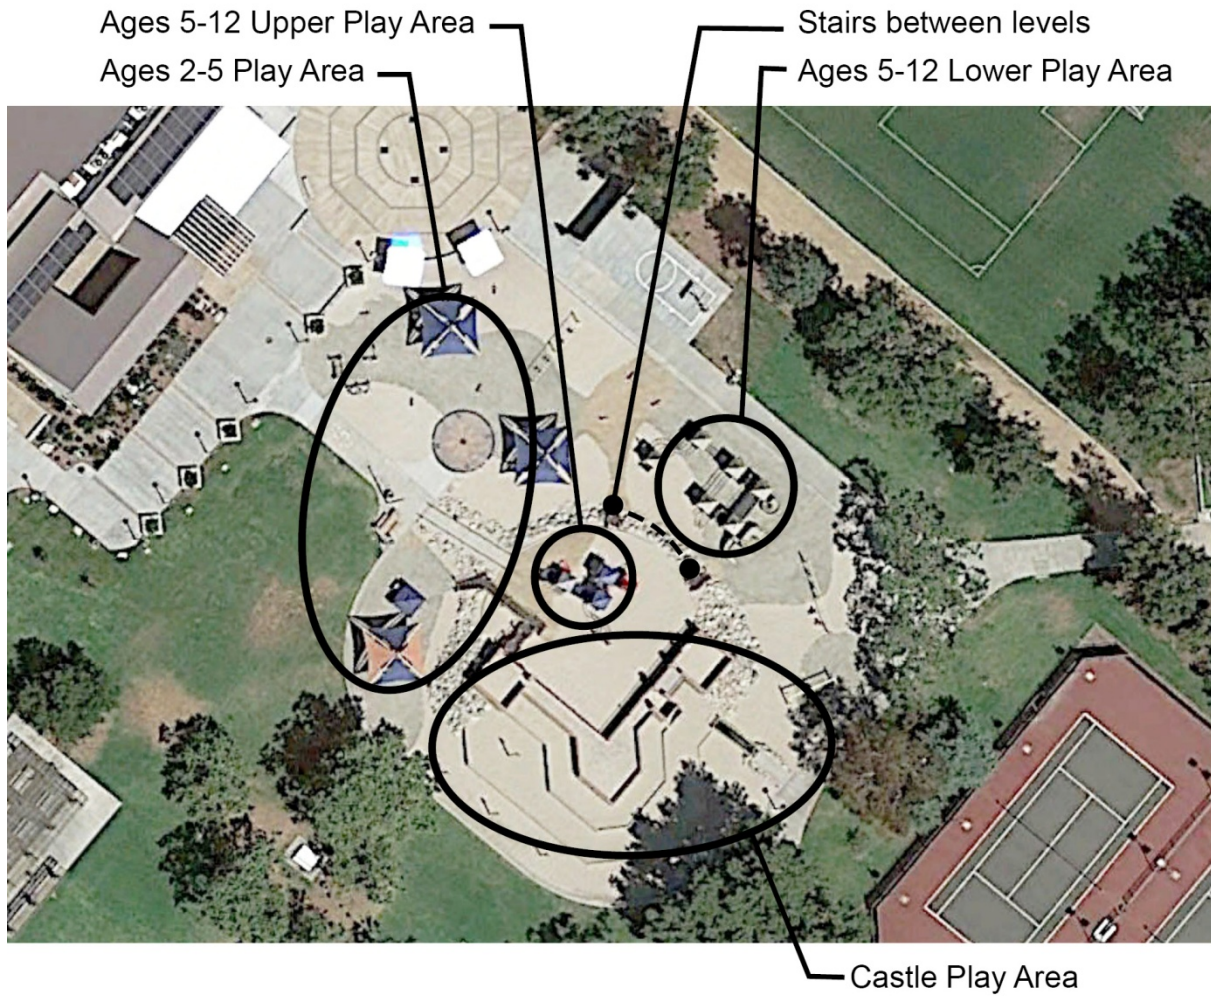
Action	Action Note	Planning Cost Estimate	Relevant Code
Improve or evaluate play area surface	Further evaluation of fall attenuation surface is recommended.	\$0	CBC 11B-1008.2.6.1 ADA 1008.2.6.1 ADA 1008.2.6.2
Install tread striping	Striping is not provided on stairs connecting play components.	\$200	CBC 11B-210.1 CBC 11B-504.4.1
Provide play components	Knee space is not provided at sand tables located off of poured in place surface due to sand (knee clearance is required to be 24 inches high minimum, 17 inches deep minimum, and 30 inches wide minimum, unless clear space for a parallel approach is provided).	\$800	CBC 11B-1008.4.3 ADA 1008.4.3
Provide an accessible path of travel	Vertical clearance at shade structure covering play area near picnic tables is 62-1/2 inches (80 inches minimum required).	\$125	CBC 11B-1008.2, ADA 1008.2
Total		\$1,125

Action	Action Note	Planning Cost Estimate	Relevant Code
Install tread striping	Striping is not provided on stairs connecting play components.	\$200	CBC 11B-210.1 CBC 11B-504.4.1
Improve or evaluate play area surface	Further evaluation of fall attenuation surface is recommended.	\$0	CBC 11B-1008.2.6.1 ADA 1008.2.6.1 ADA 1008.2.6.2
Provide play components	The play area for ages 5 to 12 on the lower level has 11 elevated play components and three ground level play component programs: swings, one tire swing, and one horizontal bar located seven linear feet off the path of travel (four minimum ground level play components of three different varieties are required).	\$5,000	CBC 11B-240.2.1.2 ADA 240.2.1.2
Total		\$5,200

Action	Action Note	Planning Cost Estimate	Relevant Code
Install tread striping	Striping is not provided on stairs connecting play components.	\$200	CBC 11B-210.1 CBC 11B-504.4.1
Improve or evaluate play area surface	Further evaluation of fall attenuation surface is recommended.	\$0	CBC 11B-1008.2.6.1 ADA 1008.2.6.1 ADA 1008.2.6.2
Provide play components	The play area for ages 5 to 12 on the upper level has eight elevated play components and two ground level play component programs (three ground level components are required including three different types of components)	\$5,000	CBC 11B-240.2.1.2 ADA 240.2.1.2
Install or modify transfer system	The 30 by 48 inch ground space adjacent to transfer platform has a slope of up to 2.3 percent (2.0 percent maximum allowed).	\$400	CBC 11B-1008.3.1.3 ADA 1008.3.1.3
Total		\$5,600

Action	Action Note	Planning Cost Estimate	Relevant Code
Provide an accessible path of travel	An accessible route to the castle play area is not provided. Routes to top level include two stairways and a fire pole. Once in top level of castle, passageways are reduced to 23-3/8 and 22-1/2 inches wide. Route to middle level includes a non-compliant stairway with five steps. Treads have a sand surface that is not accessible.	\$0	CBC 11B-206.2.17 ADA 206.2.17
Regrade or replace ramp	Ramp to bridge has a running slope of 23.4 percent for 13 linear feet (6.25 percent maximum allowed for ramps connecting ground level play equipment). Rise on bridge is equal to or greater than 12 inches depending on level of sand surface below (12 inches maximum rise permitted).	\$5,525	CBC 11B-1008.2.5.1 CBC 11B-1008.2.5.2 ADA 1008.2.5.1 ADA 1008.2.5.2
Provide an accessible path of travel	Vertical clearance below castle deck is 58 to 58-1/2 inches above non-accessible sand surface (80 inches minimum clearance required).	\$0	CBC 11B-1008.2 ADA 1008.2

Improve or evaluate play area surface	Sand surface in castle play area is not accessible, and further evaluation of fall attenuation surface is recommended. Openings between decking boards on upper level are up to 5/8 inch wide (1/2 inch maximum allowed).	\$0	CBC 11B-302.3 CBC 11B-1008.2.6.1 ADA 302.3 ADA 1008.2.6.1 ADA 1008.2.6.2
Total		\$5,525

Action	Action Note	Planning Cost Estimate	Relevant Code
Install tread striping	No tread striping provided on stairs connecting different play area levels (required for all treads on an exterior stairway).	\$400	CBC 11B-504.4.1
Replace stairs	Width of stairway is 32-3/4 inches (36 inches minimum required for an occupancy load less than 50, and 44 inches minimum for an occupancy load of greater than 50). Riser heights are eight inches (four inches minimum to seven inches maximum required).	\$600	CBC 11B-503.5.1 CBC 11B-504.2 ADA 504.2 ADA 504.3
Raise or lower existing handrail	Handrail top surface is mounted 37-1/2 to 38 inches above the stair nosing (28 inches maximum allowed for stairways primarily used by children).	\$100	CBC 11B-505.4 ADA 505.4
Install a handrail	A parallel extension is not provided at the top of the handrail (12 inches minimum allowed). An extension at the bottom of the stairway is not provided (one tread width sloped and an additional 12 inches parallel to the ground required).	\$500	CBC 11B-505.10.2 CBC 11B-505.10.3 ADA 505.10.2 ADA 505.10.3

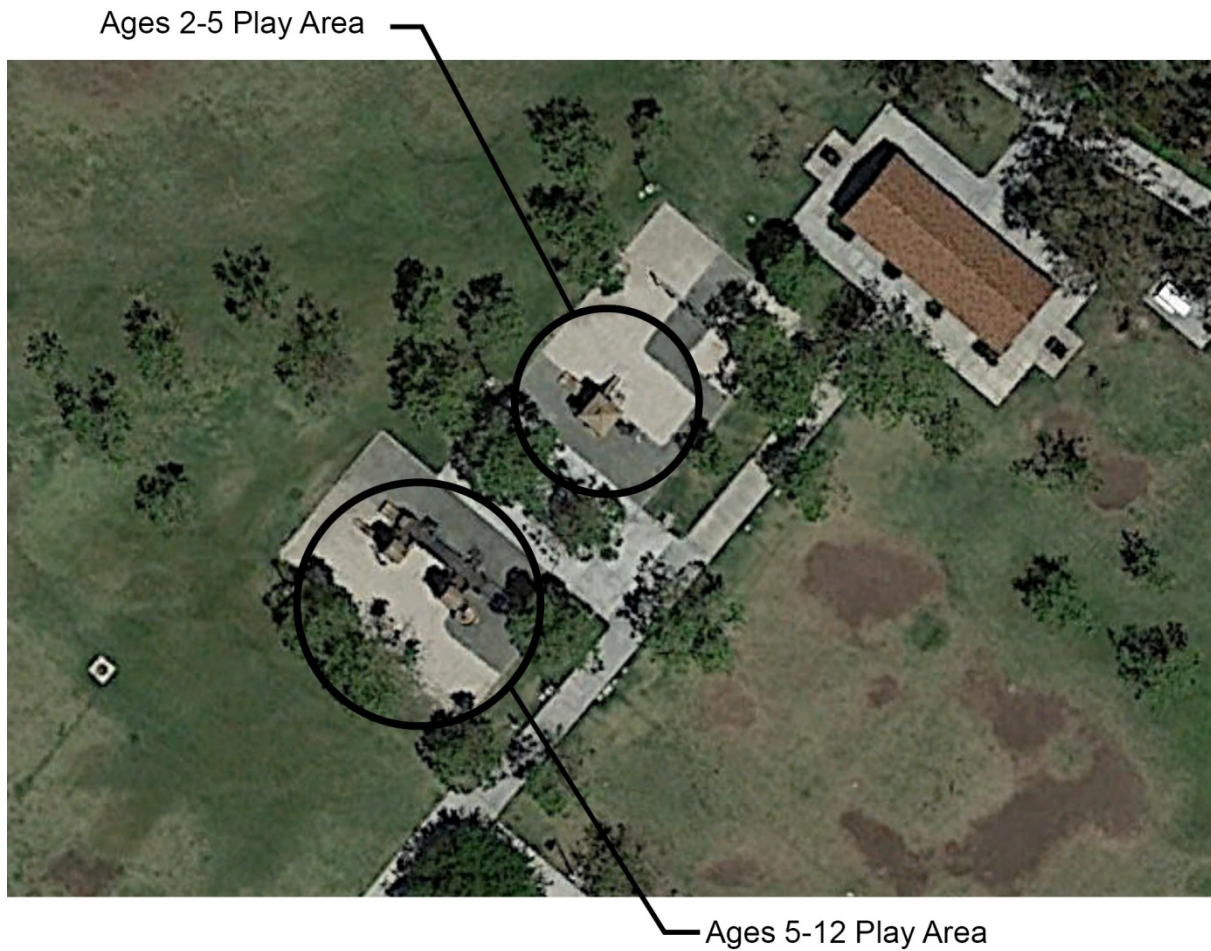
Action	Action Note	Planning Cost Estimate	Relevant Code
Improve or evaluate play area surface	Further evaluation of fall attenuation surface is recommended. Top layer of poured in place surface is worn.	\$0	CBC 11B-1008.2.6.1 ADA 1008.2.6.1 ADA 1008.2.6.2
Install or modify transfer system	The 30 by 48 inch ground space adjacent to transfer platform has a slope of up to 2.7 percent (2.0 percent maximum permitted).	\$400	CBC 11B-1008.3.1.3 ADA 1008.3.1.3
Install tread striping	Striping is not provided on stairs connecting play components.	\$200	CBC 11B-210.1 CBC 11B-504.4.1
Total		\$600

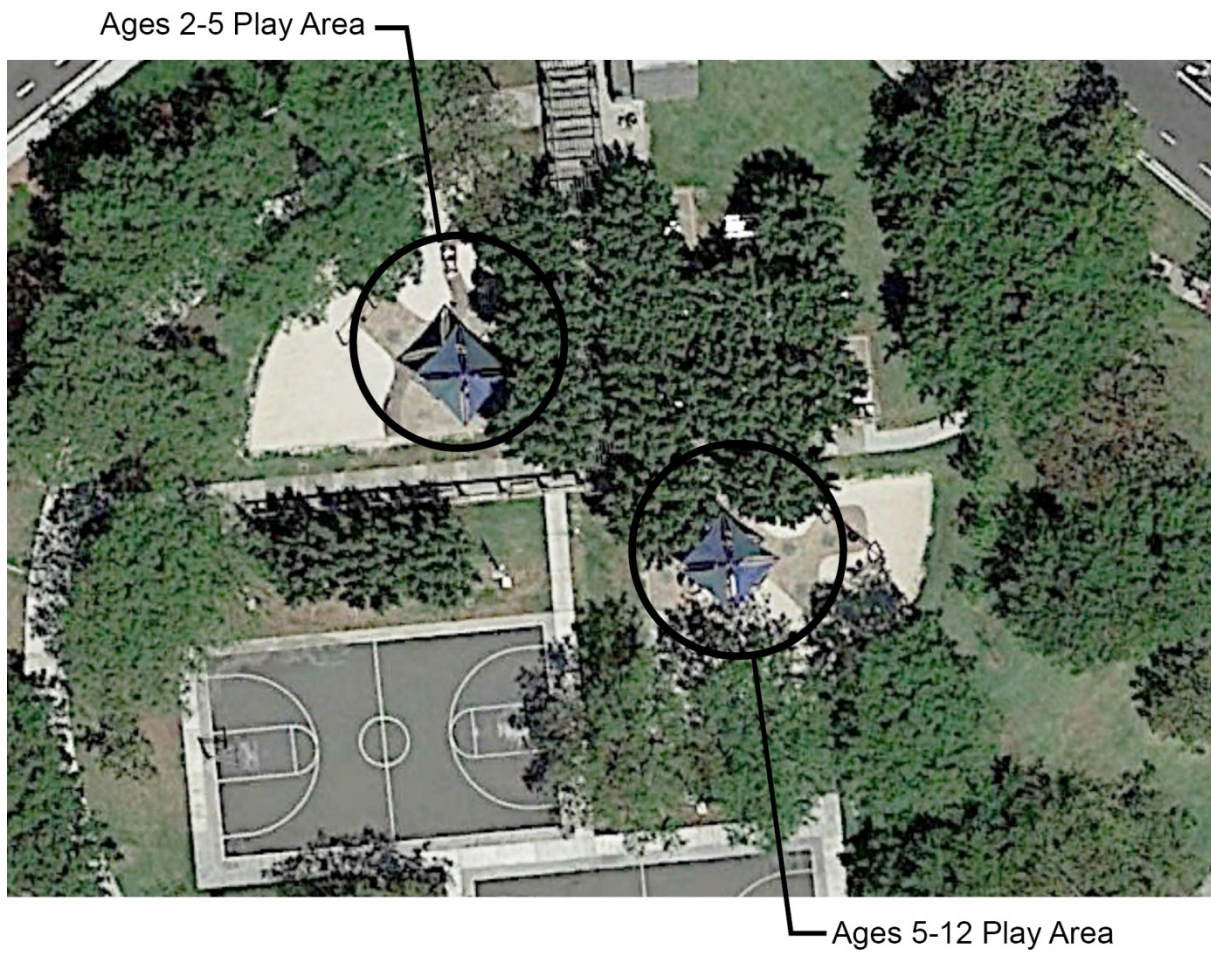
Action	Action Note	Planning Cost Estimate	Relevant Code
Improve or evaluate play area surface	Further evaluation of fall attenuation surface is recommended. One inch gap at the expansion joint between the concrete walk and play area curb (1/2 inch maximum opening allowed).	\$0	CBC 11B-302.3 CBC 11B-1008.2.6.1 ADA 302.3 ADA 1008.2.6.1 ADA 1008.2.6.2
Install tread striping	Striping is not provided on stairs connecting play components.	\$200	CBC 11B-210.1 CBC 11B-504.4.1
Provide play components	Knee space at play table is 21-3/8 inches high (24 inches minimum height required). The table is not positioned to allow for a parallel approach. Table is 11 inches behind front of benches.	\$5,000	CBC 11B-1008.4.3 ADA 1008.4.3
Provide an accessible path of travel	An accessible route is not provided from an accessible play area entry to each different play activity provided in the play area. Two cars of the train are not located along an accessible route due to width of poured in place surface (44 inches minimum width required) and adjacent sand surface.	\$480	CBC 11B-206.2.17.1 CBC 11B-1008.2 CBC 11B-1008.2.4.1 ADA 206.2.17.1 ADA 1008.2 ADA 1008.2.4.1

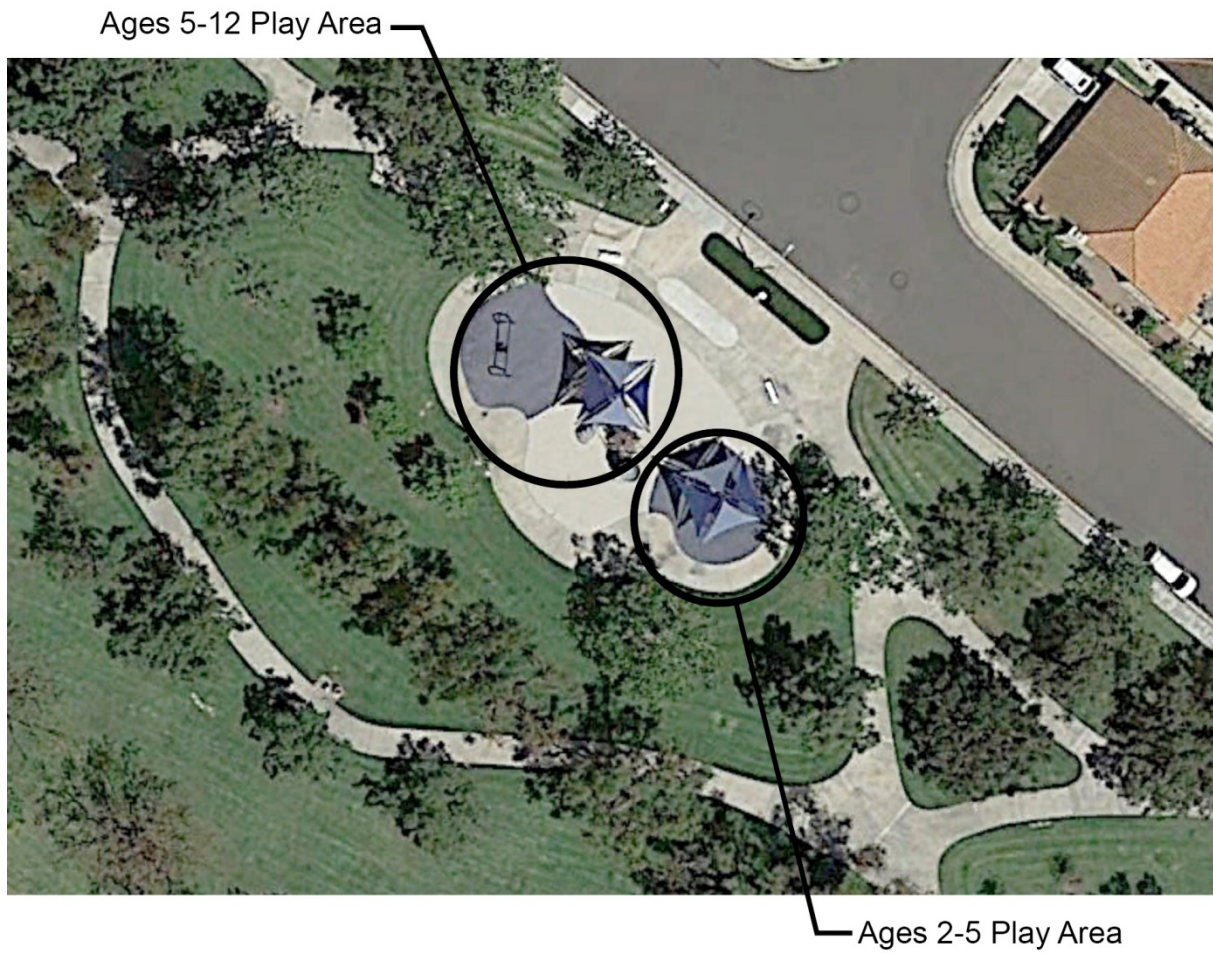
Action	Action Note	Planning Cost Estimate	Relevant Code
Improve or evaluate play area surface	Further evaluation of fall attenuation surface is recommended. There is a one inch gap between the poured in place surface and concrete walk (1/2 inch maximum opening permitted).	\$0	CBC 11B-302.3 CBC 11B-1008.2.6.1 ADA 302.3 ADA 1008.2.6.1 ADA 1008.2.6.2
Provide play components	No ground level play components are provided for the seven elevated components on the play structure (two ground level components are required including two different types of components)	\$5,000	CBC 11B-240.2.1.2 ADA 240.2.1.2
Install tread striping	Striping is not provided on stairs connecting play components.	\$200	CBC 11B-210.1 CBC 11B-504.4.1
Total		\$5,200

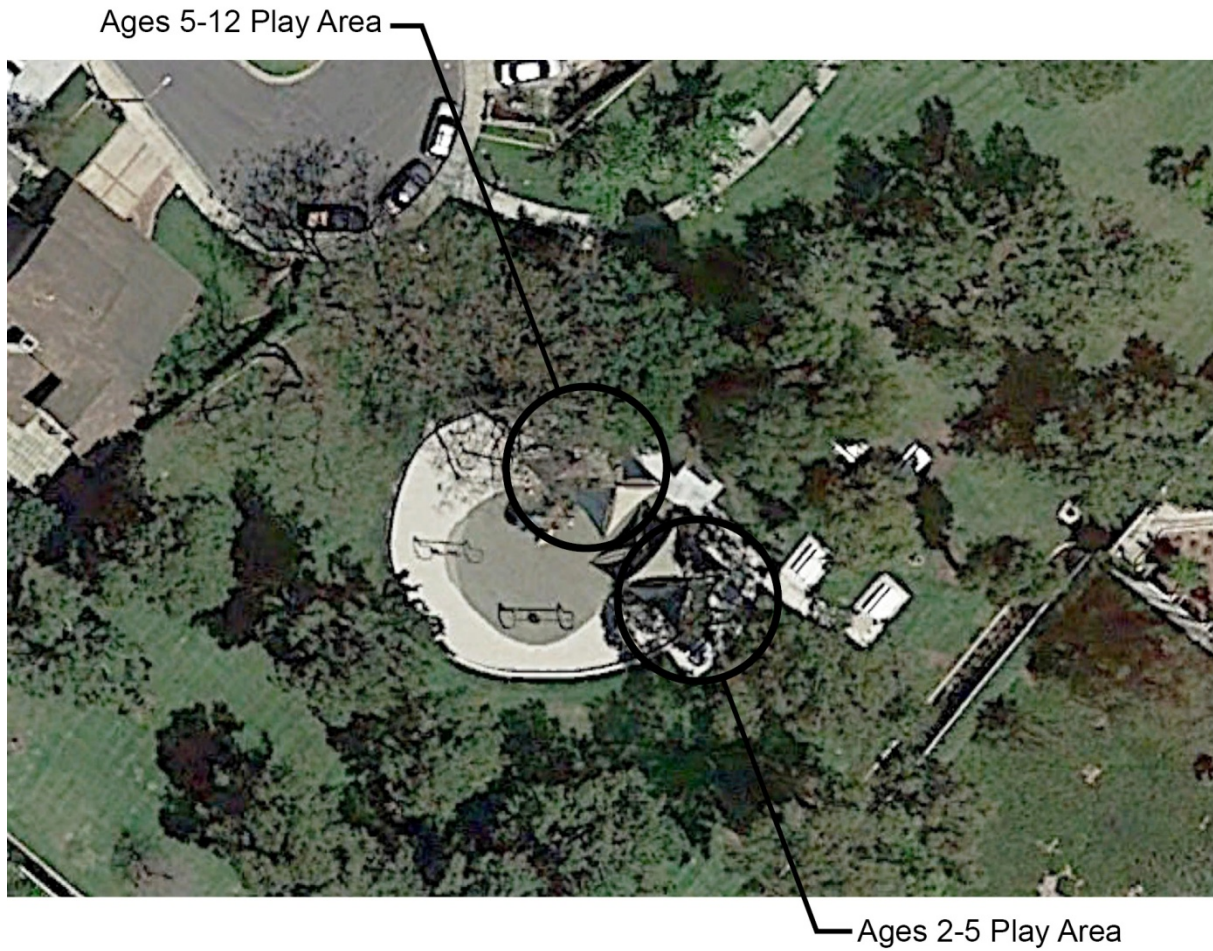
Action	Action Note	Planning Cost Estimate	Relevant Code
Provide an accessible path of travel	An accessible route is not provided to the fossil wall, play table, or play window. None of the ground level play components are on an accessible route (44 inches minimum wide required).	\$600	CBC 11B-206.2.17.1 CBC 11B-1008.2 ADA 206.2.17.1 ADA 1008.2
Improve or evaluate play area surface	Further evaluation of fall attenuation surface is recommended.	\$0	CBC 11B-1008.2.6.1 ADA 1008.2.6.1 ADA 1008.2.6.2
Install or modify transfer system	Transfer platform surface height is 10-1/4 inches (11 inches minimum to 18 inches maximum allowed) above the accessible surfacing.	\$5,000	CBC 11B-1008.3.1.2 ADA 1008.3.1.2
Install tread striping	Striping is not provided on stairs connecting play components.	\$200	CBC 11B-210.1 CBC 11B-504.4.1
Total		\$5,800

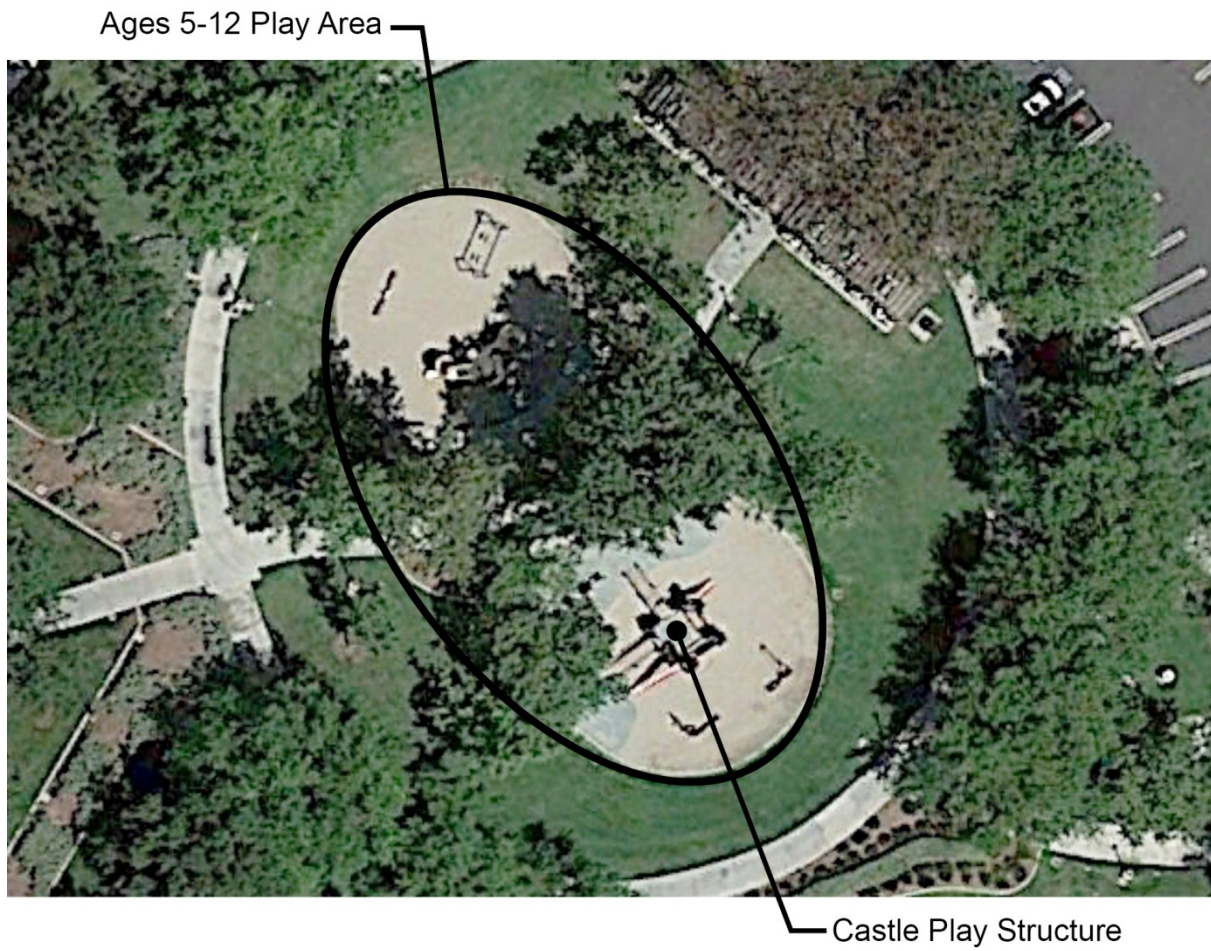
Action	Action Note	Planning Cost Estimate	Relevant Code
Improve or evaluate play area surface	Further evaluation of fall attenuation surface is recommended. Poured in place surface is separating from adjacent concrete curbs, up to four inches at castle play area and up to three inches at composite structure play area.	\$0	CBC 11B-1008.2.6.1 ADA 1008.2.6.1 ADA 1008.2.6.2
Provide an accessible path of travel	Vertical clearance into the castle is 70-3/4 inches or 76-1/4 inches (80 inches minimum required).	\$250	CBC 11B-1008.2 ADA 1008.2
Provide an accessible path of travel	An accessible route to the swings, see-saw, sand table, and castle corners is not provided due to sand surface.	\$6,000	CBC 11B-206.2.17.1 CBC 11B-1008.2 ADA 206.2.17.1 ADA 1008.2
Install or modify transfer system	A transfer system is not provided to elevated play components on castle structure.	\$5,000	CBC 11B-1008.3 ADA 1008.3

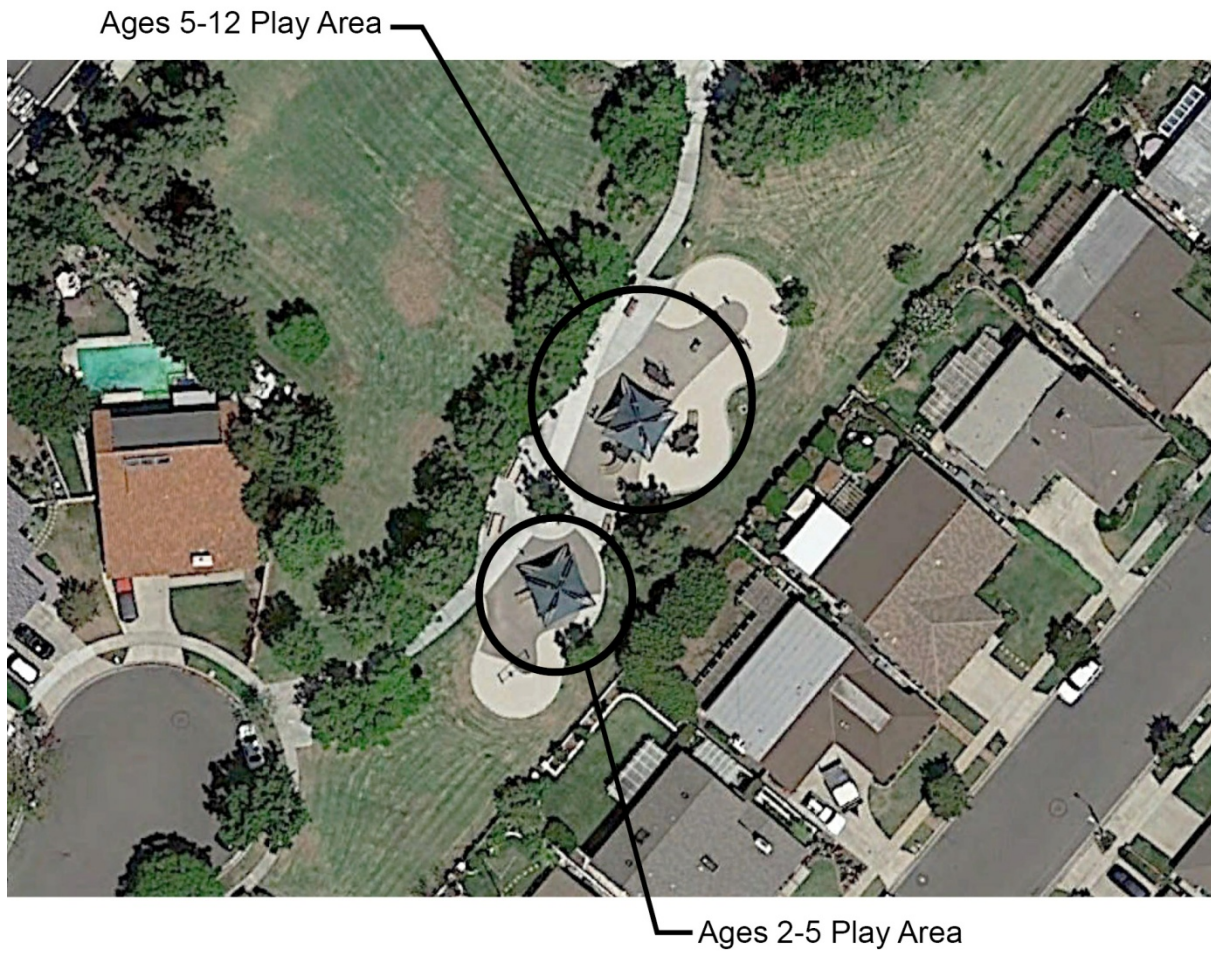
Action	Action Note	Planning Cost Estimate	Relevant Code
Improve or evaluate play area surface	Further evaluation of fall attenuation surface is recommended.	\$0	CBC 11B-1008.2.6.1 ADA 1008.2.6.1 ADA 1008.2.6.2
Install tread striping	Striping is not provided on stairs connecting play components.	\$200	CBC 11B-210.1 CBC 11B-504.4.1
Total		\$200

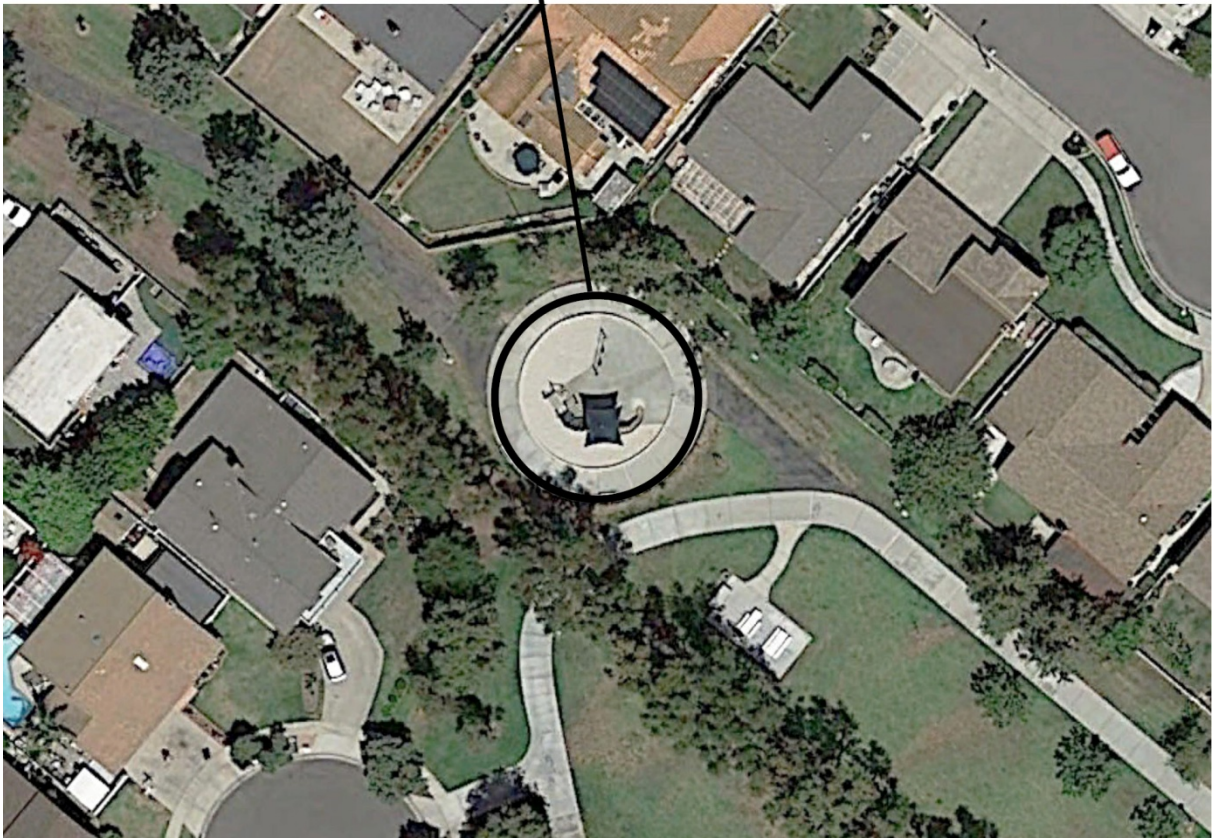
Ages 5-12 Play Area

Action	Action Note	Planning Cost Estimate	Relevant Code
Improve or evaluate play area surface	Further evaluation of fall attenuation surface is recommended. Sand has migrated on to poured in place surface. Surface needs on-going maintenance.	\$0	CBC 11B-1008.2.6.1 ADA 1008.2.6.1 ADA 1008.2.6.2
Install tread striping	Striping is not provided on stairs connecting play components.	\$200	CBC 11B-210.1 CBC 11B-504.4.1
Provide play components	Knee space at play table is 21-3/4 inches high (24 inches minimum height is required).	\$5,000	CBC 11B-1008.4.3 ADA 1008.4.3
Total		\$5,200
