City of Irvine
Parks Master Plan
FINAL | JULY 2015

ADA Assessment of Play Areas in Irvine Parks

TECHNICAL SUPPLEMENT

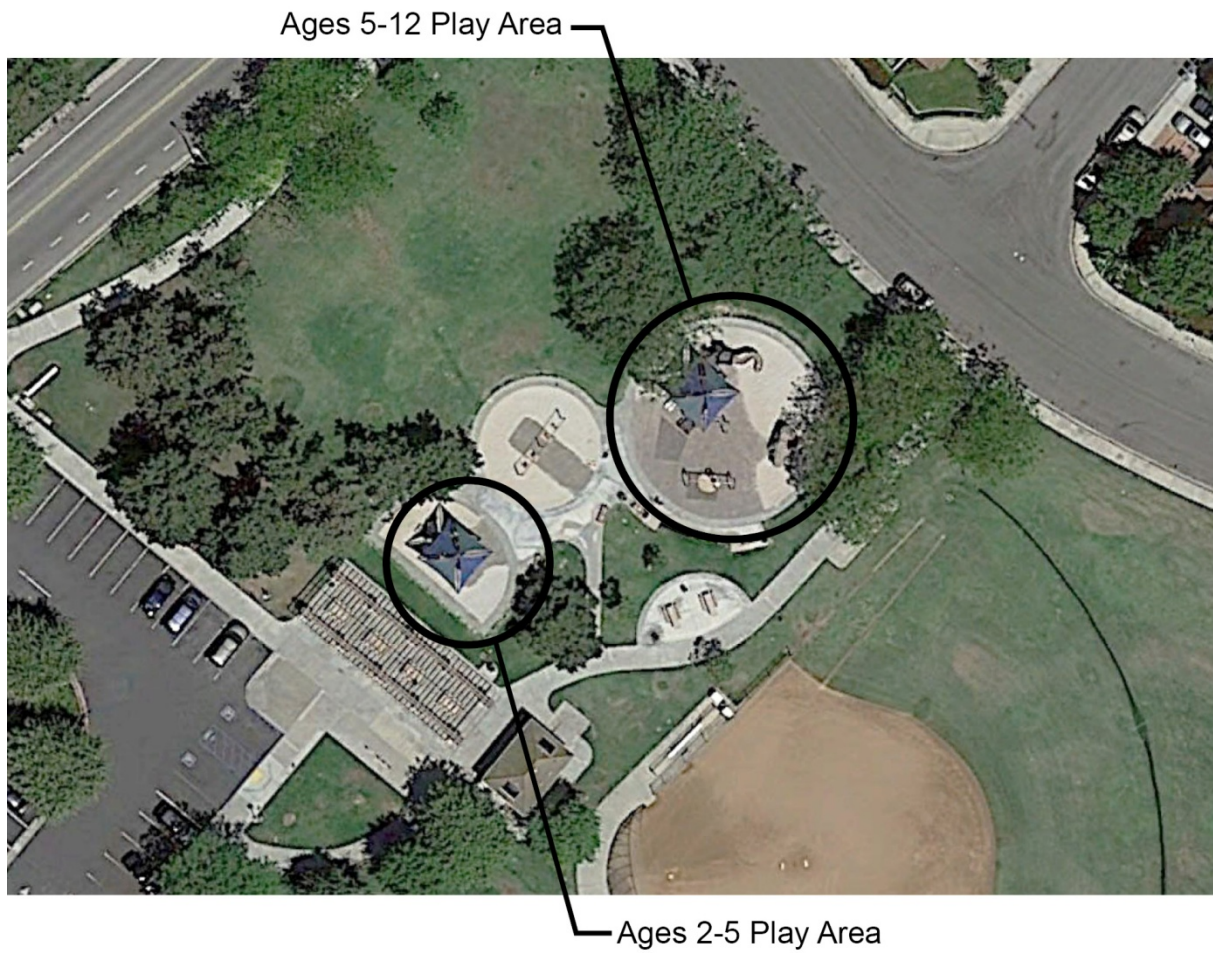
Action	Action Note	Planning Cost Estimate	Relevant Code
Provide an accessible path of travel	An accessible route to the play equipment area is not provided to the play table. Route is 28 inches wide (44 inches minimum required).	\$160	CBC 11B-1008.2.4.1 ADA 1008.2.4.1
Improve or evaluate play area surface	Further evaluation of fall attenuation surface is recommended. Sand has migrated onto poured in place surface. Surface is in need of maintenance.	\$0	CBC 11B-1008.2.6.1 ADA 1008.2.6.1 ADA 1008.2.6.2
Install tread striping	Striping is not provided on stairs connecting play components.	\$200	CBC 11B-210.1 CBC 11B-504.4.1
Modify play component	A 56 inch diameter turning area provided at play table (60 inches minimum required).	\$100	CBC 11B-1008.4.1 ADA 1008.4.1
Provide play components	Knee space at play table is 21 inches high (24 inches minimum height is required). The table is not positioned to allow for a parallel approach. Table is 9 inches behind front of benches and is not set up for parallel approach.	\$5,000	CBC 11B-1008.4.3 ADA 1008.4.3

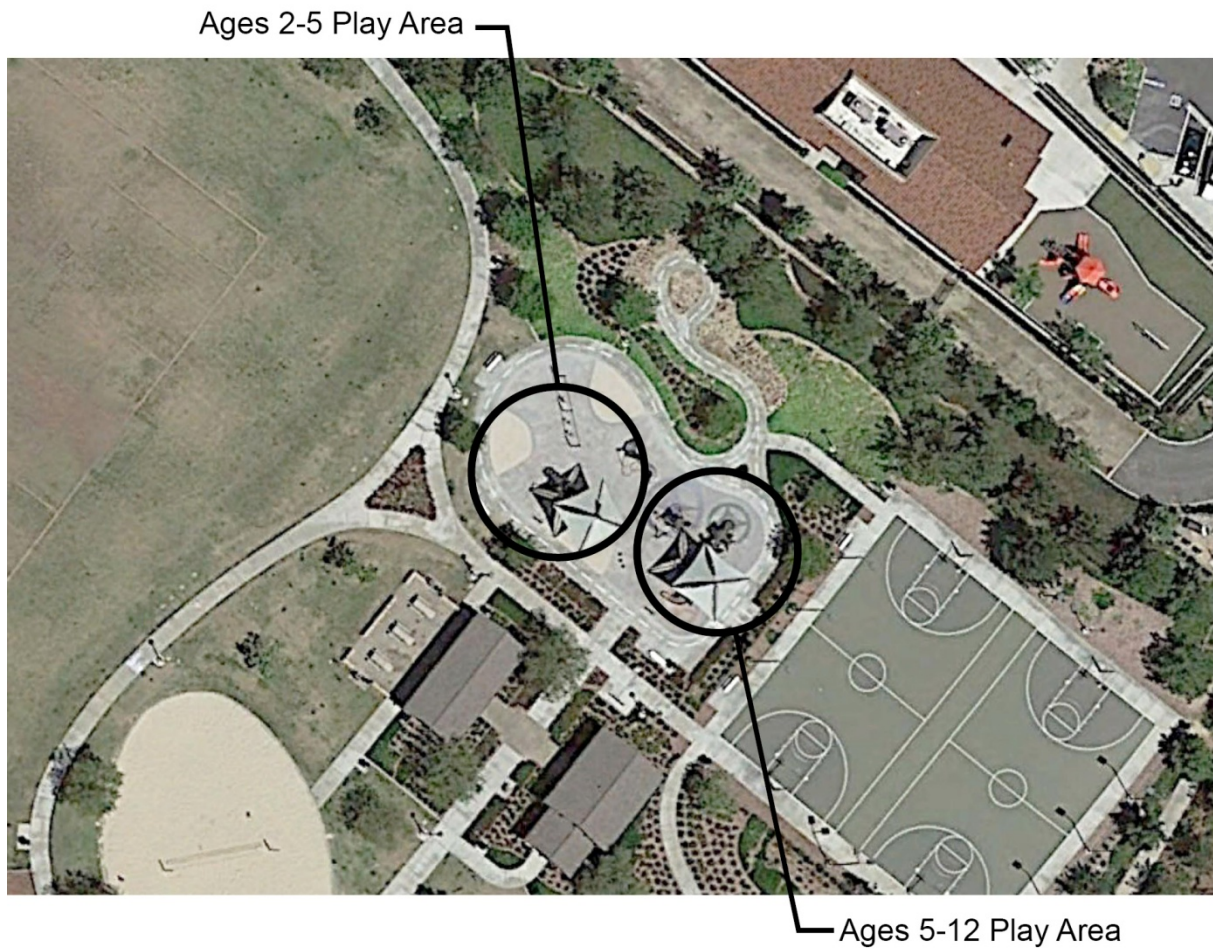
Action	Action Note	Planning Cost Estimate	Relevant Code
Improve or evaluate play area surface	Further evaluation of fall attenuation surface is recommended. Poured in place surface has cracks in top layer. Sand surface has migrated onto poured in place and is in need of maintenance.	\$0	CBC 11B-1008.2.6.1 ADA 1008.2.6.1 ADA 1008.2.6.2
Install or modify transfer system	The 30 by 48 inch ground space adjacent to transfer platform has a slope of up to 2.3 percent (2.0 percent maximum allowed).	\$400	CBC 11B-1008.3.1.3 ADA 1008.3.1.3
Install tread striping	Striping is not provided on stairs connecting play components.	\$200	CBC 11B-210.1 CBC 11B-504.4.1
Provide play components	Knee space at play table is 23-1/4 inches high (24 inches minimum height is required). The table is not positioned to allow for a parallel approach. Table is 10 inches behind front of benches and not set up for parallel approach.	\$5,000	CBC 11B-1008.4.3 ADA 1008.4.3

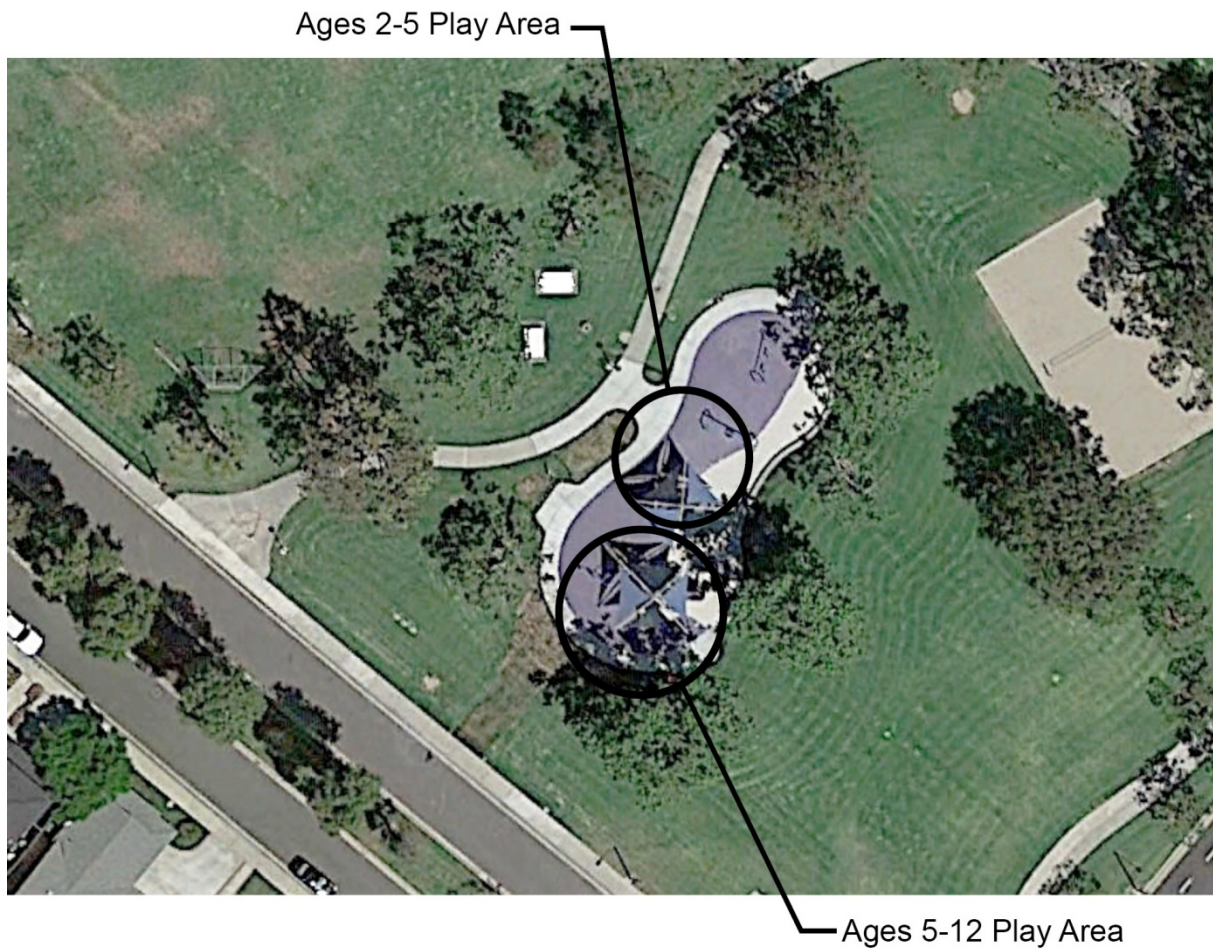
Action	Action Note	Planning Cost Estimate	Relevant Code
Modify play component	A 30 by 48 inch minimum clear space with a slope of 2.0 percent maximum is not provided at the play table. Slope is up to 60 percent at transition between poured in place and sand surfaces.	\$400	CBC 11B-1008.4.2 ADA 1008.4.2
Improve or evaluate play area surface	Further evaluation of fall attenuation surface is recommended.	\$0	CBC 11B-1008.2.6.1 ADA 1008.2.6.1 ADA 1008.2.6.2
Install tread striping	Striping is not provided on stairs connecting play components.	\$200	CBC 11B-210.1 CBC 11B-504.4.1
Provide an accessible path of travel	Accessible routes to the fossil play area and play table are not provided due to sand surface.	\$800	CBC 11B-206.2.17.1 CBC 11B-1008.2 ADA 206.2.17.1 ADA 1008.2
Total		\$1,400

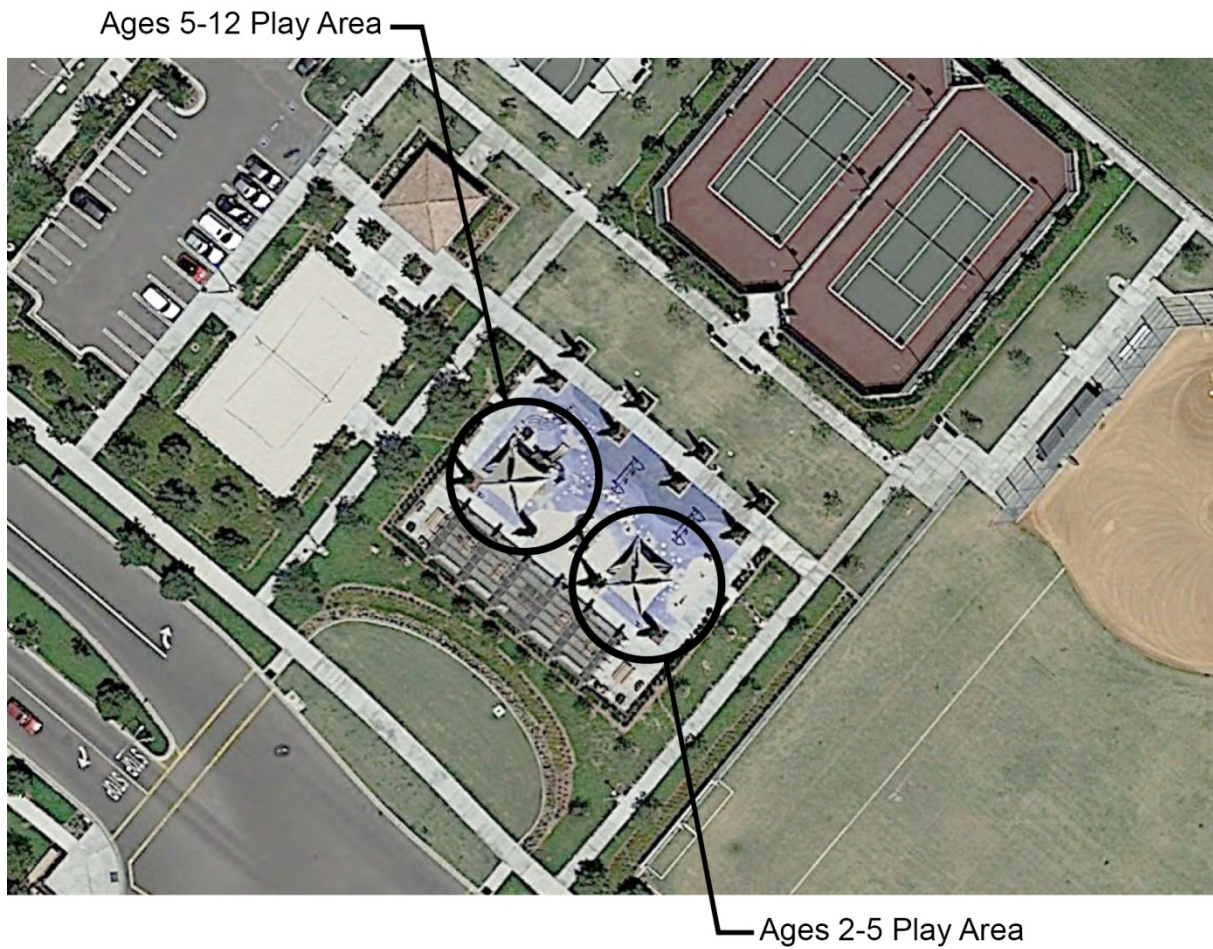
Action	Action Note	Planning Cost Estimate	Relevant Code
Improve or evaluate play area surface	Further evaluation of fall attenuation surface is recommended.	\$0	CBC 11B-1008.2.6.1 ADA 1008.2.6.1 ADA 1008.2.6.2
Install tread striping	Striping is not provided on stairs connecting play components.	\$200	CBC 11B-210.1 CBC 11B-504.4.1
Provide play components	Knee space at play table is 20-3/4 inches high (24 inches minimum height required). The table is not positioned to allow for a parallel approach. Table is 11 inches behind front of benches and not set up for parallel approach.	\$5,000	CBC 11B-1008.4.3 ADA 1008.4.3
Total		\$5,200

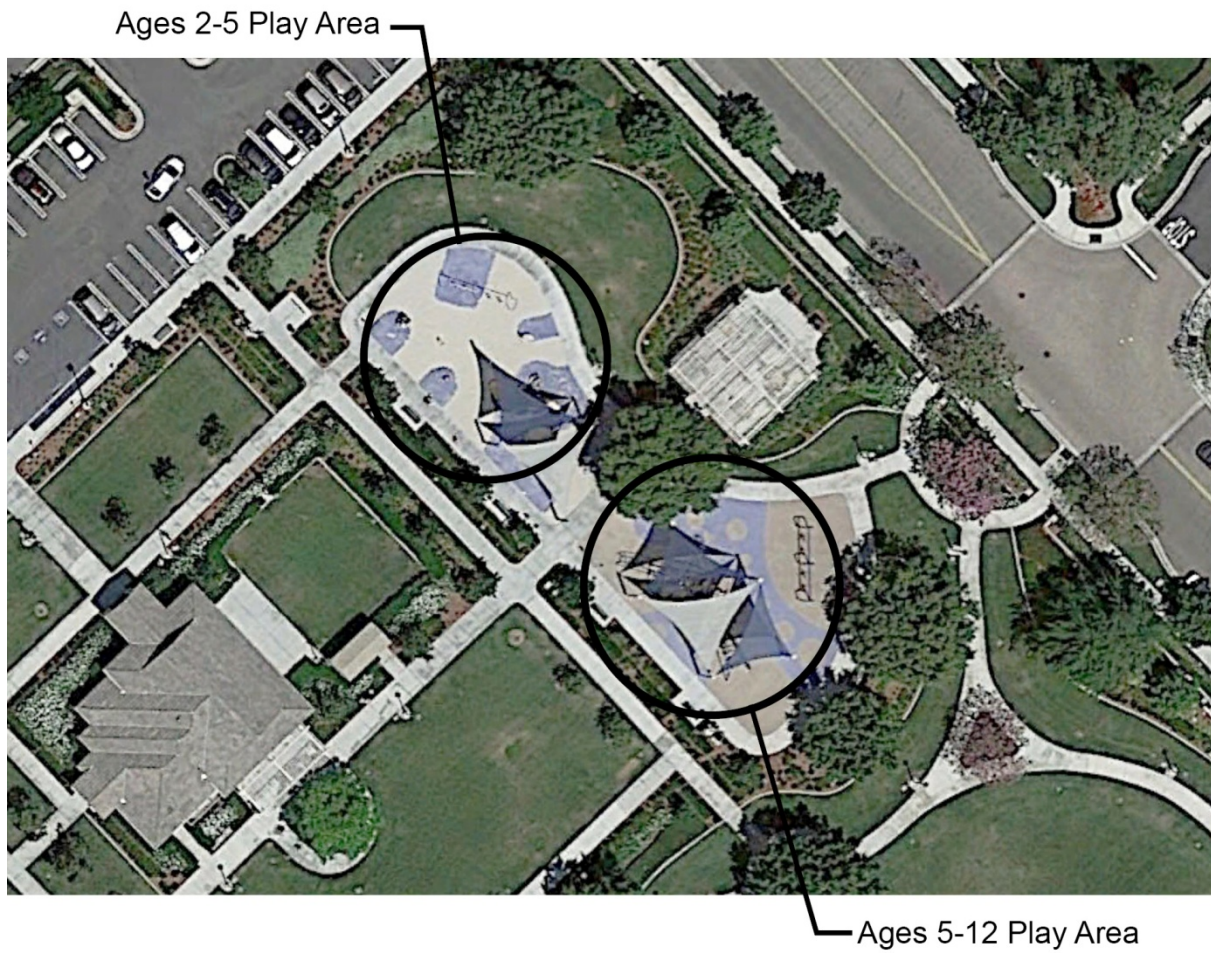
Action	Action Note	Planning Cost Estimate	Relevant Code
Improve or evaluate play area surface	Further evaluation of fall attenuation surface is recommended.	\$0	CBC 11B-1008.2.6.1 ADA 1008.2.6.1 ADA 1008.2.6.2
Modify play component	A 30 by 48 inch minimum clear space with a slope of 2.0 percent maximum is not provided at each ground level component. Slope is up to 3.3 percent at play table under composite structure and up to 3.2 percent at boat play.	\$800	CBC 11B-1008.4.2 ADA 1008.4.2
Install tread striping	Contrasting striping is not provided on stairs connecting play components. Existing striping is a texture but does not provide adequate visual contrast.	\$200	CBC 11B-210.1 CBC 11B-504.4.1
Install or modify transfer system	The 30 by 48 ground space adjacent to transfer platform has a slope of up to 3.0 percent (2.0 percent maximum allowed). Top transfer step is 8-1/4 inches high (eight inches maximum allowed). Vertical clearance between transfer platform surface and panel is 20 to 24 inches. This should be further examined as to whether it inhibits the functionality of the transfer. A transfer platform is not provided at second boat area closest to parking lot.	\$5,000	CBC 11B-1008.3.1.3 CBC 11B-1008.3.2.1 CBC 11B-1008.3.2.2 ADA 1008.3.1.3 ADA 1008.3.2.1 ADA 1008.3.2.2

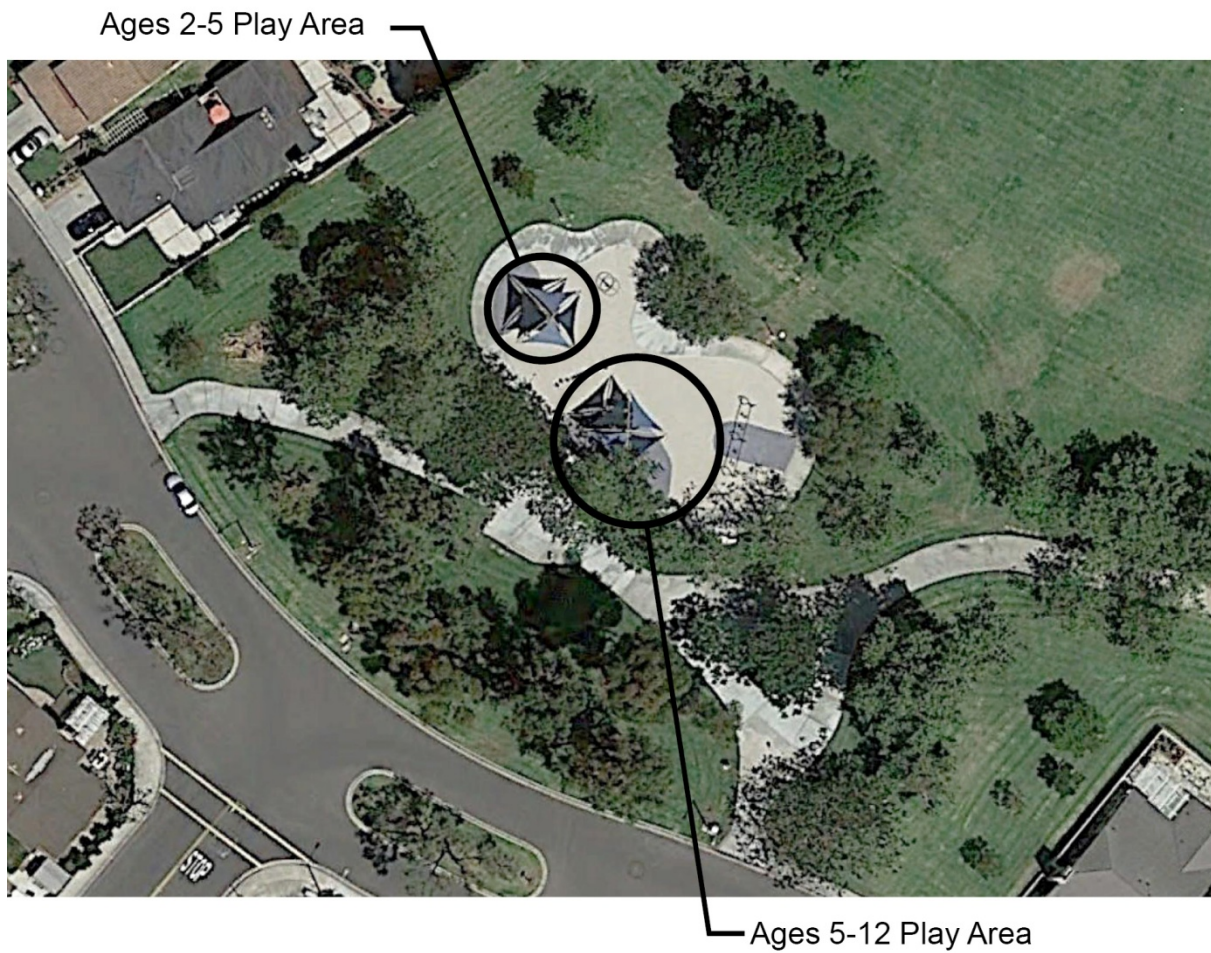
Action	Action Note	Planning Cost Estimate	Relevant Code
Improve or evaluate play area surface	Further evaluation of fall attenuation surface is recommended.	\$0	CBC 11B-1008.2.6.1 ADA 1008.2.6.1 ADA 1008.2.6.2
Install tread striping	Striping is not provided on stairs connecting play components.	\$200	CBC 11B-210.1 CBC 11B-504.4.1
Install or modify transfer system	Transfer platform surface height is 10-5/8 inches (11 inches minimum to 18 inches maximum allowed) above the accessible surfacing.	\$5,000	CBC 11B-1008.3.1.2 ADA 1008.3.1.2
Provide an accessible path of travel	An accessible route to the play table is not provided. Route is three linear feet over sand.	\$240	CBC 11B-206.2.17.1 CBC 11B-1008.2 ADA 206.2.17.1 ADA 1008.2
Modify play component	The 30 by 48 inch clear space adjacent to the toddler swing has a slope up to 2.8 percent (2.0 percent maximum allowed).	\$400	CBC 11B-1008.4.2 ADA 1008.4.2

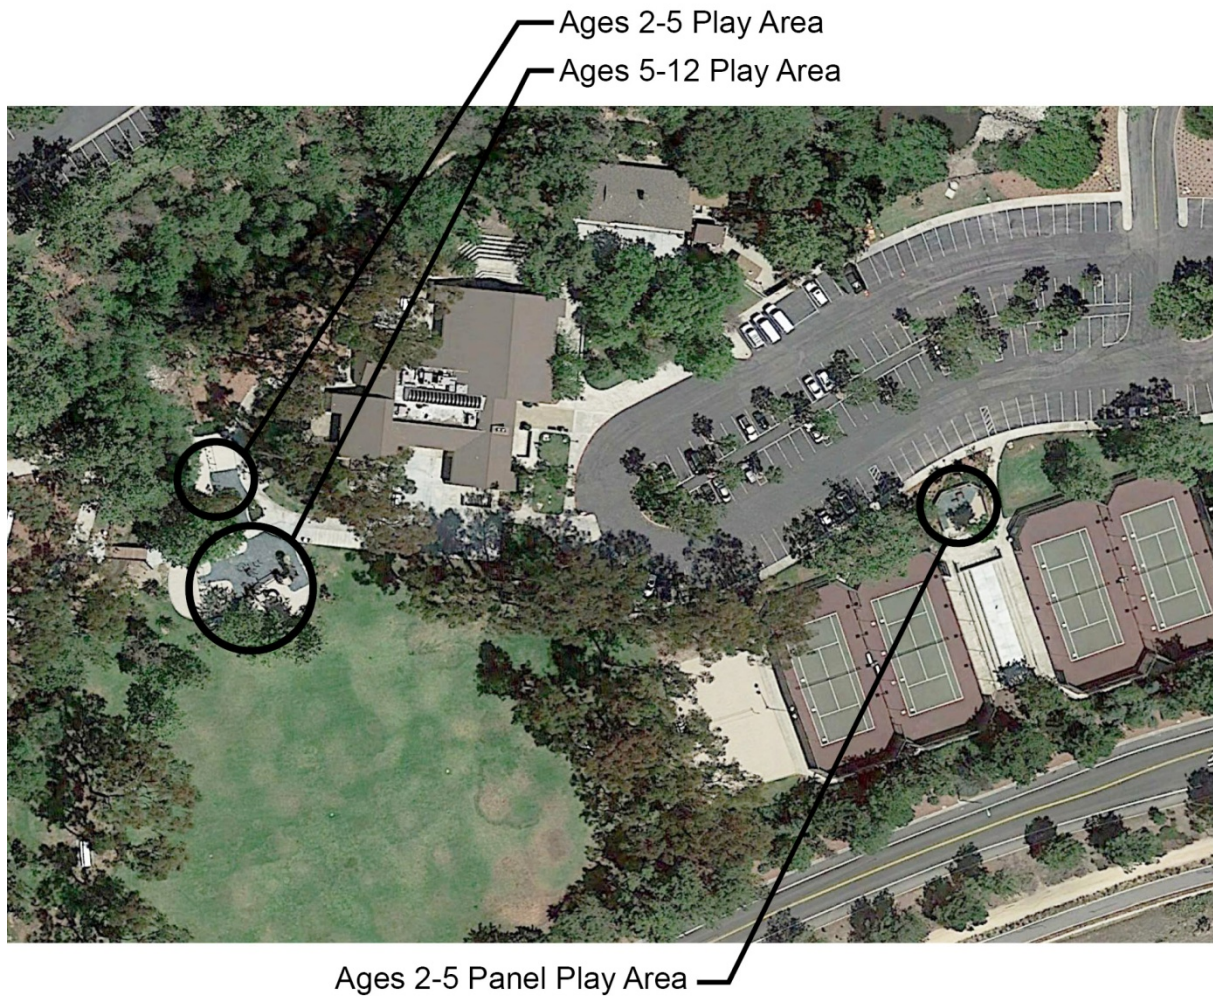
Action	Action Note	Planning Cost Estimate	Relevant Code
Improve or evaluate play area surface	Further evaluation of fall attenuation surface is recommended. Edges of poured in place surface are fraying.	\$0	CBC 11B-1008.2.6.1 ADA 1008.2.6.1 ADA 1008.2.6.2
Modify play component	The 30 by 48 inch minimum clear space at four-in-a-row panel is up to 3.5 percent (2.0 percent maximum is allowed).	\$400	CBC 11B-1008.4.2 ADA 1008.4.2
		\$400

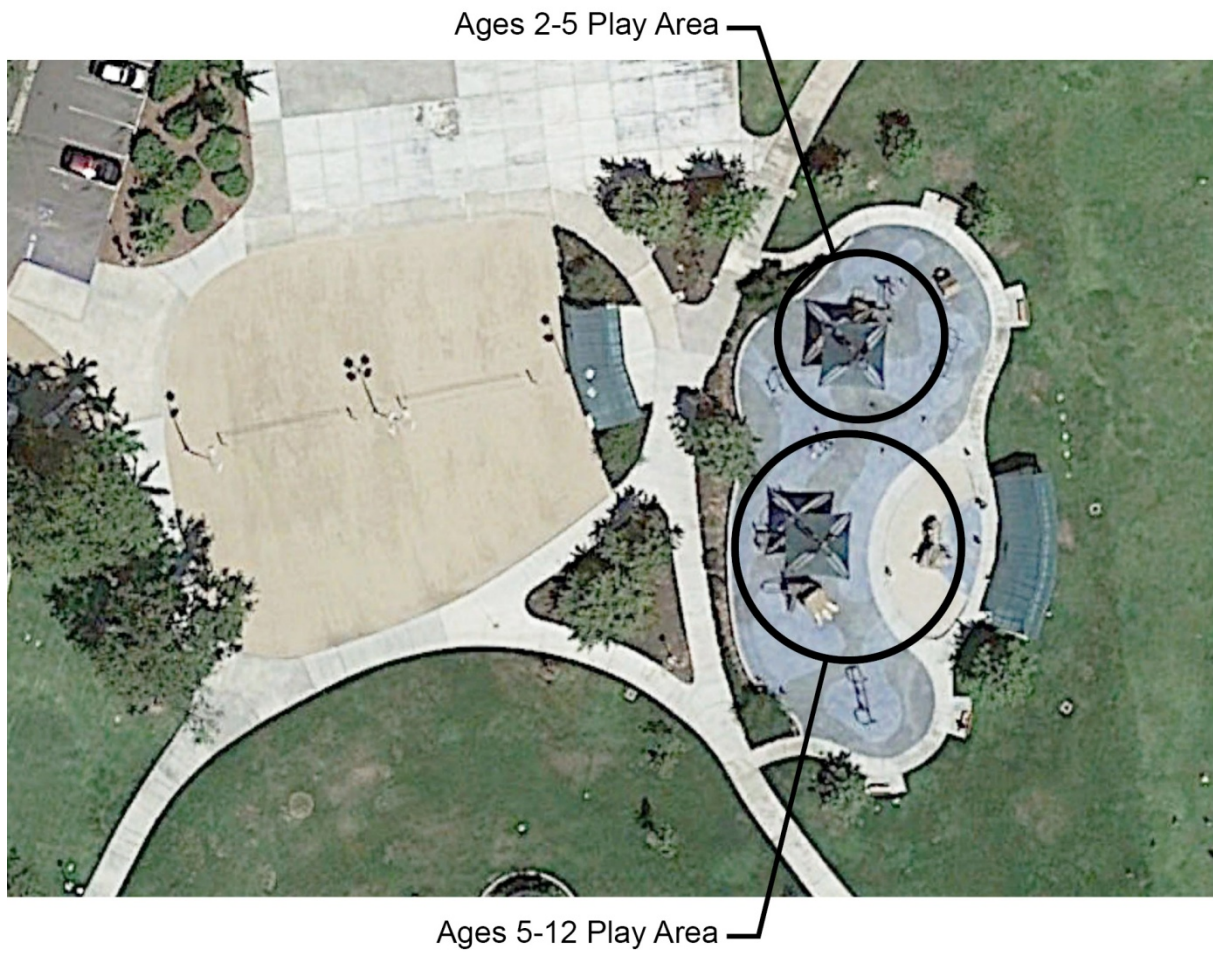
Action	Action Note	Planning Cost Estimate	Relevant Code
Improve or evaluate play area surface	Further evaluation of fall attenuation surface is recommended.	\$0	CBC 11B-1008.2.6.1 ADA 1008.2.6.1 ADA 1008.2.6.2
Install or modify transfer system	The 30 by 48 inch ground space adjacent to transfer platform has a slope of up to 2.8 percent (2.0 percent maximum allowed).	\$400	CBC 11B-1008.3.1.3 ADA 1008.3.1.3
Install tread striping	Striping is not provided on stairs connecting play components.	\$200	CBC 11B-210.1 CBC 11B-504.4.1
Modify play component	The 30 by 48 inch ground space with a slope of 2.0 percent maximum is not provided at each ground level component. The clear space adjacent to the play table has a slope of up to 3.4 percent, the clear floor space adjacent to the swings is up to 2.6 percent, and the clear floor space at the play counter is up to 2.3 percent (2.0 percent maximum allowed).	\$800	CBC 11B-1008.4.2 ADA 1008.4.2

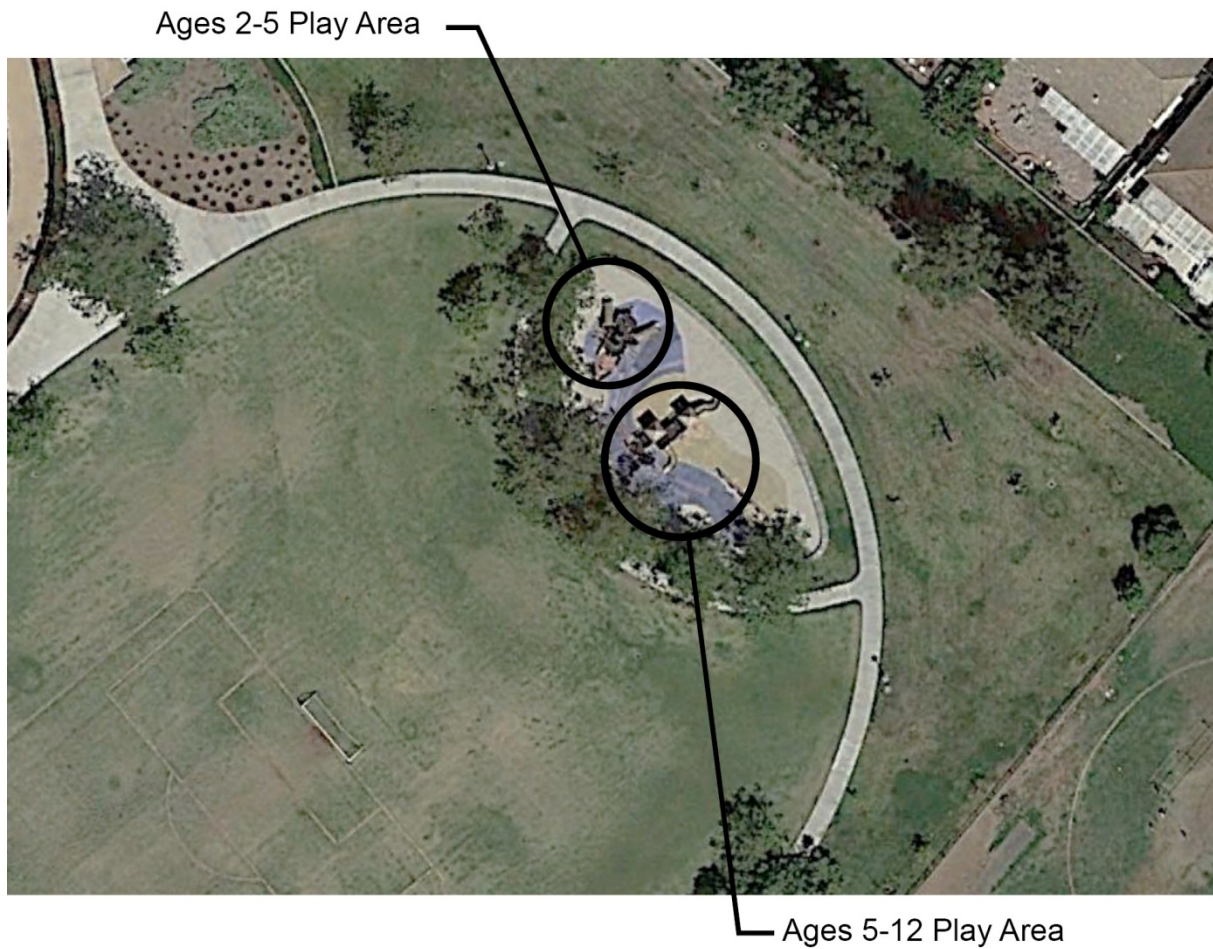
Action	Action Note	Planning Cost Estimate	Relevant Code
Improve or evaluate play area surface	Further evaluation of fall attenuation surface is recommended. Poured in place surface is cracked and patched in areas. Sand had migrated onto poured in place and is in need of maintenance.	\$0	CBC 11B-1008.2.6.1 ADA 1008.2.6.1 ADA 1008.2.6.2
Install tread striping	Striping is not provided on stairs connecting play components.	\$200	CBC 11B-210.1 CBC 11B-504.4.1
Modify play component	A 30 by 48 inches minimum clear space with a slope of 2.0 percent maximum is not provided at talk tubes in boat structure. Shared clear floor space between talk tubes is 33 inches. It is permissible to have clear floor spaces overlap but in this situation the location of the clear floor space limits use of ground level play components and circulation on the path of travel.	\$0	CBC 11B-1008.4.1 CBC 11B-1008.4.2 ADA 1008.4.1 ADA 1008.4.2

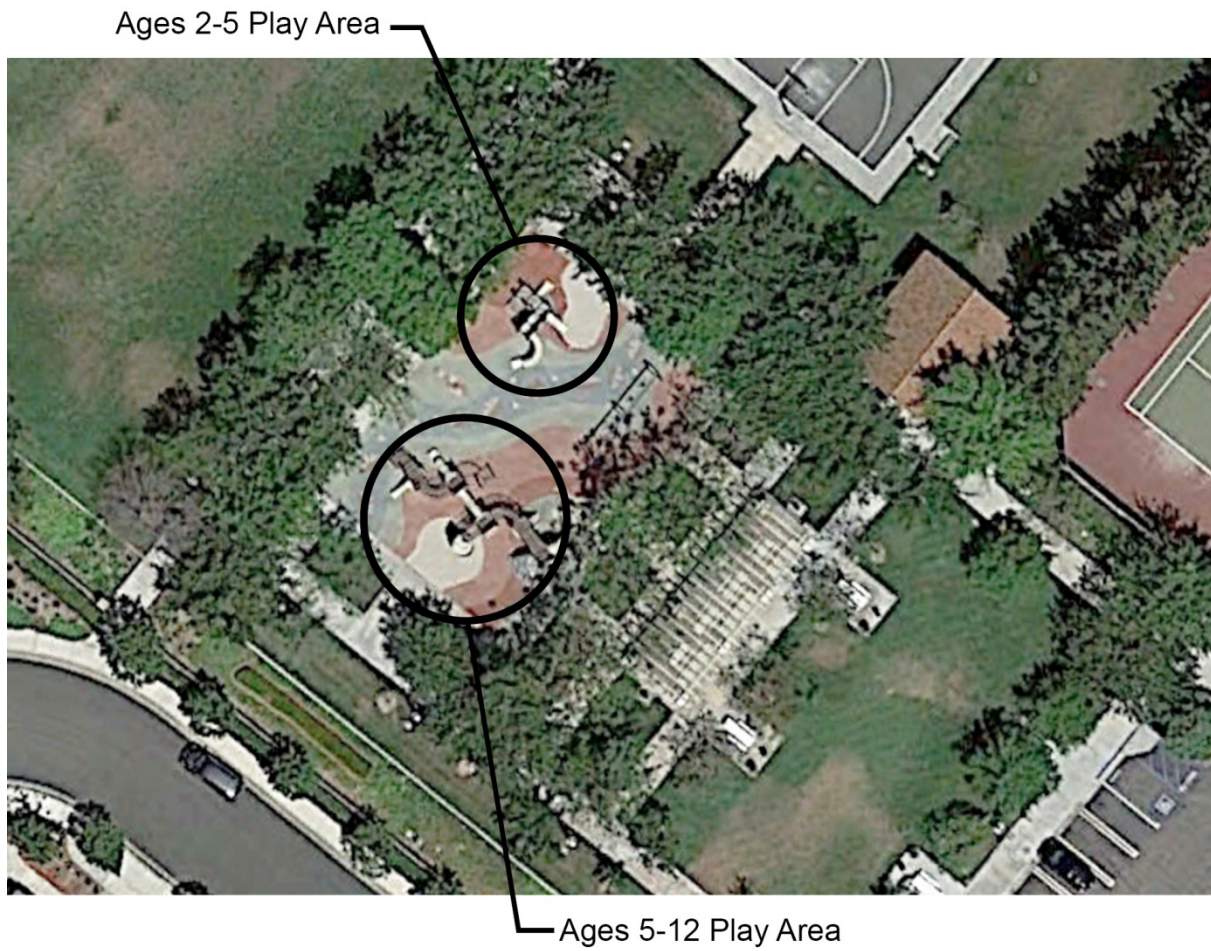
Action	Action Note	Planning Cost Estimate	Relevant Code
Improve or evaluate play area surface	Further evaluation of fall attenuation surface is recommended.	\$0	CBC 11B-1008.2.6.1 ADA 1008.2.6.1 ADA 1008.2.6.2
Install tread striping	Striping is not provided on stairs connecting play components.	\$200	CBC 11B-210.1 CBC 11B-504.4.1
Install or modify transfer system	Transfer platform is 20-1/4 inches wide between vertical supports (24 inches minimum wide required).	\$125	CBC 11B-1008.3.1.1 ADA 1008.3.1.1
Provide play components	One ground level play component is provided for six elevated (two ground level components are required including two different types).	\$5,000	CBC 11B-240.2.1.2 ADA 240.2.1.2
Total		\$5,325
