## GEOTECHNICAL INVESTIGATION AND WATER PERCOLATION TEST REPORT

HERITAGE PARK POOL FACILITY AND PARKING LOT 14301 YALE AVENUE CITY OF IRVINE, ORANGE COUNTY, CALIFORNIA

CONVERSE PROJECT No. 22-32-125-01

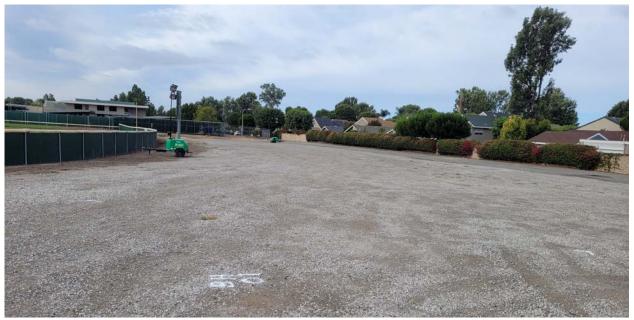
Photograph No. 1: Present site conditions at BH-01 facing southwest.

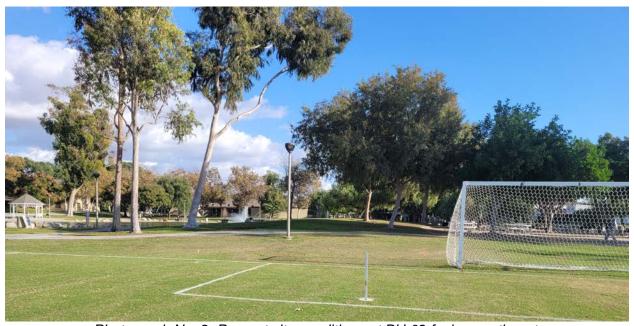
Photograph No. 2: Present site conditions at BH-02 facing southeast.

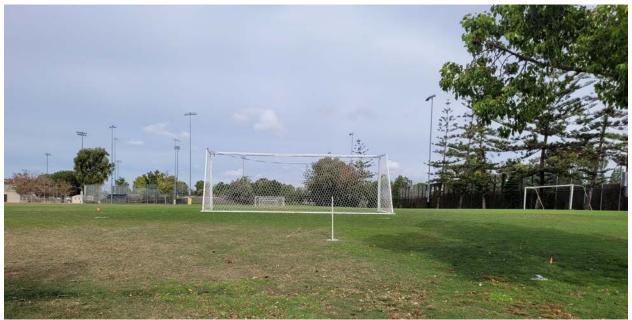
Photograph No. 3: Present site conditions at BH-03 facing northwest.
