Comprehensive Long-Term Environmental Action Navy (CLEAN) II
Contract No. N62742-94-D-0048
Contract Task Order No. 0104

Final
Environmental Baseline Survey
Former Marine Corps Air Station
El Toro, California

September 2003

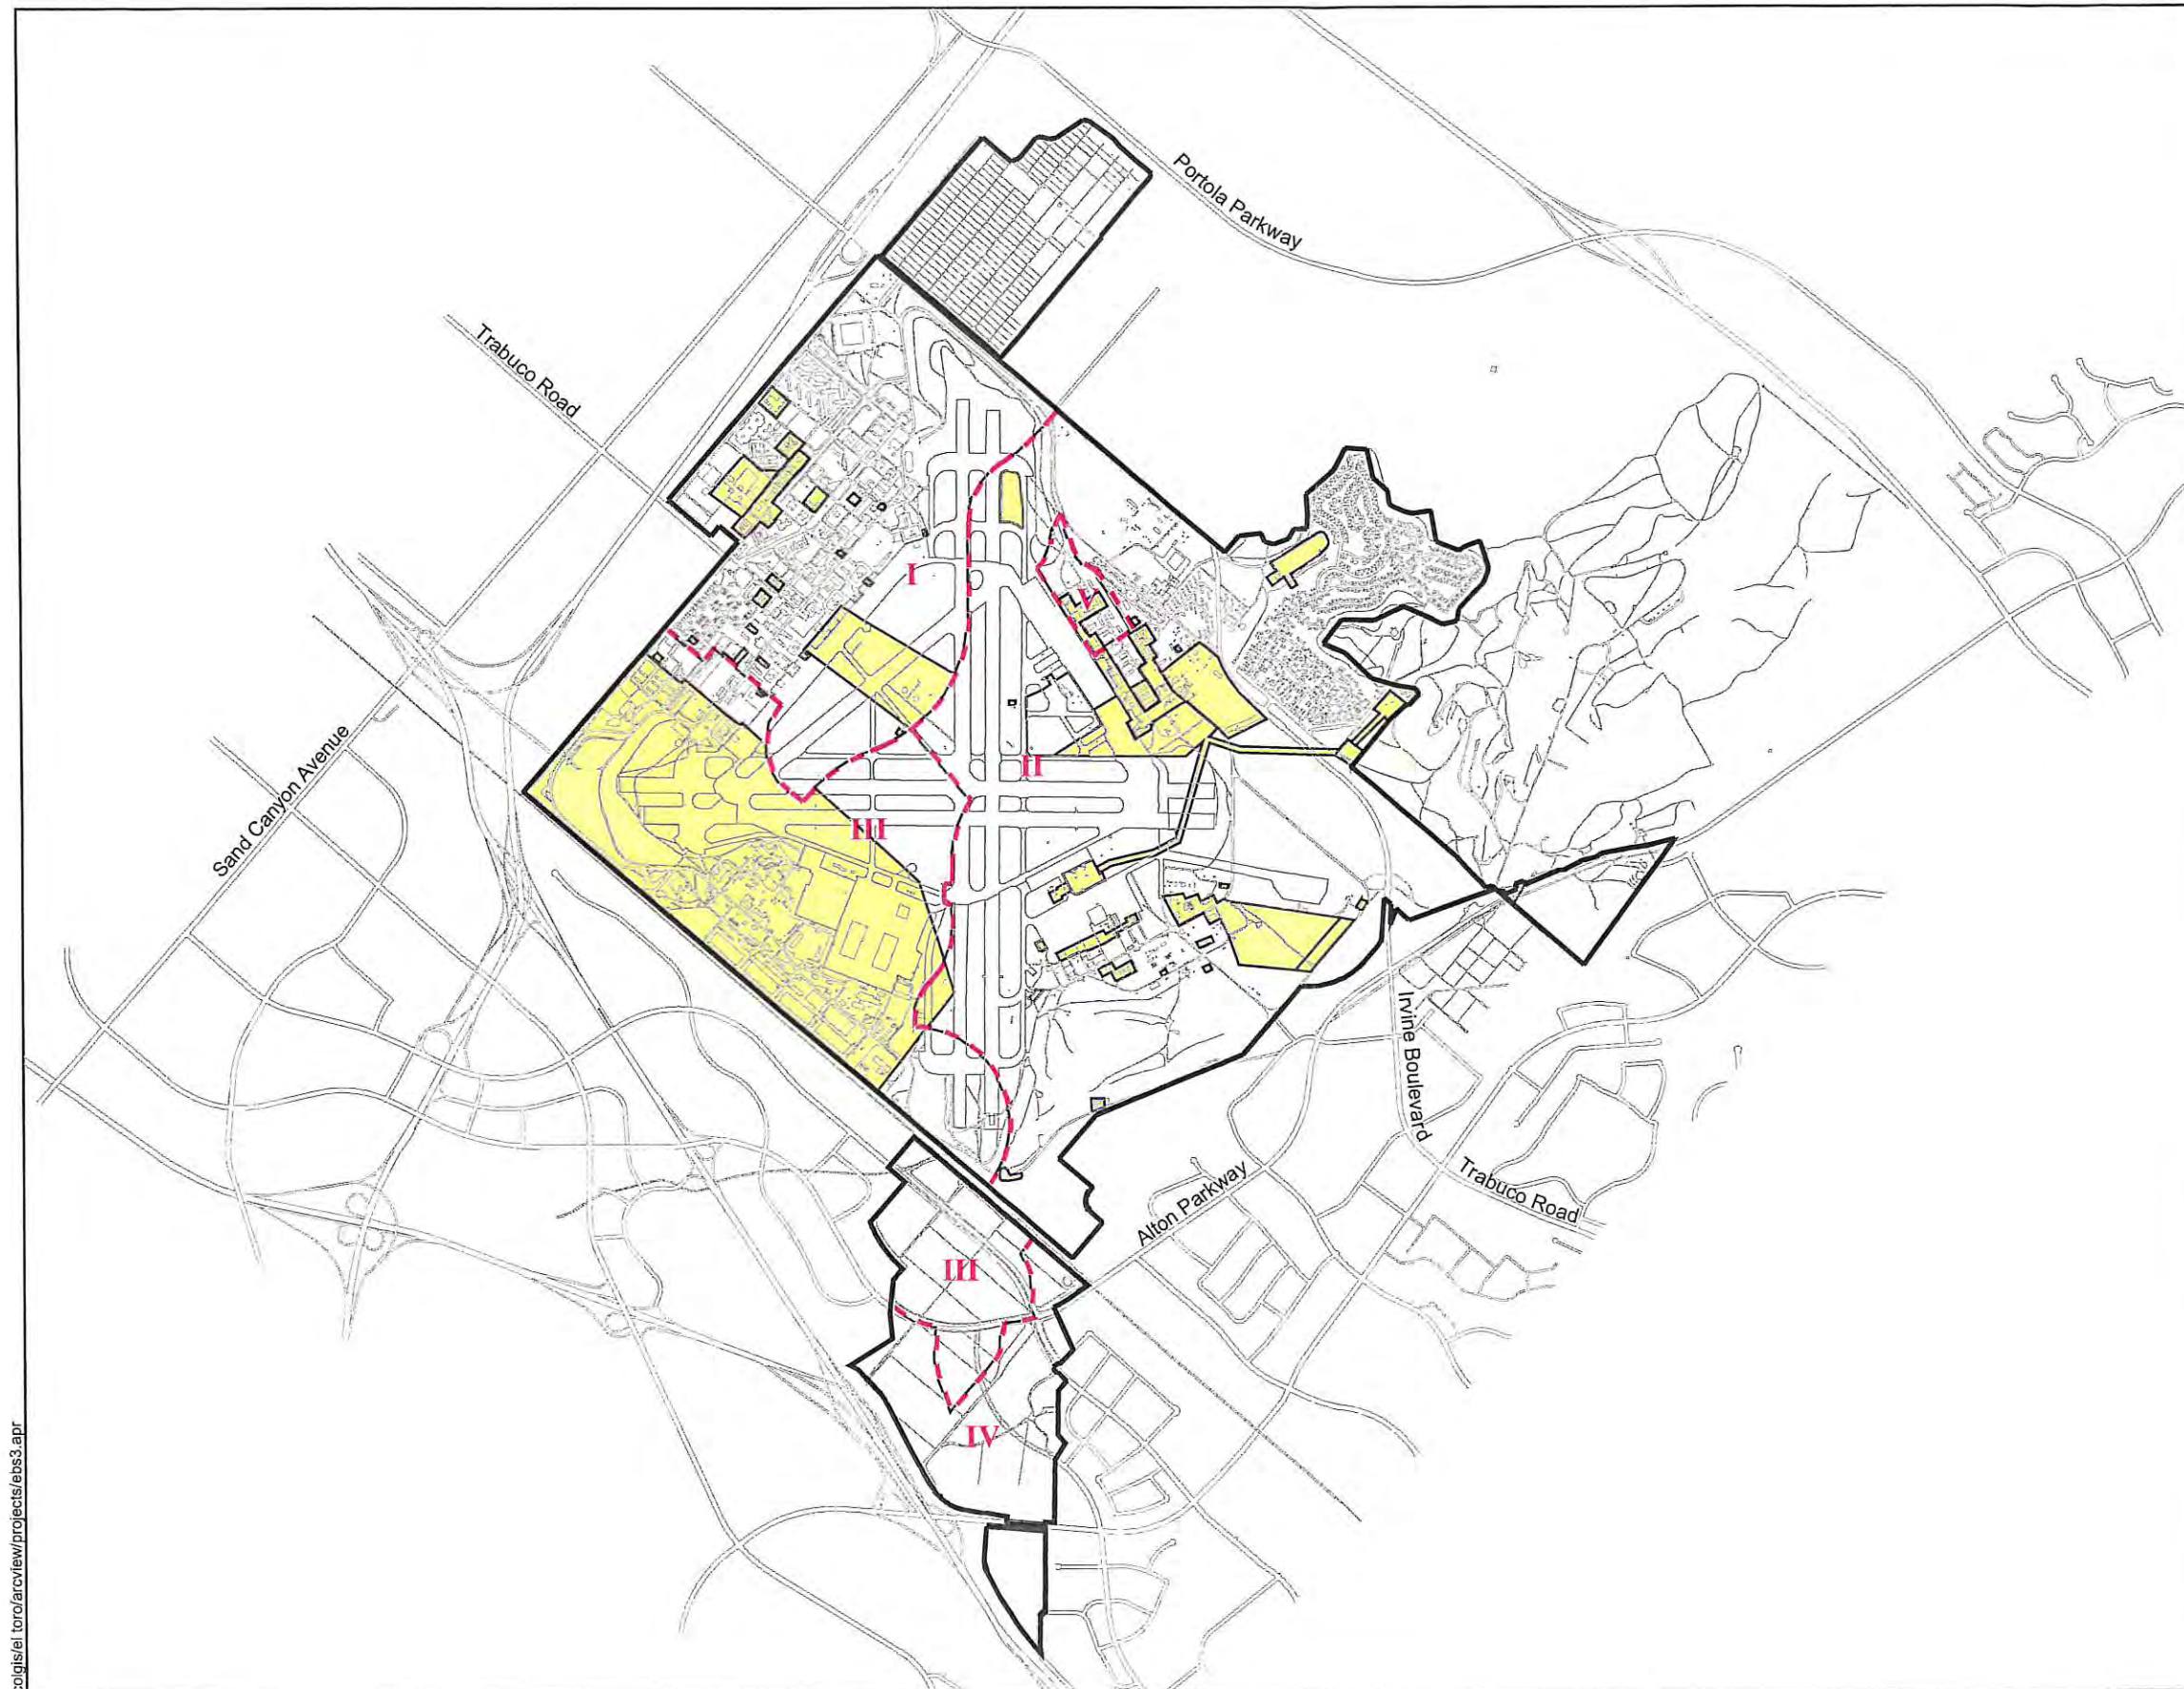
Figure ES-1
ECP Categories 1-4
and ECP Categories 5-7
Environmental Baseline Survey
Former MCAS El Toro
California

Based on the findings of this EBS, it has been determined that approximately 78 percent of the 3,717 acres of base property is environmentally suitable for transfer at this time. Figure ES-2 depicts the transferable and non-transferable property within former MCAS El Toro. Ongoing and future environmental investigations and response actions will cause the amount of property suitable for transfer to increase in the future.

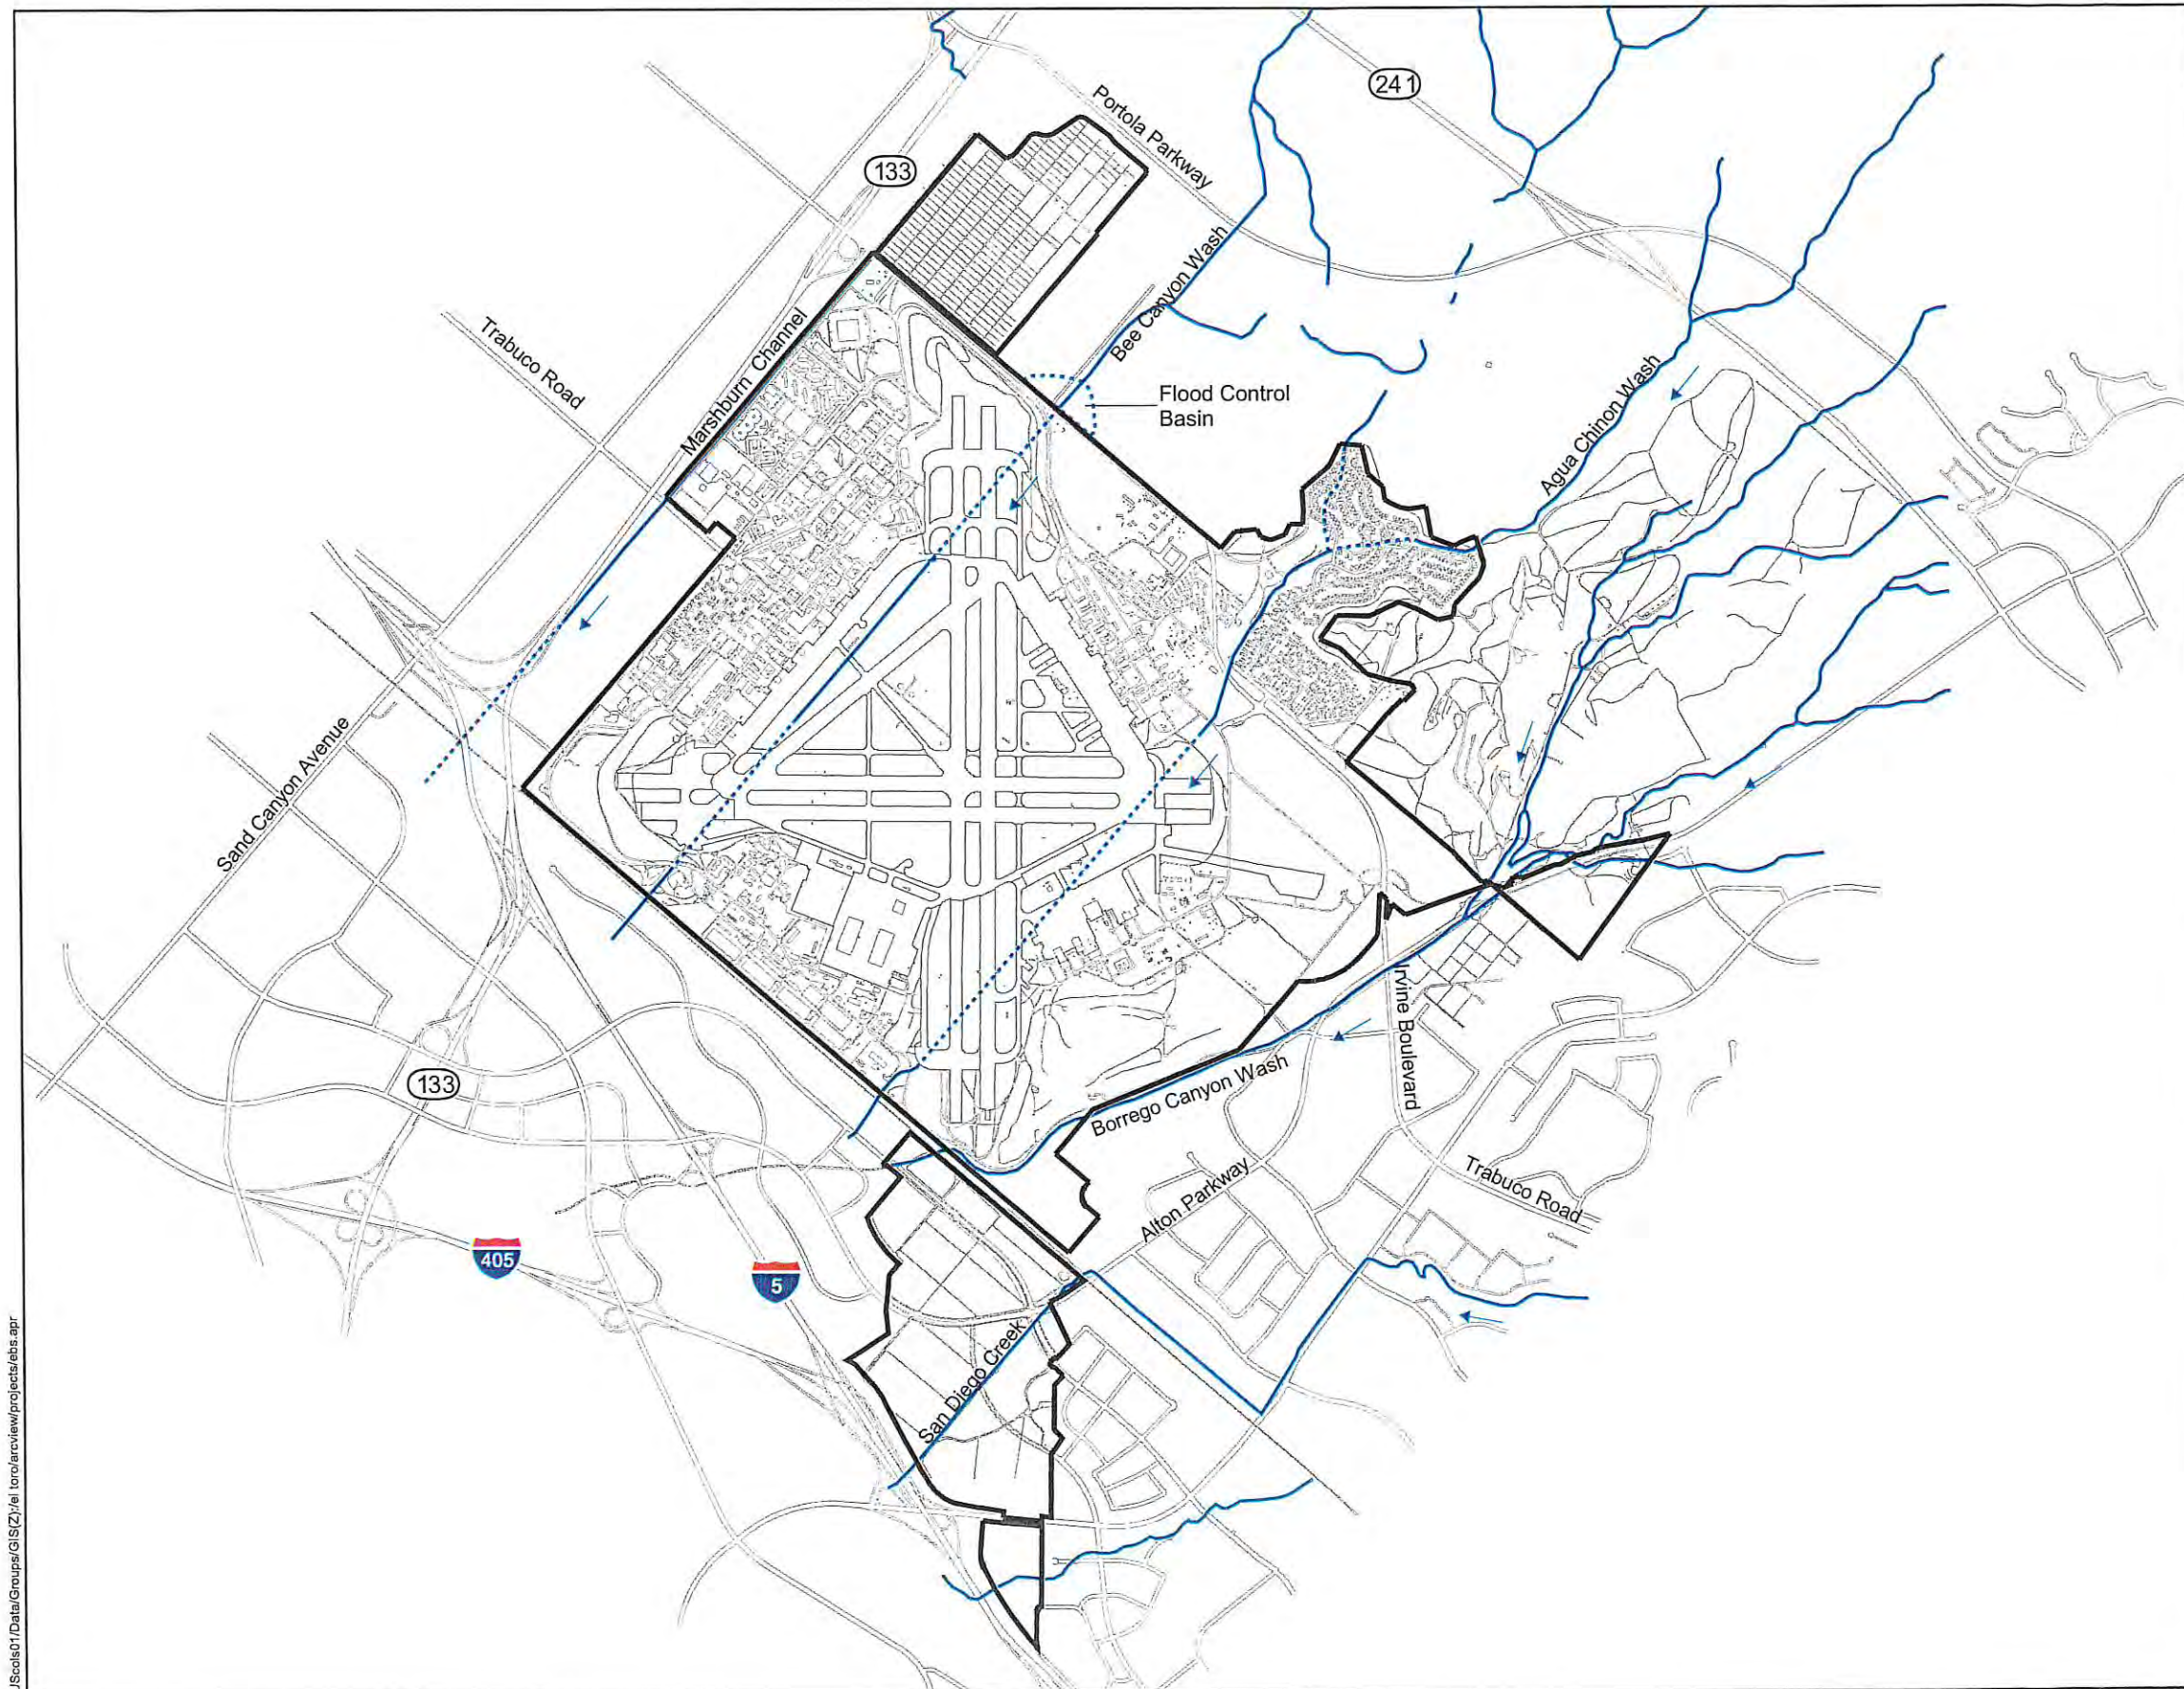
Figure 3-1
Surface Water Drainages
Environmental Baseline Survey
Former MCAS El Toro
California

- Property Boundary
- Roads
- Buildings
- Open Channels
- Underground Drainage
- Direction of Flow

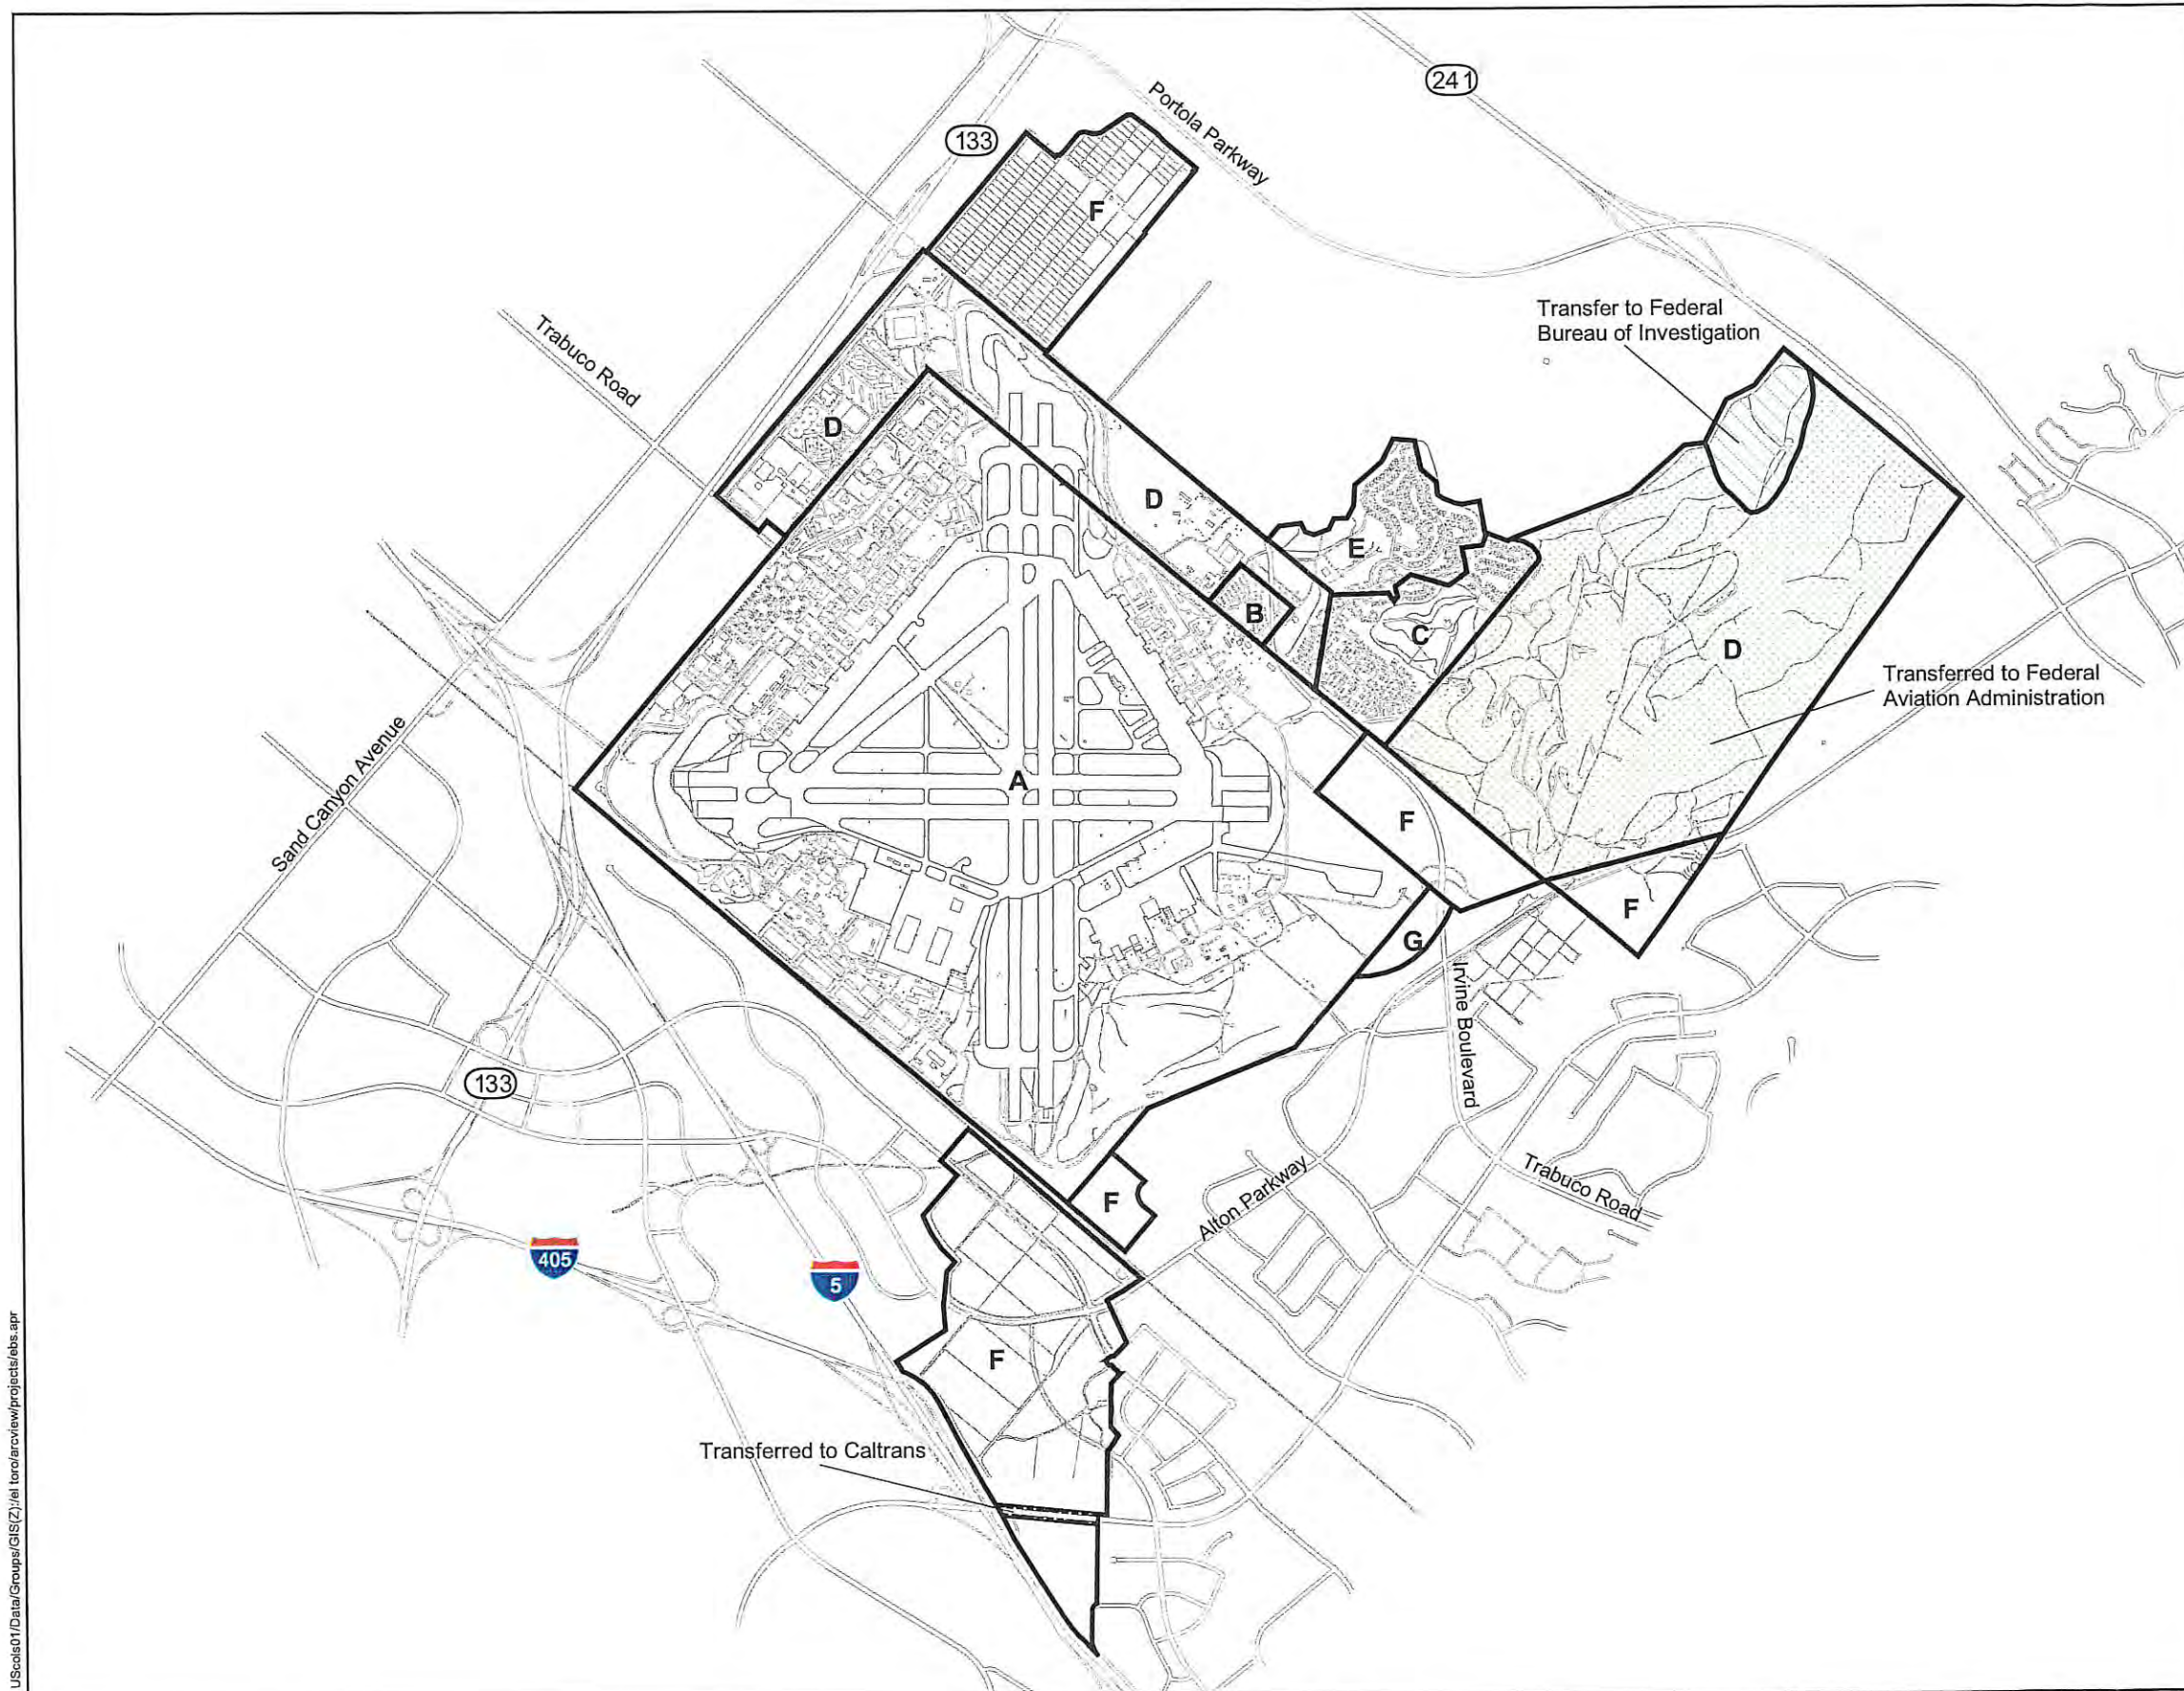
Figure 3-2
Property Acquisitions and Transfers
Environmental Baseline Survey
Former MCAS El Toro
California

part of the station, the other in the north part of the station. This property is currently used as an agricultural lease area. Finally, in December 1986, 17.7 acres of land were purchased from The Irvine Company. This property included a small piece of land in the east portion of the station. The total acreage for MCAS El Toro was 4,710 (USMC 1999).
