City of Irvine
Parks Master Plan
FINAL | JULY 2015

ADA Assessment of Play Areas in Irvine Parks

TECHNICAL SUPPLEMENT

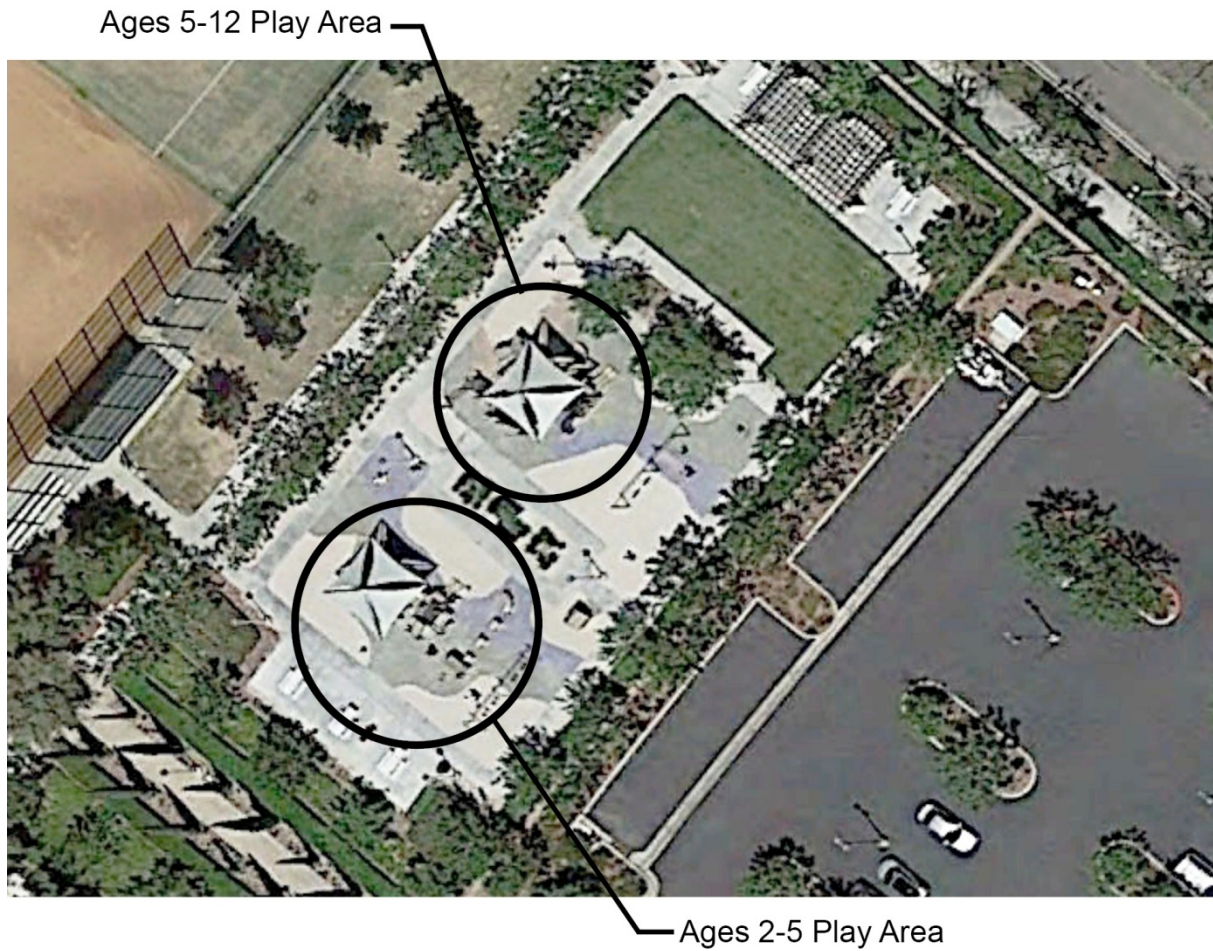
Woodbury Park: Ages 2 to 5 Play Equipment Area

Action	Action Note	Planning Cost Estimate	Relevant Code
Improve or evaluate play area surface	Further evaluation of fall attenuation surface is recommended. Worn top layer particularly at climber component.	\$0	CBC 11B-1008.2.6.1 ADA 1008.2.6.1 ADA 1008.2.6.2
Install or modify transfer system	The 30 by 48 inch ground space adjacent to transfer platform has a slope of up to 3.0 percent (2.0 percent maximum is allowed).	\$400	CBC 11B-1008.3.1.3 ADA 1008.3.1.3
Install tread striping	Striping is not provided on stairs connecting play components.	\$200	CBC 11B-210.1 CBC 11B-504.4.1
Modify play component	A 30 by 48 inch minimum clear space with a slope of 2.0 percent maximum is not provided at each ground level play component. Slope is up to 3.1 percent at spring toy, 3.4 percent at sand table, and 3.3 percent at swings.	\$1,200	CBC 11B-1008.4.2 ADA 1008.4.2
Provide play components	Knee space at play table is 18-5/8 inches high and 22 inches wide between benches (knee clearance shall be 24 inches high minimum and 30 inches wide minimum for tables not set up for parallel approach). The table is not positioned to allow for a parallel approach. Table is 12 inches behind front of benches.	\$5,000	CBC 11B-1008.4.3 ADA 1008.4.3
