Existing Conditions Report: University Community Park Adventure Playground

KISHIMOTO ARCHITECTS, INC.

October 13, 2010

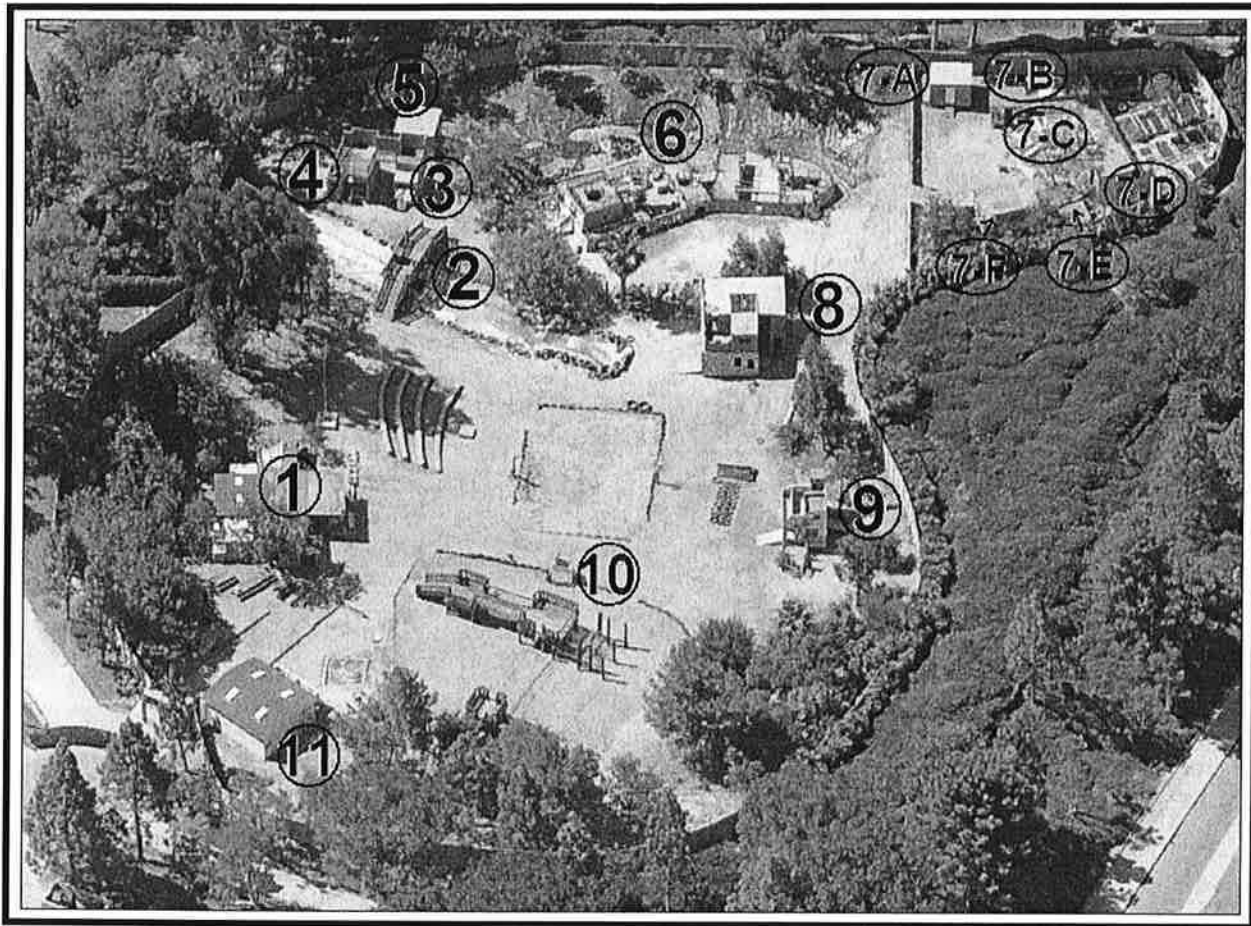
AERIAL PHOTO OF ADVENTURE PLAYGROUND AND LIST OF STRUCTURES/FEATURES

List of Structures

Additionally, aerial photos of the site are shown below on page 2 and page 3.
